## ENGINE RUN REPORT

| ENGINE MODEL | O-470-K |
| AIRCRAFT MAKE & MODEL | Cessna 180D |
| FILE NUMBER | 18-272 |

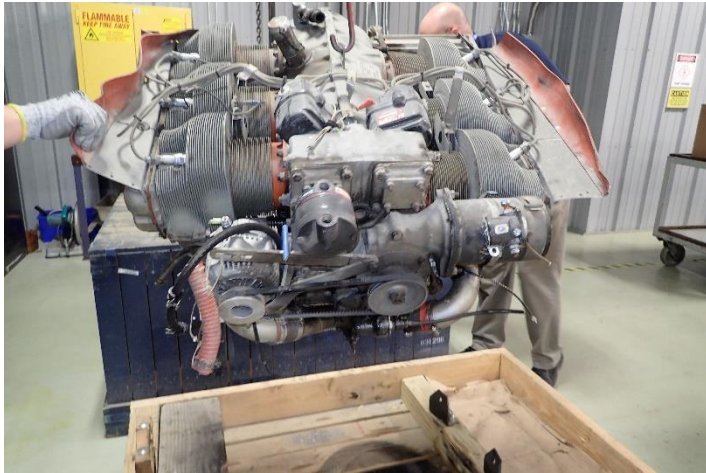
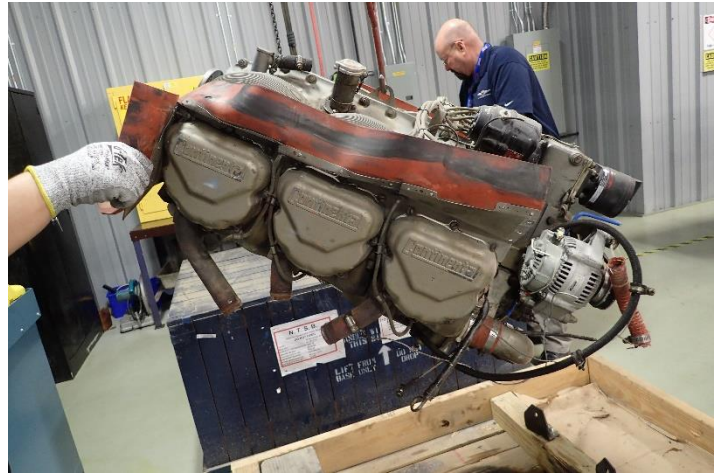
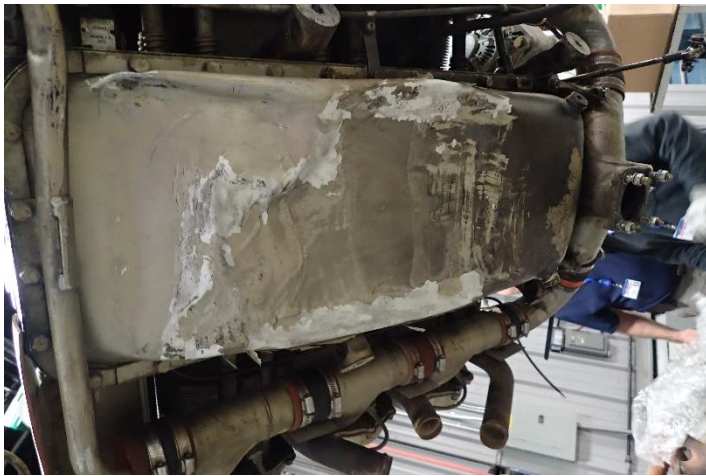
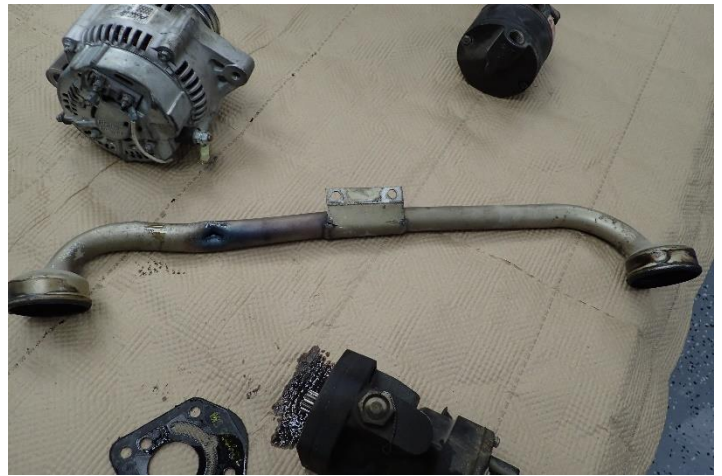
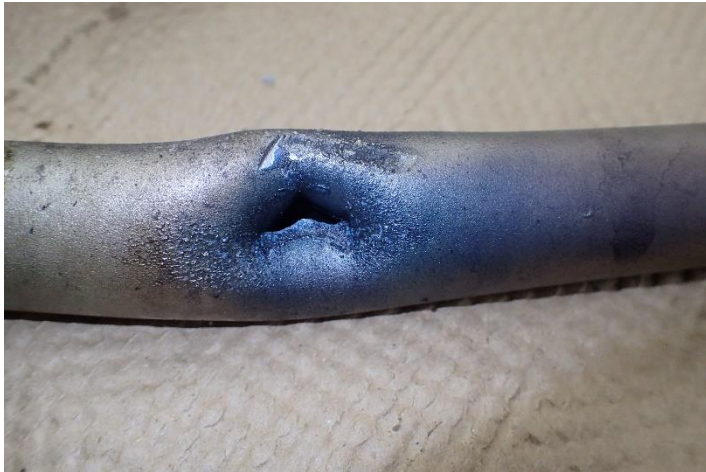
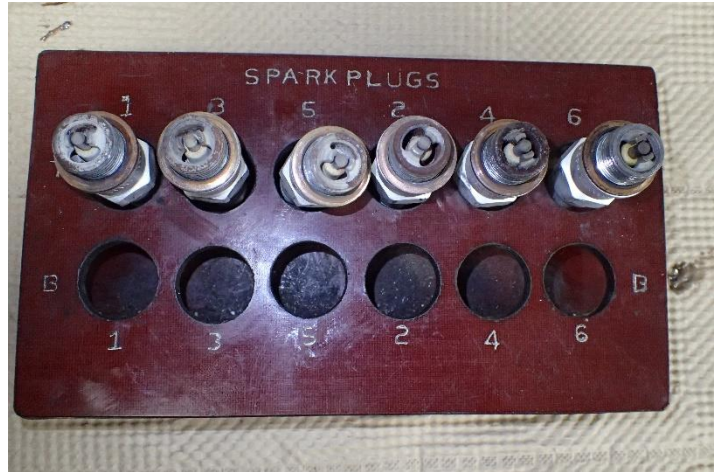
The engine displayed impact damage signatures to the oil sump, exhaust, and balance tube. The rest of the engine was undamaged. The crankcase was intact and there were no holes in the crankcase that would indicate a catastrophic internal engine failure. The propeller flange remained attached to the rest of the crankshaft and was undamaged. All six cylinders remained attached to their cylinder bays and were undamaged. The oil sump displayed impact damage signatures and was removed for replacement; the oil inlet screen was observed and displayed a small amount of sludge in the screen; however, the screen was not blocked. The camshaft was partially visible and displayed normal operating and lubrication signatures.

The induction system displayed impact damage signatures to the balance tube. There was a small hole noted at the impact damaged area and blue staining surrounded the hole. The induction risers were intact and there were no signs of fuel leaks observed around the risers. The exhaust system displayed impact damage signatures to the risers and to the muffler. The muffler heat exchanger shroud was removed and examined; there were no signs of exhaust leaks observed with any of the exhaust components.
