# Continental Motors

## ENGINE EXAMINATION REPORT

| ENGINE MODEL | O-470-K (P. Ponk conversion to O-470-50) |
| FILE NUMBER | 18-346 |

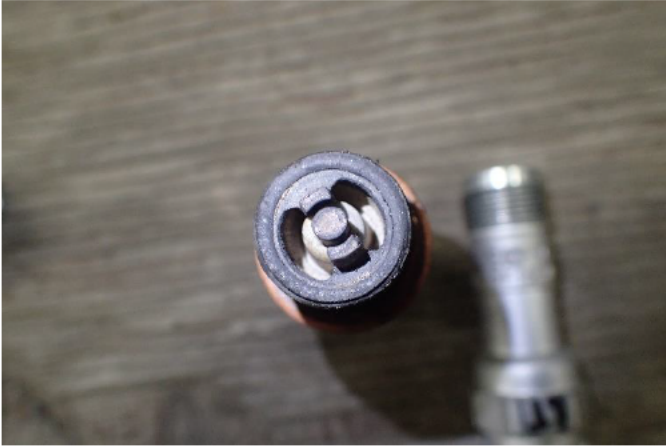
#4 Top Spark Plug

All of the spark plugs remained installed in their cylinders and were undamaged. The top spark plugs were removed, and the electrodes were visually inspected. The electrodes displayed normal operating and wear signatures. The bottom spark plug electrodes were inspected using a lighted borescope; the electrodes displayed normal operating signatures. There were no anomalies noted.

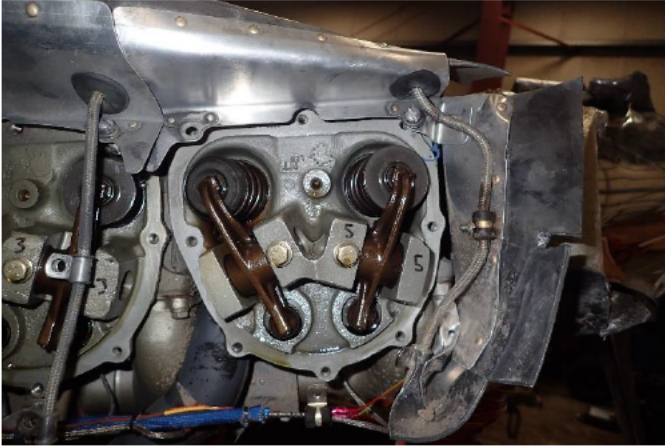
#5 Cylinder (borescope photo obscured by oil on lens)

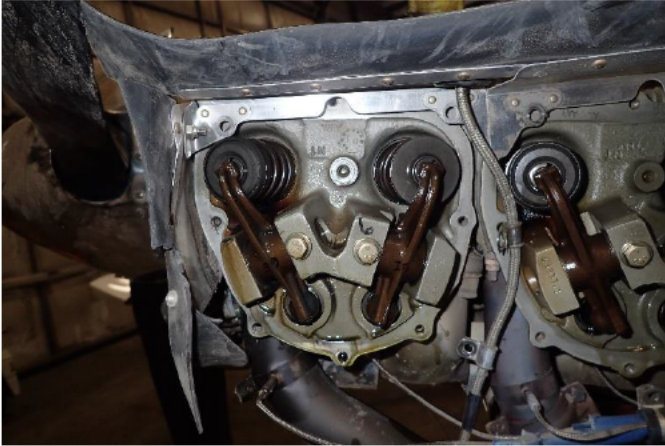
#6 Cylinder (borescope photo obscured by oil on lens)
