## INVESTIGATION SUPPLEMENTAL DOCUMENTATION

On January 23, 2019, at 1143 Pacific standard time, a Bell 206L-3, N8227J, collided with trees while maneuvering near the Siskiyou Summit south of Ashland, Oregon. The airline transport pilot, the sole pilot, was fatally injured; the helicopter sustained substantial damage. The helicopter was registered to HeliFleet LLC and operated by Erickson Helicopters Inc., under the provision of 14 Code of Federal Regulations Part 91. Marginal visual meteorological conditions prevailed in the area of the accident and a company visual flight rules flight plan had been opened. The local area time-building flight originated from the Medford Airport, Medford, Oregon, at 0920.

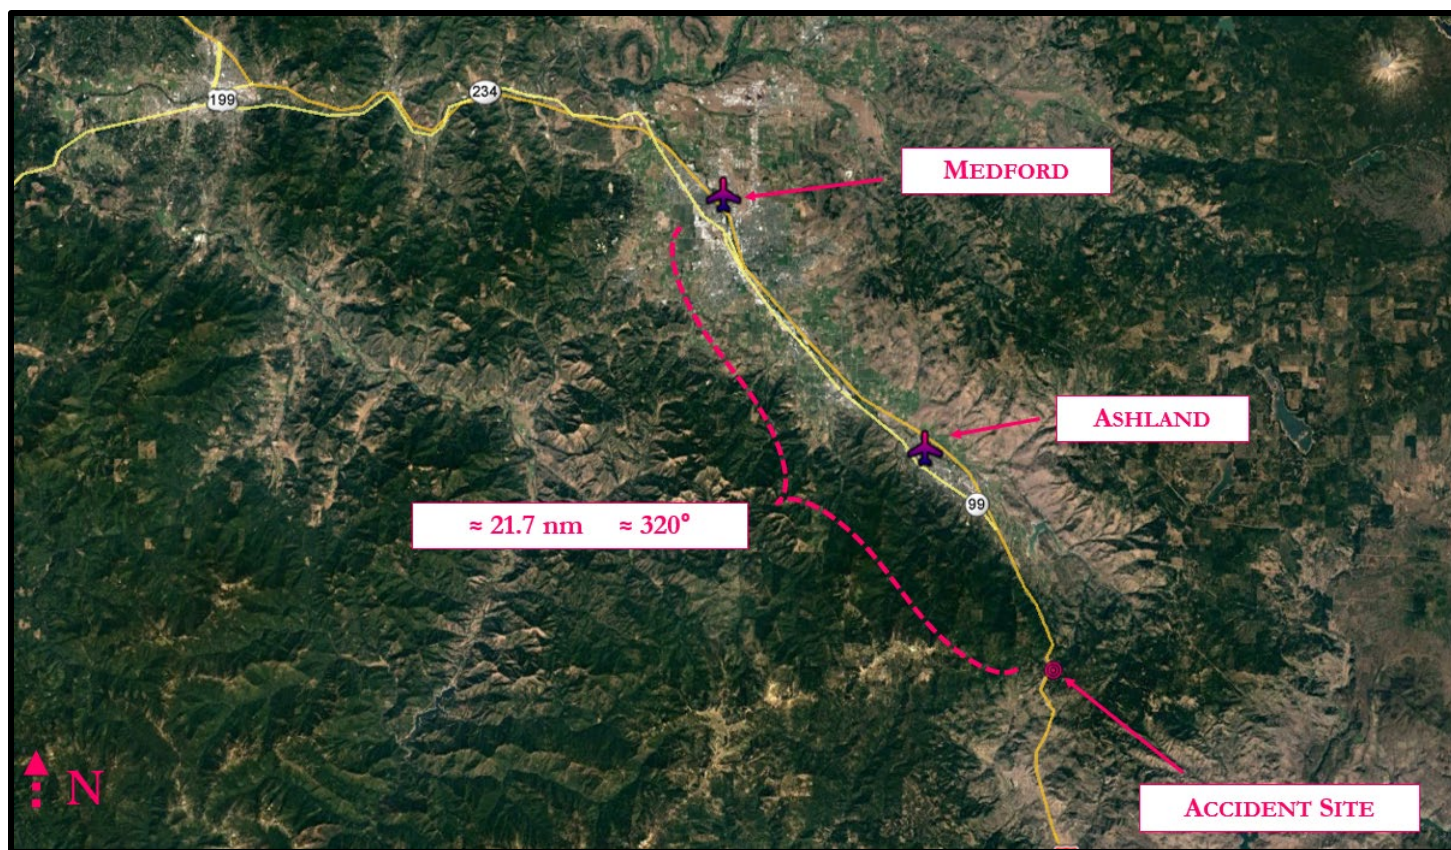
Figure 1: Accident Site in Reference to Departure Airport

The accident site was located in the dense tress about 9 nautical miles (nm) southeast of Ashland. In character, the terrain was composed of mature Douglas-Fir and Ponderosa Pines trees between 100-150 feet in height. The wreckage was found distributed over a 100 ft distance with no discernable flight path direction.

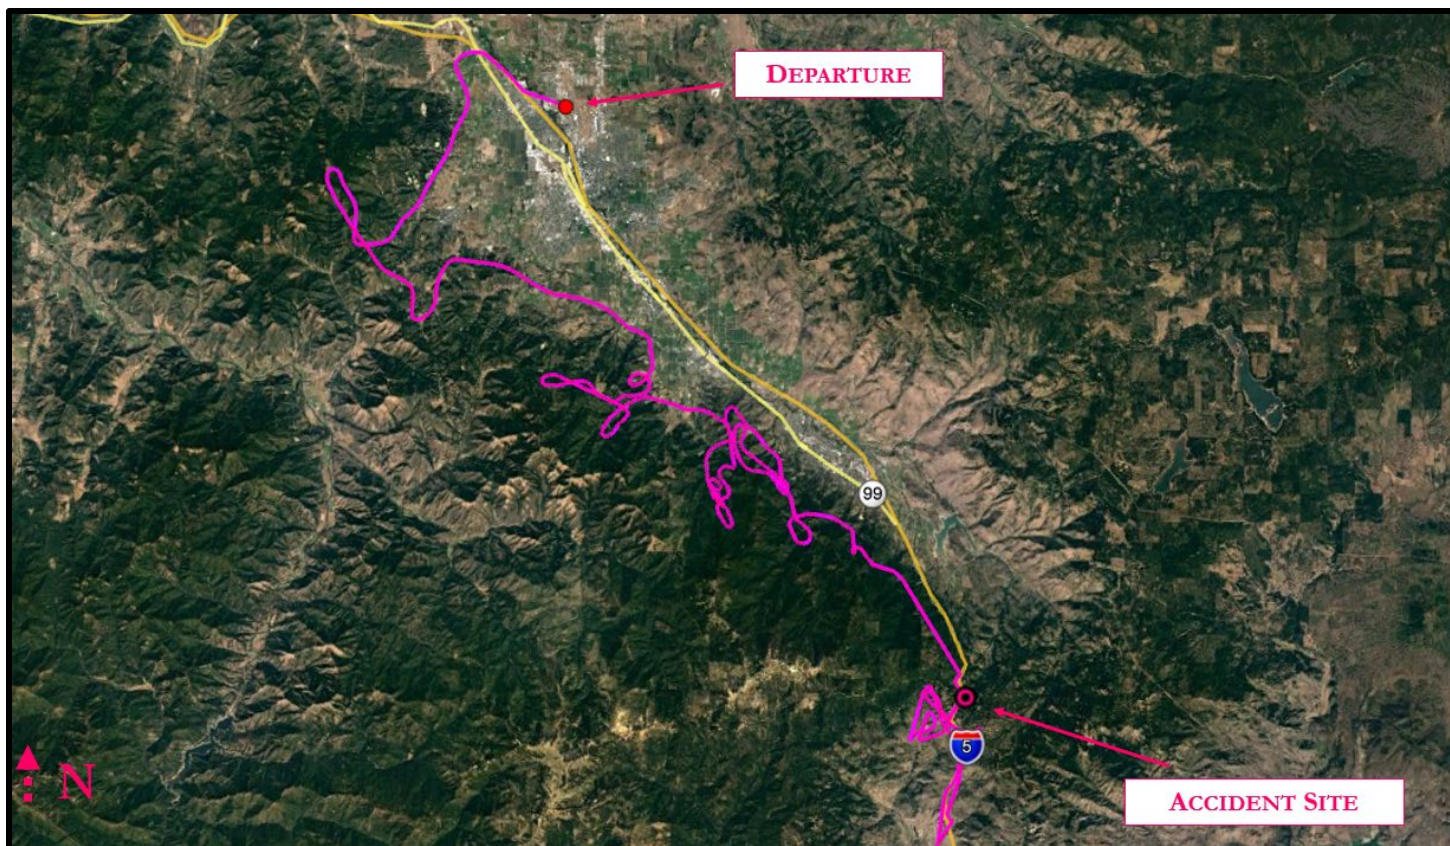
Figure 2: Radar Data

A review of the preliminary radar data disclosed that in the 1.5 hours following departure, the helicopter maneuvered in the local area west of Ashland making numerous turns. Thereafter the helicopter continued south over the Siskiyou Summit and after making various low-level maneuvers, followed Interstate 5 (I-5) toward Hilt, Oregon. Around 1120 the helicopter began to head north and made several turns and slow maneuvers. At 1141, the helicopter continued north and adjoined the I-5 for about 1.5 minutes. At 1142:50 the radar track showed that the helicopter then made several turns until heading east. The last radar return at 1143:30 was located in the immediate vicinity of the accident site and oriented about 600 ft east of the interstate at an elevation of about 4,100 ft.

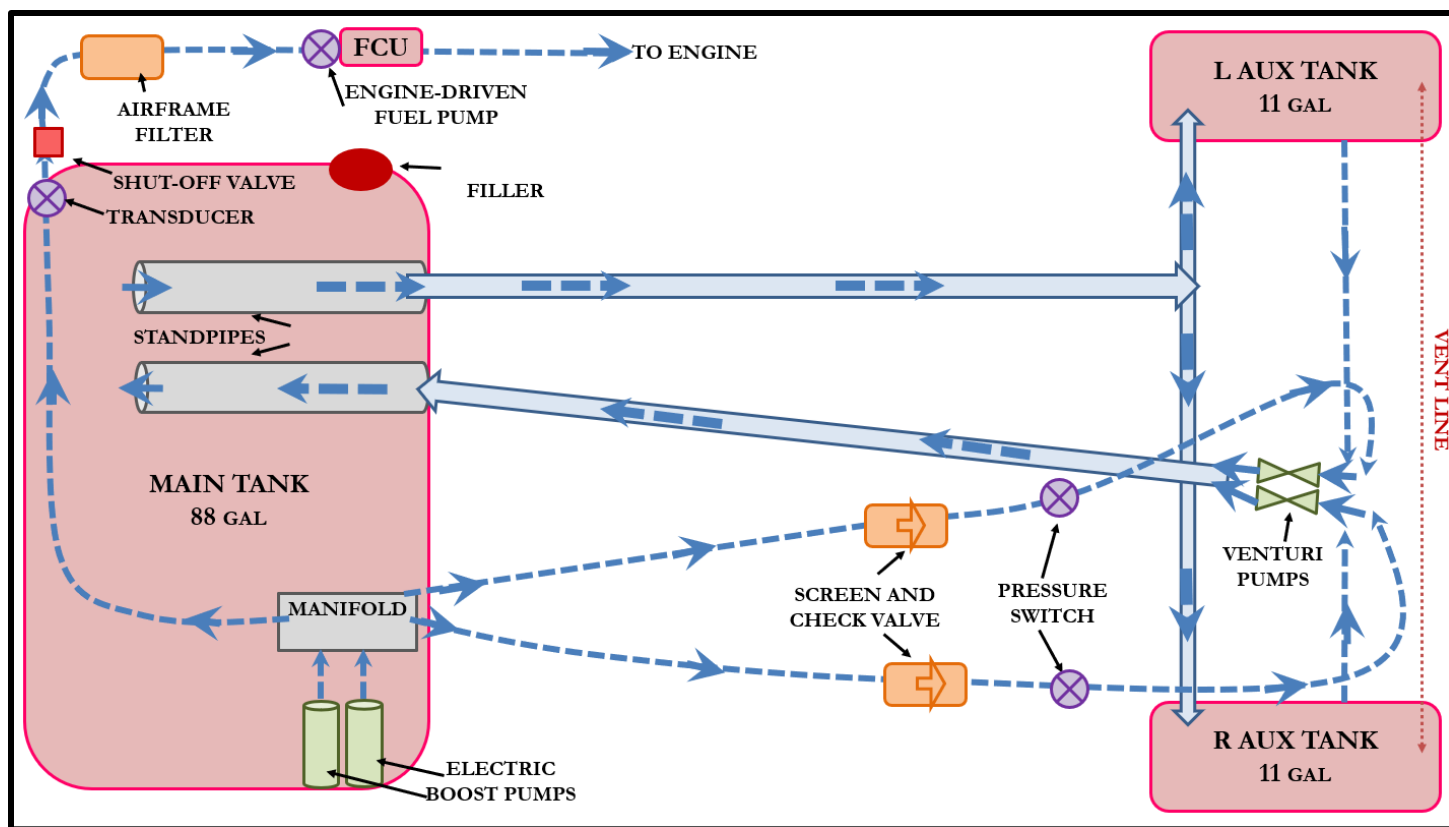
Figure 16: Fuel Diagram

After being picked up at the bottom of the main tank and passing through the two boost pumps, fuel was piped to the top of the tank. From there fuel was piped to the engine through a fuel pressure sensor, electrically-operated shut-off valve and low pressure fuel filter.

The fuel valve was observed to be in the Open position. The airframe fuel filter was empty of fuel when examined; no particulate was observed in the bottom of the fuel filter canister and the paper filter was also clean. Fuel line connections on the floor between the forward fuel cells and the main (aft) fuel cell were not fractured. The ejector pump assembly and flow switches between the two forward fuel cells were intact. The forward fuel cells were unbreached and contained fuel. It was reported by Erickson that fuel was removed from the fuel cells during recovery and approximately 27 gallons of fuel was removed from both forward and main (aft) cells. The boost pump plate remained attached to the main fuel cell and the pumps appeared to be intact. The main fuel cell was observed to be torn near the boost pump plate in an area of airframe fracturing.

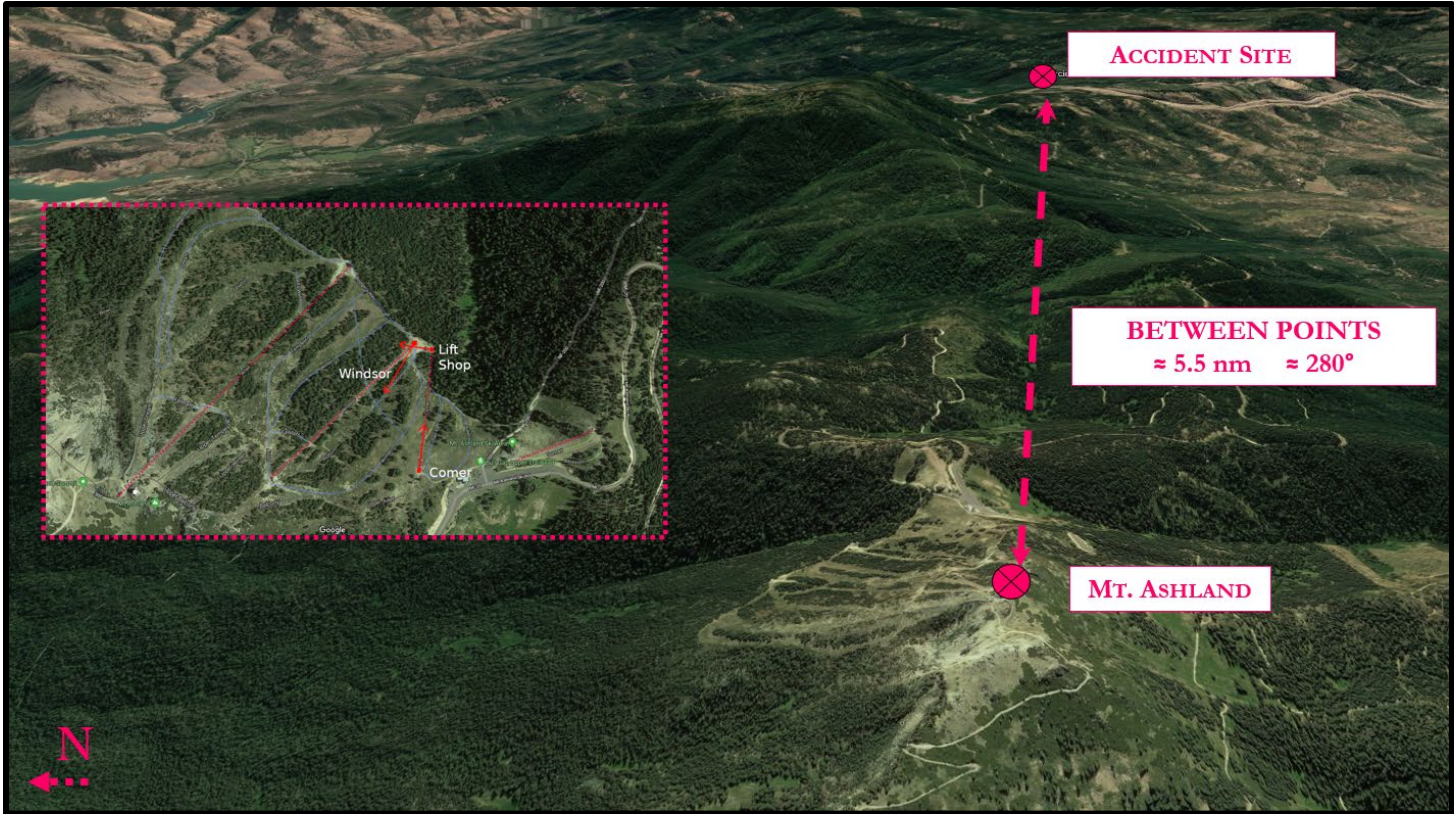
Figure 23: Cameras in Relation to Accident Site

Cameras were located at the nearby ski mountain, Mt. Ashland.

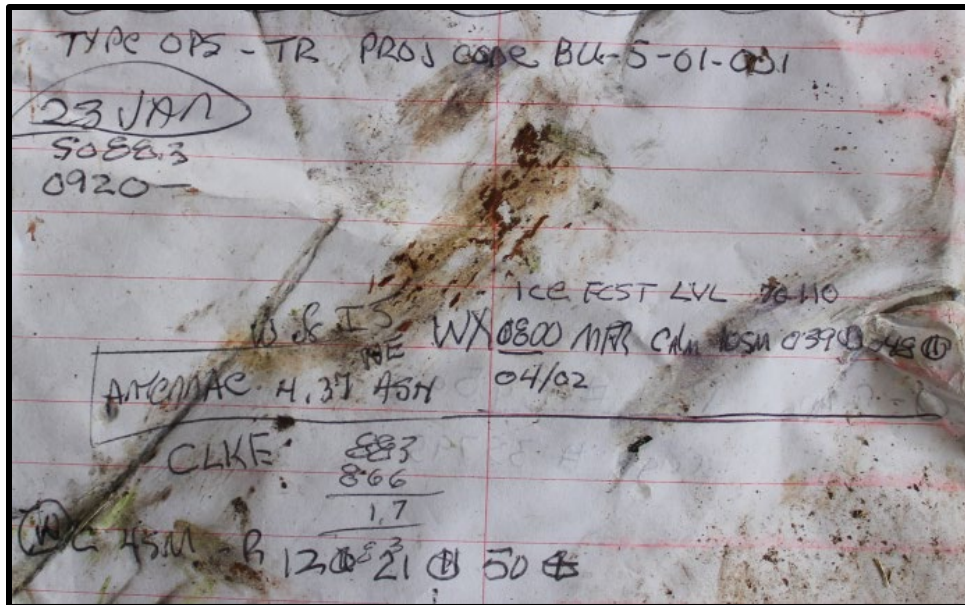
Figure 24: Pilot's Kneeboard Notes

The pilot’s kneeboard writings was consistent with the 0853 METAR at Medford:  
MVFR METAR KMFR 231653Z 00000KT 4SM -RA BR BKN012 BKN021 OVC050 04/02 A3048 RMK AO2 RAB40

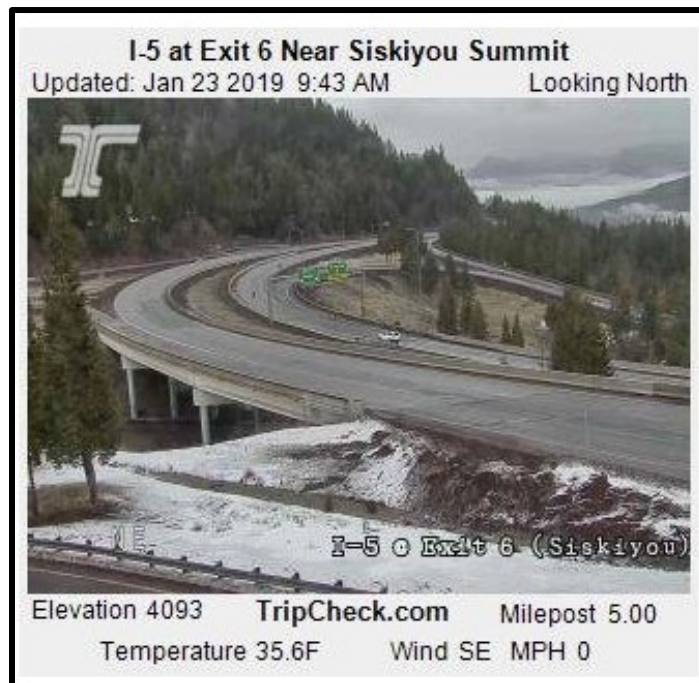
Figure 25: ODOT Webcam near the Accident

The Oregon Department of Transportation (ODOT) webcam 45, located about 3,300 ft northwest of the accident site streamed the weather the day of the accident, but the images are not recorded. Weather Underground recorded the image at 0943 the day of the accident.
