**NATIONAL TRANSPORTATION SAFETY BOARD**

**AIRPLANE EXAMINATION**

**WPR19LA098**

**WPR19LA098**  
**Reno, Nevada**  
**March 17, 2019**  
**0815 PT**  
**Piper PA-24 – N5028P**

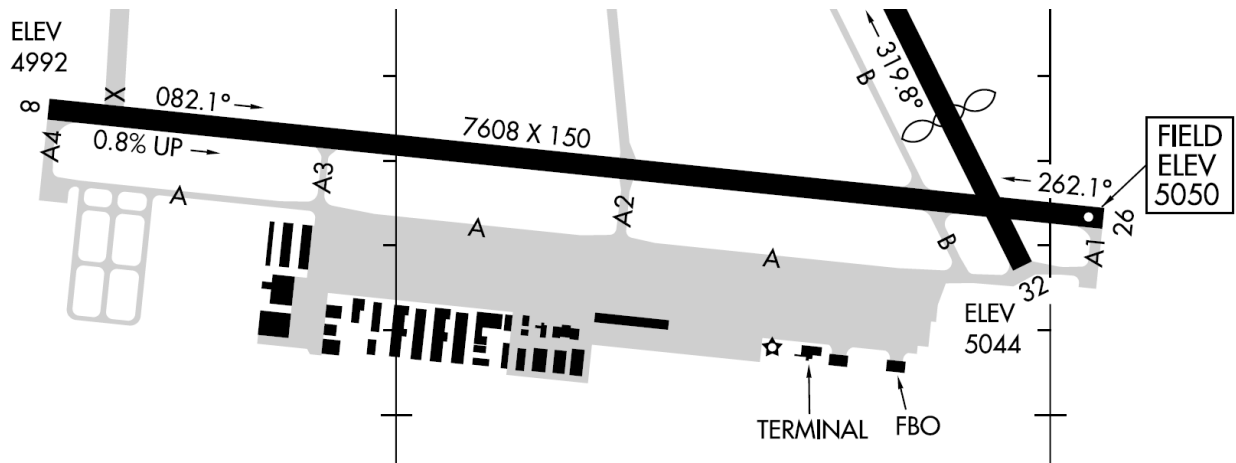
Photograph 1: Reno/Stead Airport Diagram (Airnav)

Runway tire markings were displayed along the left side of the runway centerline about taxiway B. Main landing gear tire marks arced to the right of the runway centerline and continued to the left of centerline and terminated at the left side runway edge in the direction of the runway distance remaining sign that was impacted adjacent to taxiway A2 (photograph 1).
