**NATIONAL TRANSPORTATION SAFETY BOARD**  
**Office of Aviation Safety**  
**Washington, D.C. 20594**

**POWERPLANT GROUP CHAIRMAN'S FACTUAL REPORT**

**NTSB No: WPR19LA122**

Aircraft: Bell 206 Helicopter, Registration Number N206JH

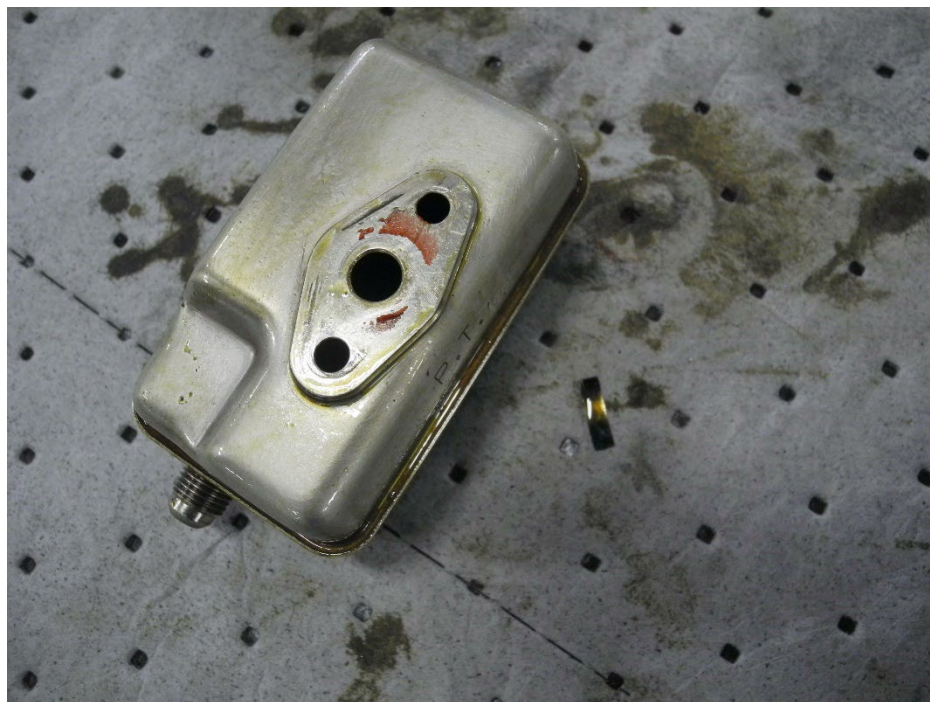
Photo 7 – Last Chance Oil Screen

The gearbox module, S/N CAG-36471, and was intact and appeared to be undamaged ([Photo 4](#)). An examination of the two chip detectors revealed fine particles on the upper chip detector and a small shiny flake in the lower chip detector ([Photo 5](#)). A rattling noise emanated from the No. 6 and No. 7 bearing oil sump can as it had been drained of approximately a ½ cup of oil, and upon further investigation revealed that it contained a damper from one of the No. 6 or No. 7 bearings ([Photo 6](#)). The oil supply nozzles for the Nos. 6, 7 and 8 nozzles were removed and found to be oil wetted and undamaged. The last-chance oil screen was clean ([Photo 7](#)). Alcohol was introduced into the feed tube and seen to exit the nozzles, indicating a clear flow path.

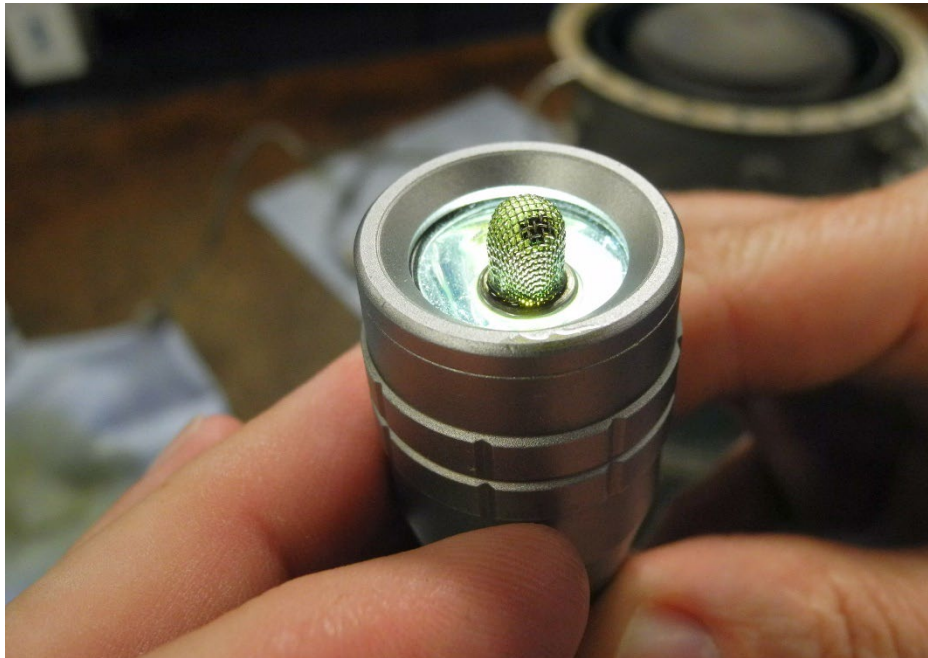
The oil filter was examined and found to be clean ([Photo 8](#)).

Photo 8 – Oil Filter - Clean
