| <b>Rolls-Royce</b> | Rolls-Royce Corporation<br>450 S. Meridian Street<br>Indianapolis, Indiana<br>46225-1103, USA | <b>REPORT NO.</b><br>19FAE-061-PR | <b>REV.</b><br>Initial | <b>PAGES</b><br>1 of 64 |
| <b>TITLE</b><br><br><b>METALLURGICAL INVESTIGATION OF A THIRD STAGE TURBINE WHEEL, P/N 23065818, REMOVED FROM AN M250 C20B ENGINE, S/N CAE832565 OPERATED BY WILBUR ELLIS CO.</b> | | <b>PREPARED</b><br><br>Signatures on File | | |

| Part Name: | Third Stage Turbine Wheel |
| Engine Serial Number: | CAE832565 |

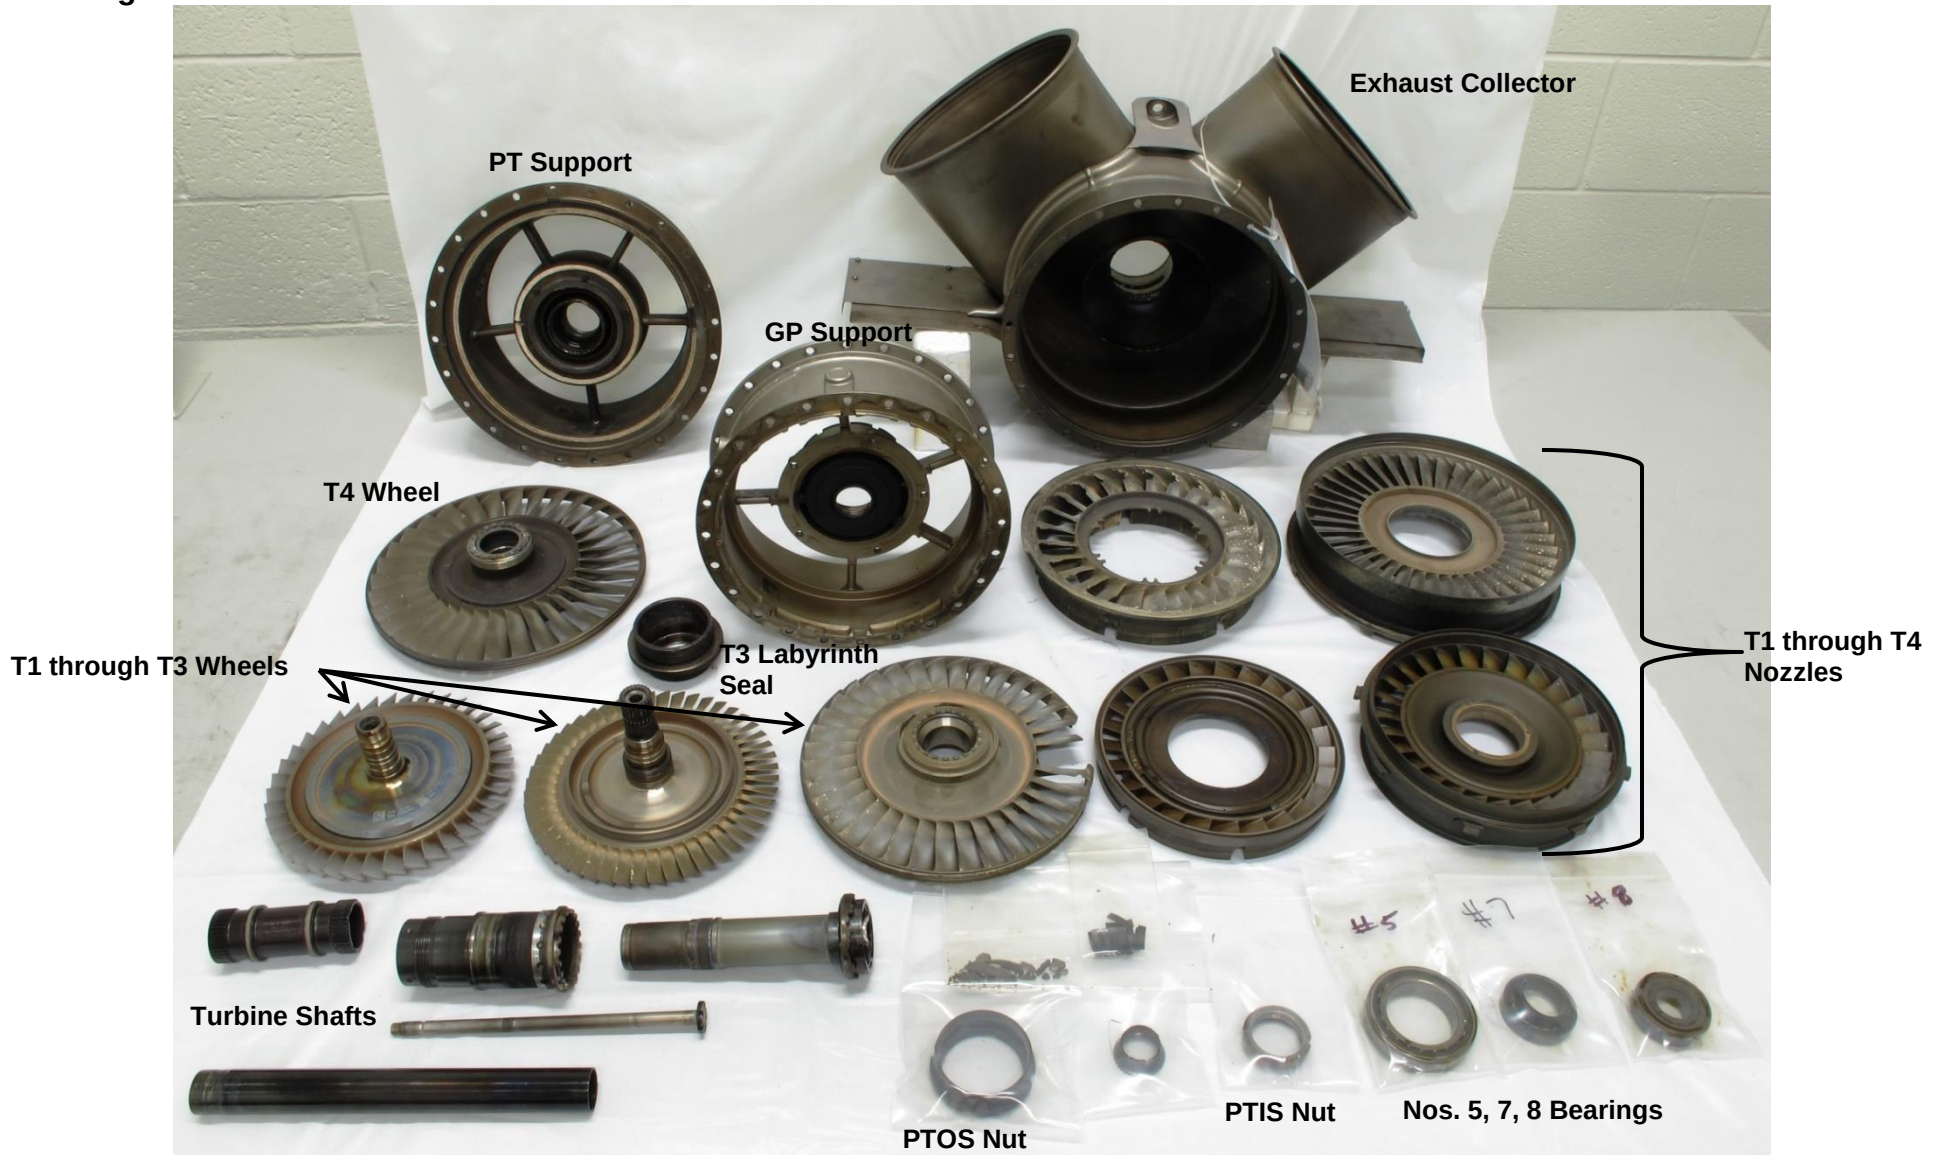
Figure 1 shows the hardware returned to the laboratory in the as-received condition. The components submitted to the laboratory are listed in Table 1.

Figure 1. As-received condition of the components returned to the laboratory.

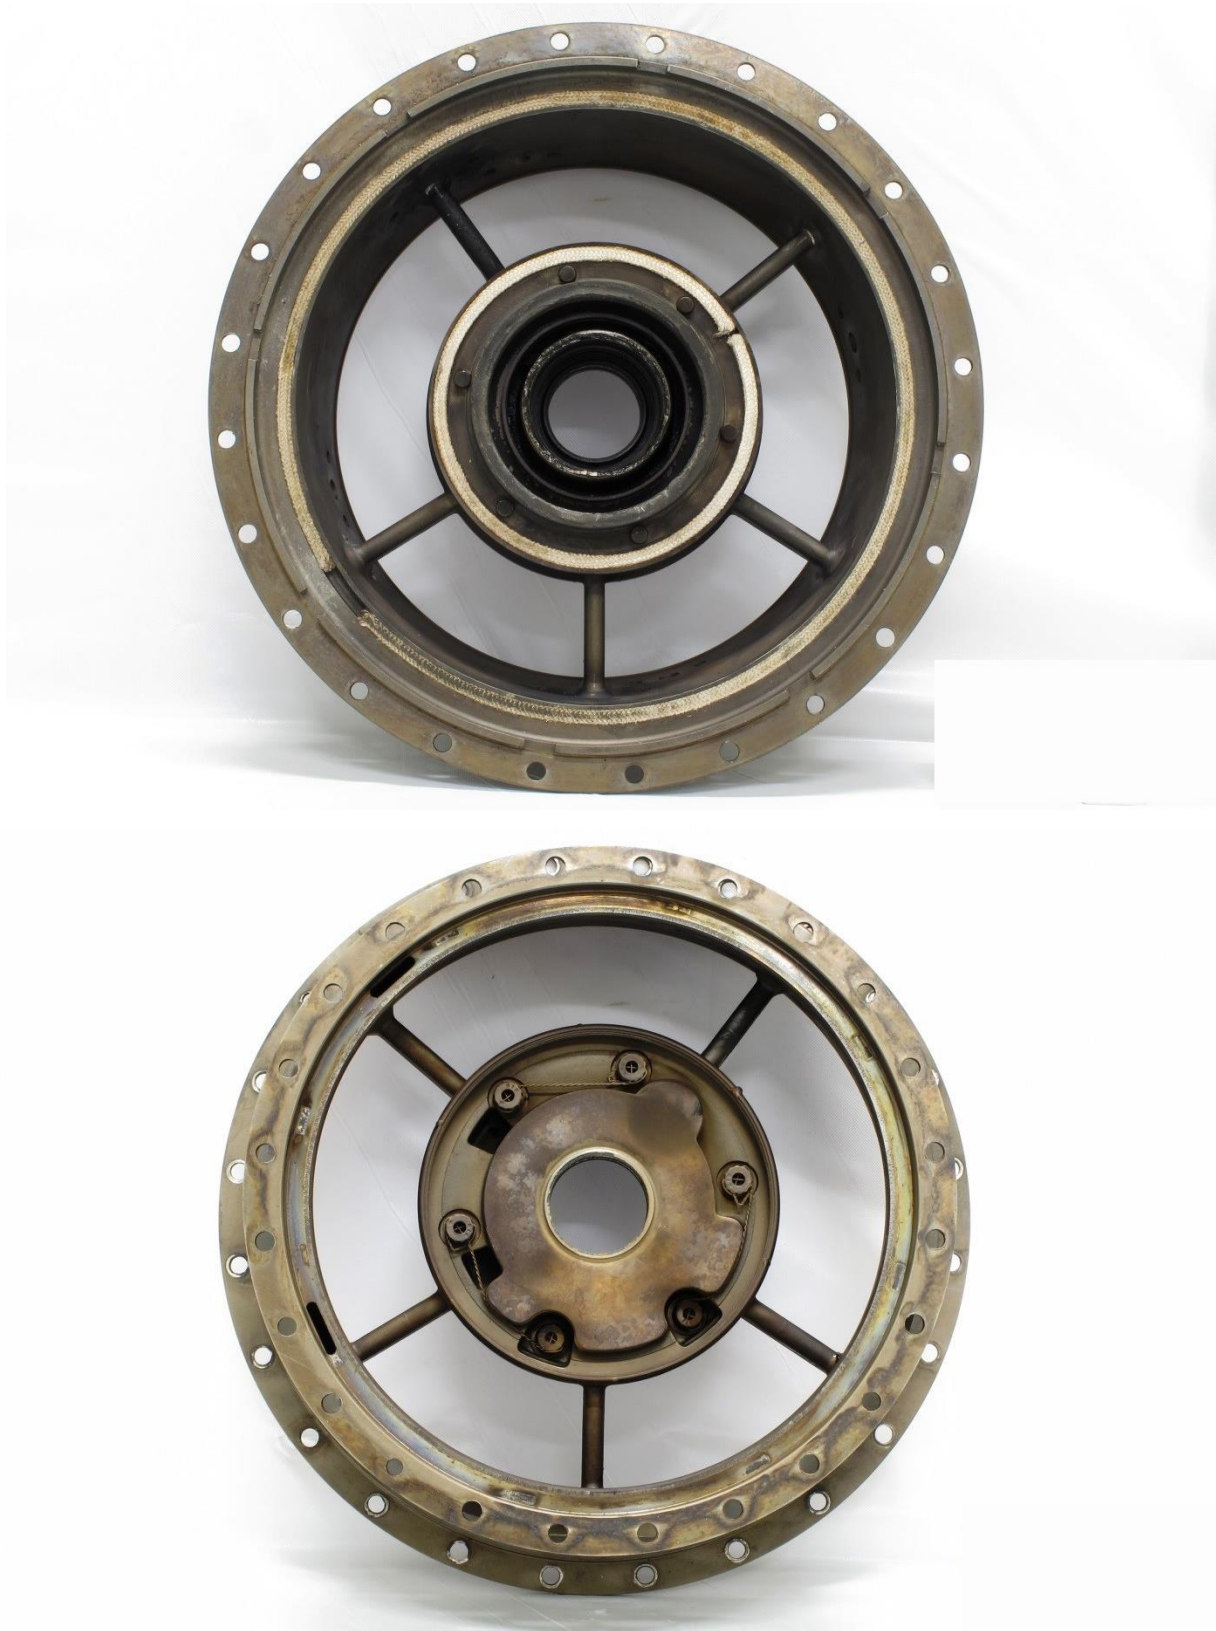
Figure 47 through Figure 49 show the power turbine support assembly, the Nos. 6 and 7 bearing sump stationary labyrinth seal, and the Nos. 6 and 7 bearing sump. The bore was fractured at the forward end. Figure 50 shows the gas producer turbine support. The forward face of the bore exhibited coked oil on the surface.

**Figure 47. Forward (top) and aft (bottom) side views showing the power turbine support.**

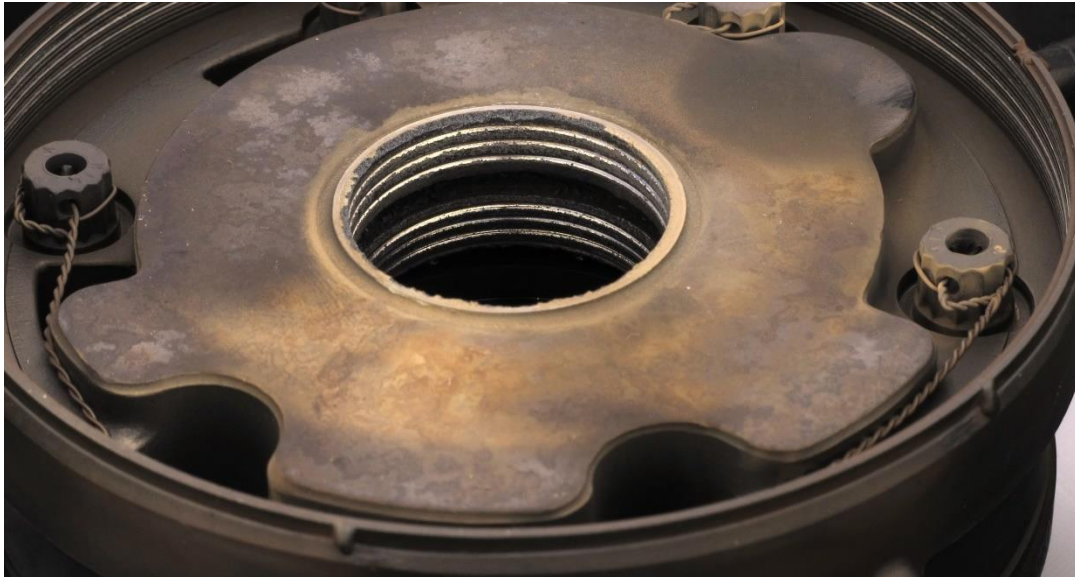
**Figure 48.** Detailed view showing the Nos. 6 and 7 bearing sump stationary labyrinth seal in the power turbine support assembly bore.

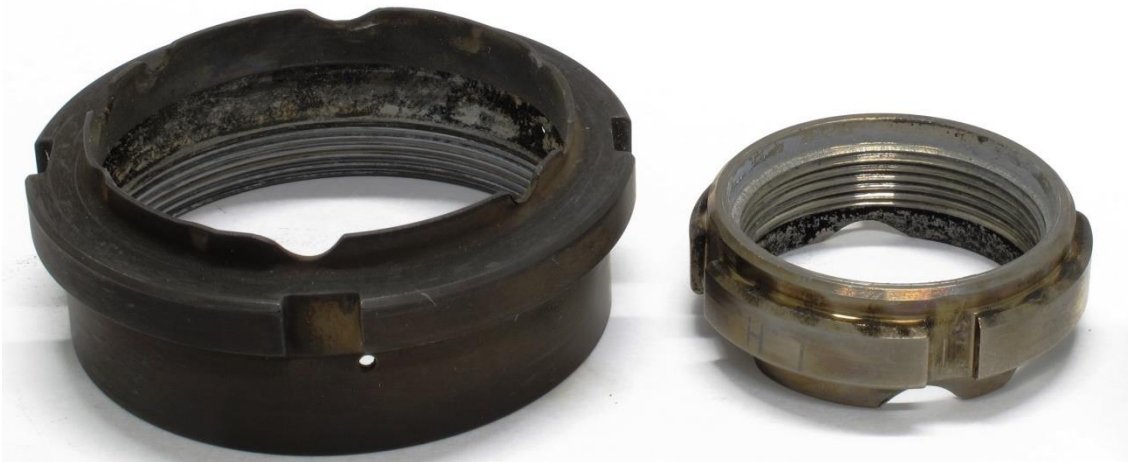
Figure 51 shows the power turbine outer shaft (PTOS). The PTOS exhibited rub and coked oil deposits on the outer diameter surface. Figure 52 shows the power turbine inner shaft (PTIS) with the fractured-off portion of the PT support bore and the No. 6 bearing, Figure 53, retained on the aft end of the shaft. Figure 54 shows the PT

**Figure 54. Power turbine outer (left) and inner (right) shaft nuts.**

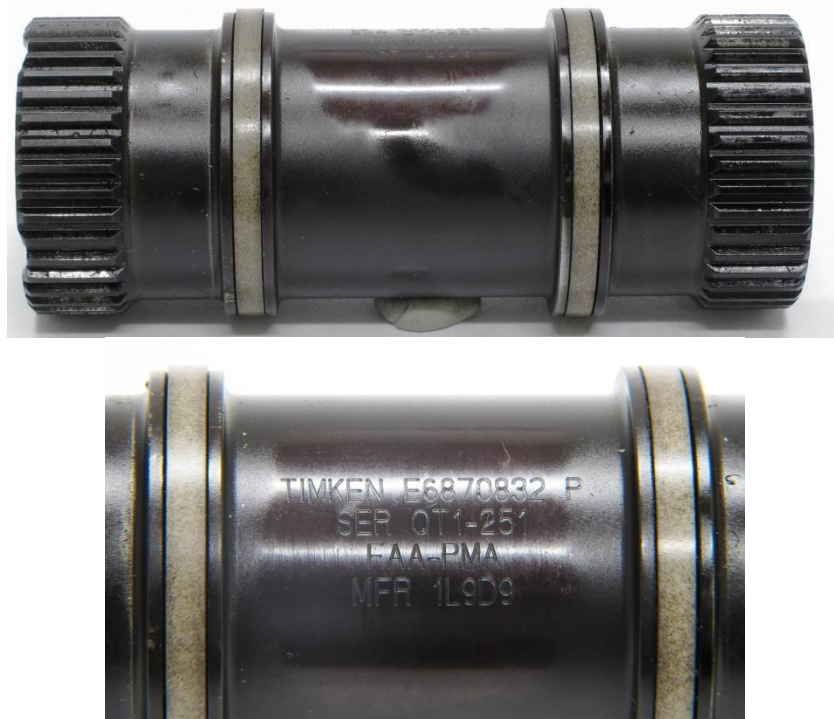
outer and inner shaft nuts. Figure 55 and Figure 56 show the third stage power turbine labyrinth seal, which exhibited rub that rubbed through the seal forward of the knives. Figure 57 shows the turbine to pinion gear coupling, which was a PMA component and was not examined in detail. Figure 58 shows the turbine to compressor coupling, which exhibited rub damage on the outer diameter at one end. Figure 59 shows the turbine tie bolt, which was not fractured. Figure 60 shows the No. 7 bearing. Figure 61 shows the No. 8 bearing, which was a PMA component and not examined in detail. Figure 62 shows the No. 5 bearing, which was a PMA component and not examined in detail.

Figure 57. Photographs of the turbine to pinion gear coupling, which was a PMA component and not examined in detail.

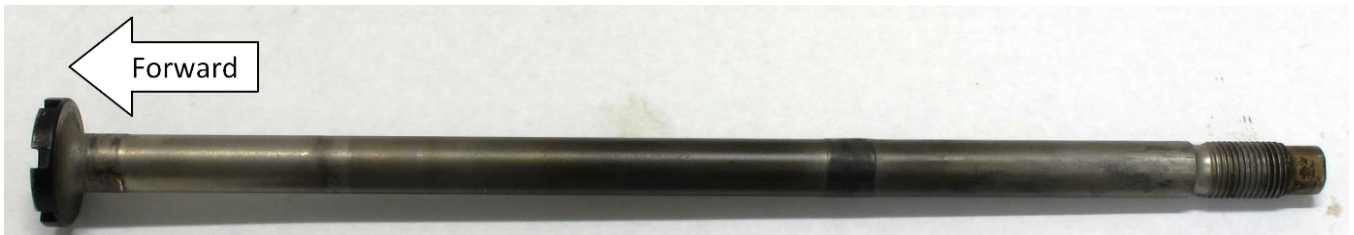
**Figure 59. As-received condition of the turbine tie bolt.**

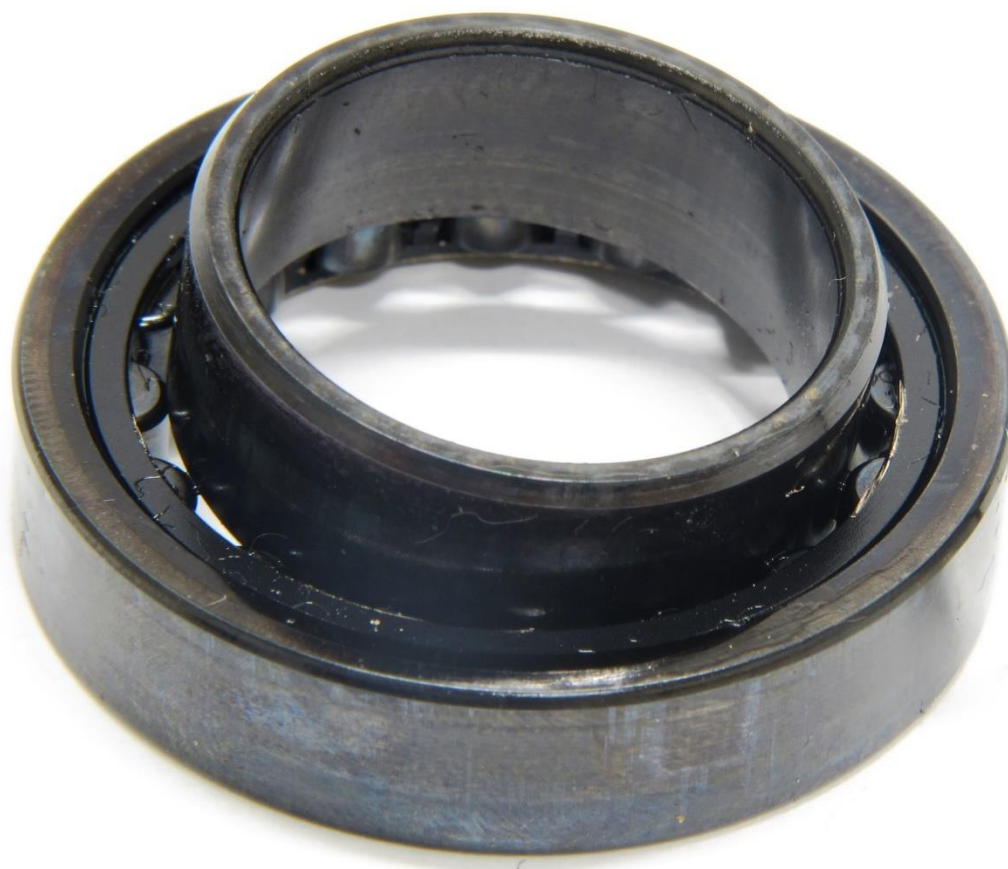
**Figure 60. As-received condition of the No. 7 bearing.**

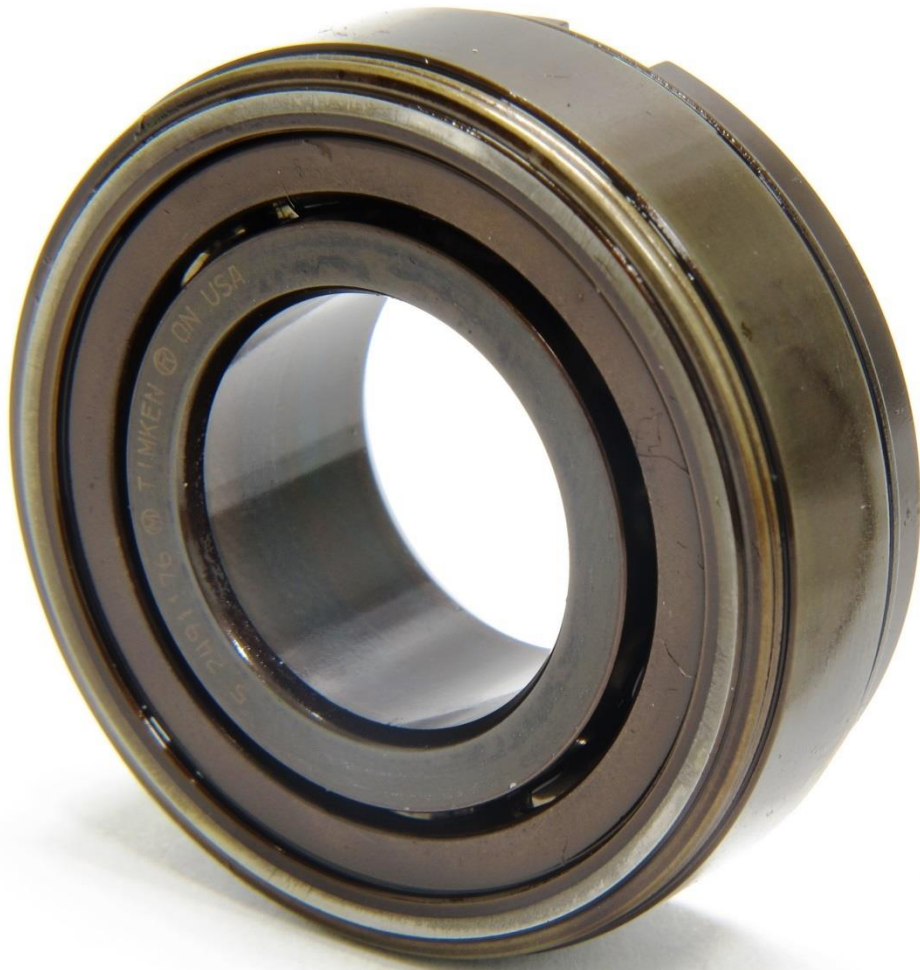
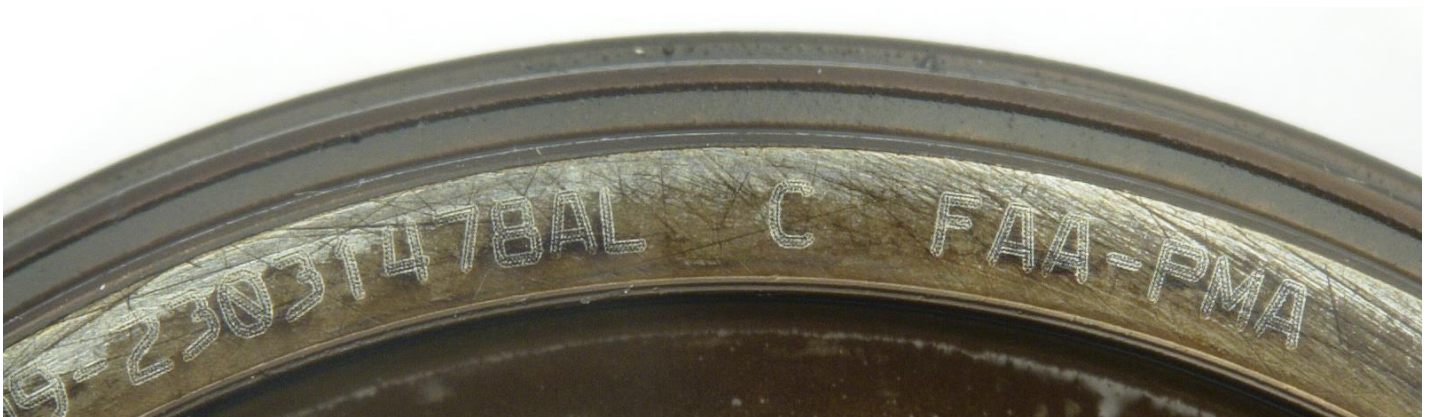
**Figure 61. Forward looking aft view (top) showing the as-received condition of the No. 8 bearing, which was a PMA component (bottom).**

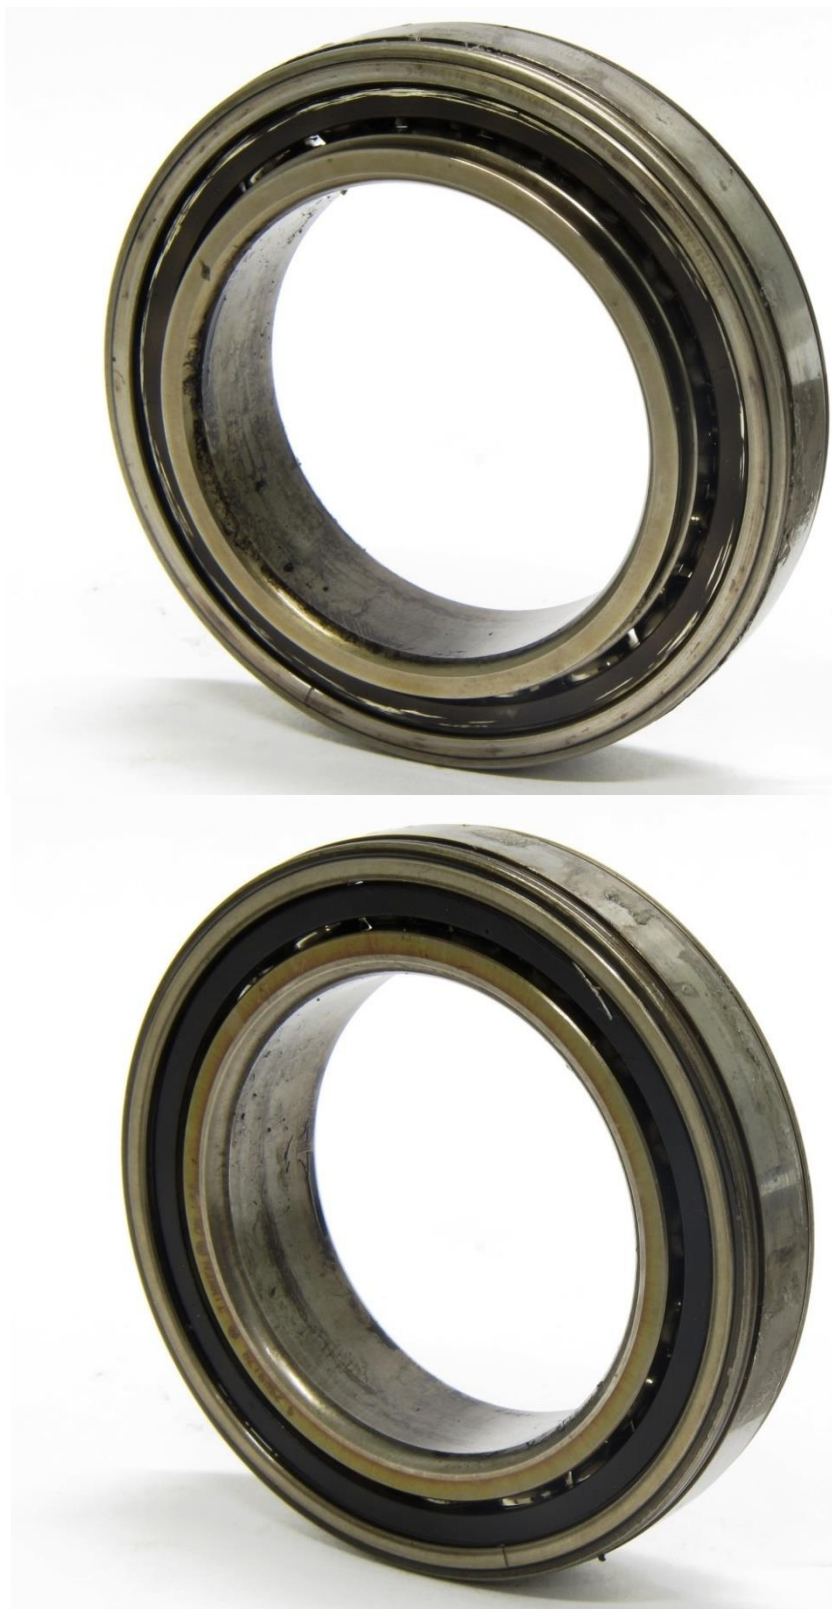
**Figure 62. Forward (top) and aft (bottom) side views of the No. 5 bearing.**

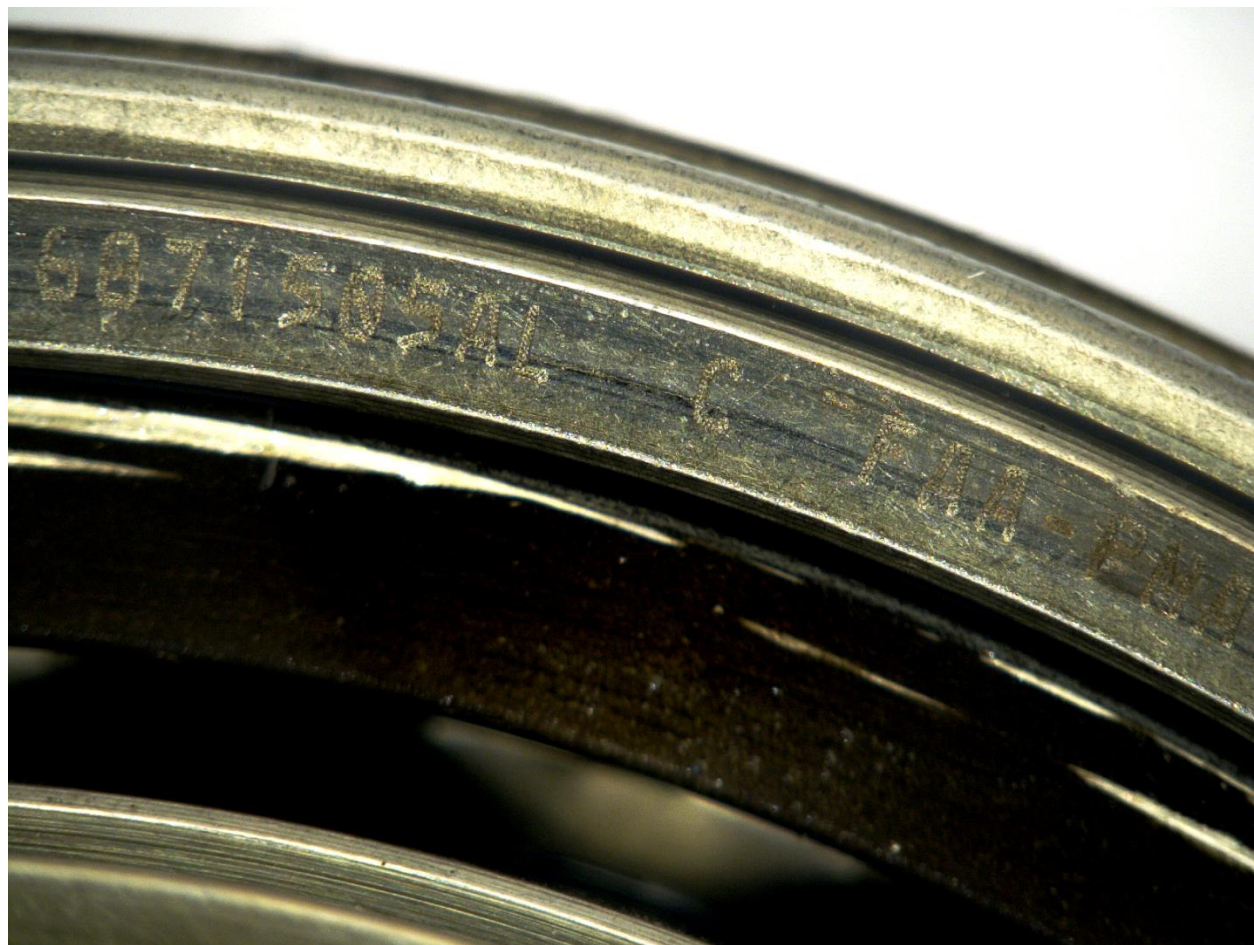
**Figure 63. PMA marking (red dashed outlined area) on the No. 5 bearing.**
