# NATIONAL TRANSPORTATION SAFETY BOARD

## POWERPLANTS GROUP FIELD NOTES

NTSB ID No.: WPR19LA157

Aircraft: Vought F4U-7, N965CV

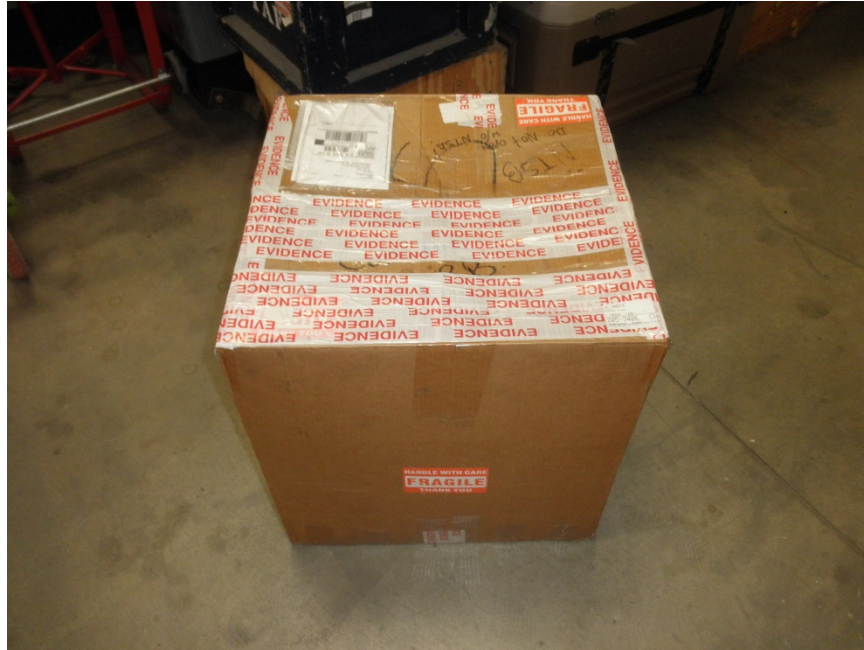
The carburetor was shipped to Vintage Carburetors, Inc., Tehachapi, California for testing and disassembly. The box was received at Vintage sealed. (Photo No. 1) The box was opened in the presence of an NTSB investigator. (Photo No. 2)

Photo No. 1: Box containing carburetor as received at Vintage Carburetor prior to opening.

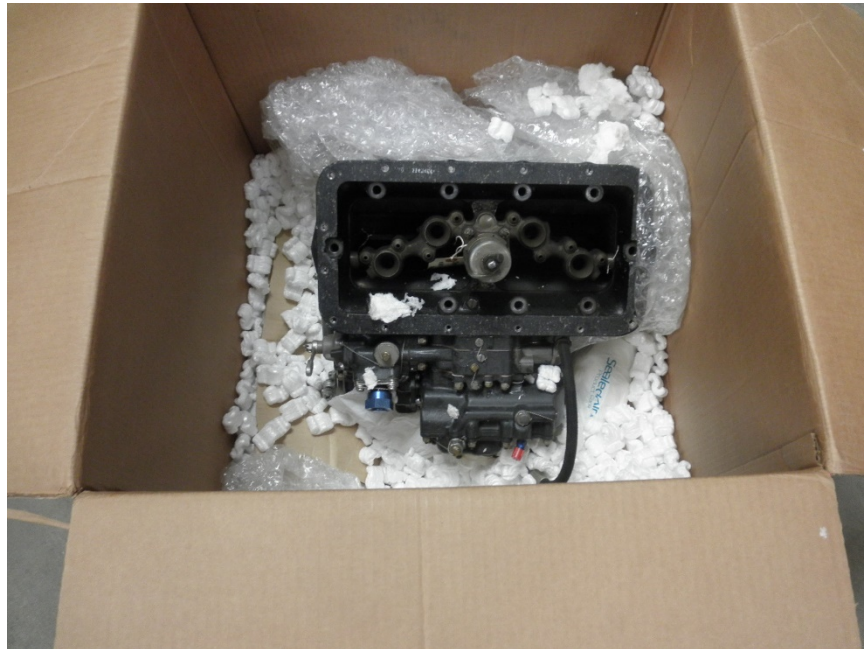
Photo No. 2: Carburetor after the box was opened.

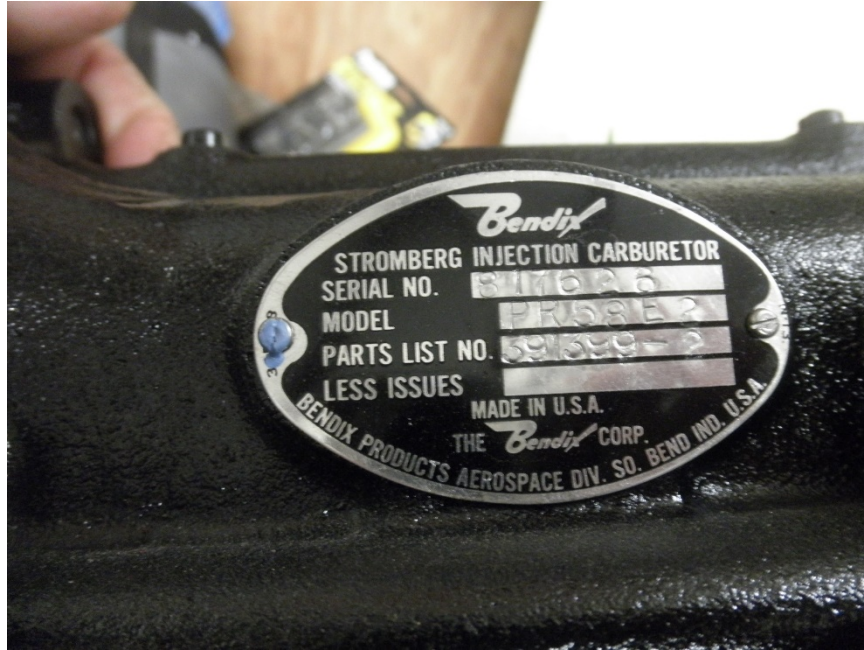
The carburetor was removed from the box and placed on a work bench for a visual examination. The carburetor's data plate indicated it was a Stromberg Injection Carburetor Model Number PR58E2, Serial Number 817626, Parts List Number 391399-2. (Photo No. 3)

Photo No. 3: Close up view of carburetor's data plate.

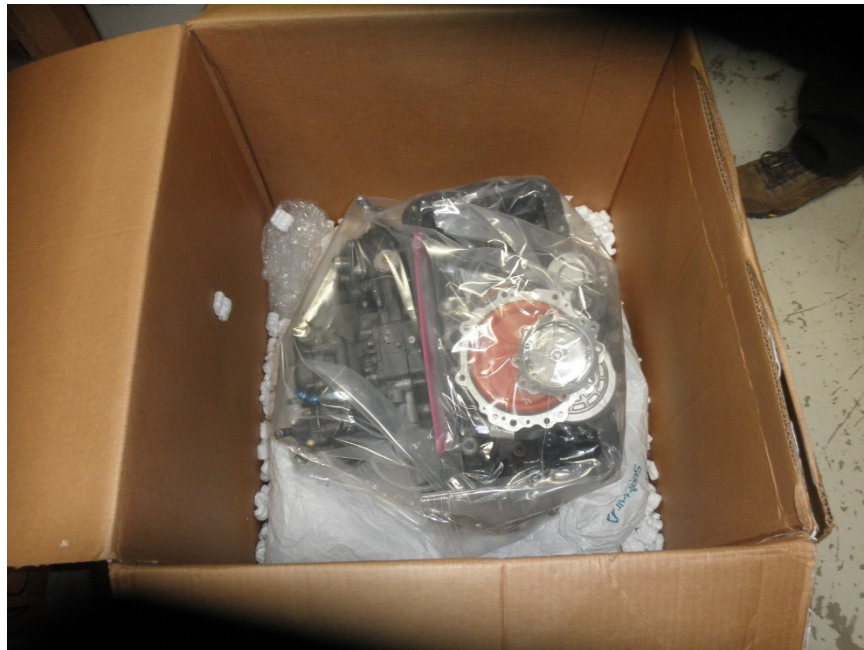
The carburetor was reassembled with the nuts and bolts only finger tight. The carburetor was then placed in a large plastic bag that was then placed in a box that was sealed. The box was labeled for return to the Investigator-in-Charge. (Photos Nos. 16, 17, and 18)

Photo No. 16: Carburetor placed back in the box.

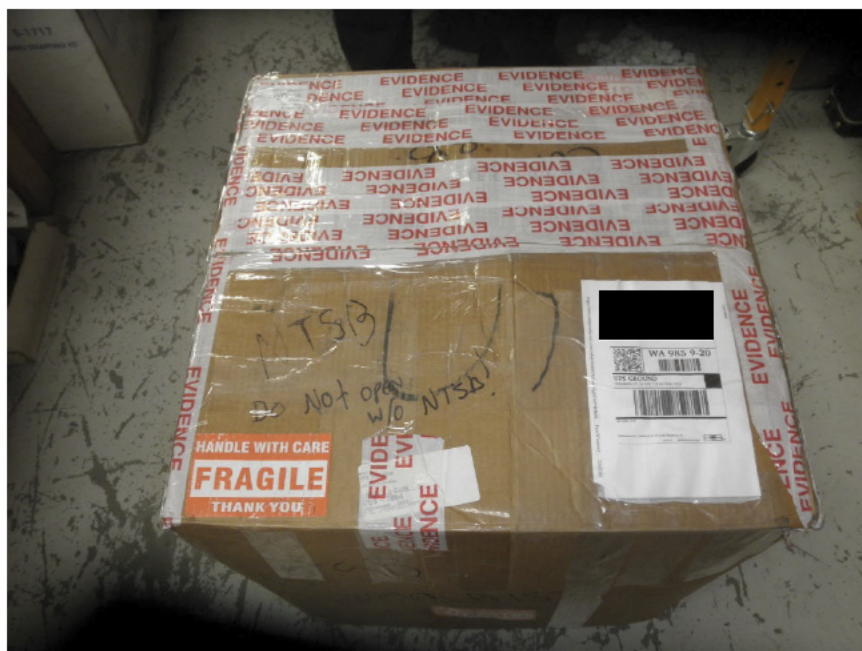
Photo No. 17: Box sealed with carburetor inside.

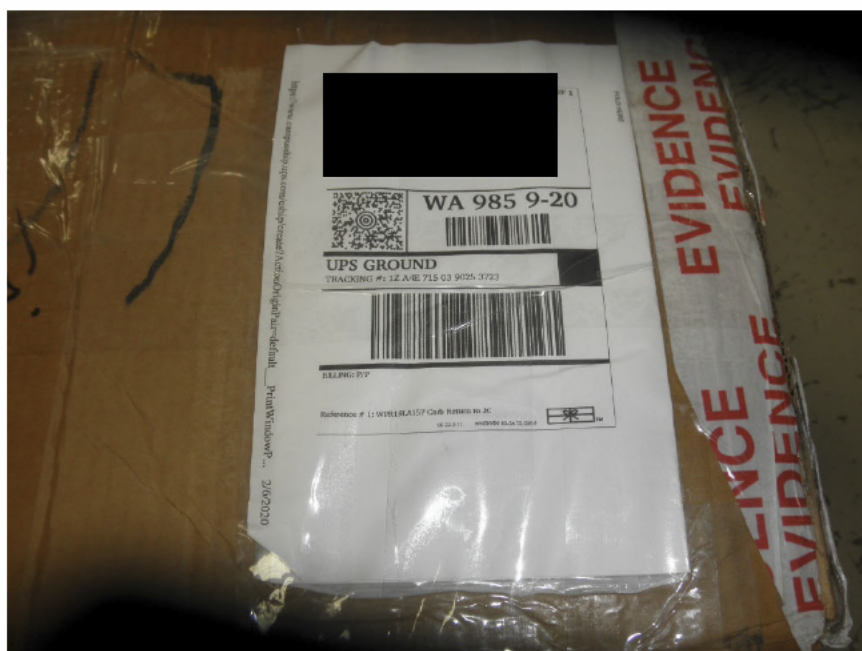
Photo No. 18: Shipping label on box to return it to the IIC.
