## INVESTIGATION SUPPORT SUMMARY

On June 10, 2019, about 1245 Pacific daylight time, a Cessna 210D, N3997Y, experienced a total loss of power and collided with terrain short of the runway during an emergency landing to Ramona Airport, Ramona, California. The certified flight instructor (CFI), the registered owner, was operating the airplane under the provisions of 14 *Code of Federal Regulations* (CFR) Part 91. The CFI and pilot-rated passenger were not injured; the airplane sustained substantial damage to the right wing. The personal local flight departed from Gillespie Field, San Diego, California, about 1200 and was diverting to Ramona, California. Visual meteorological conditions prevailed and no flight plan had been filed.

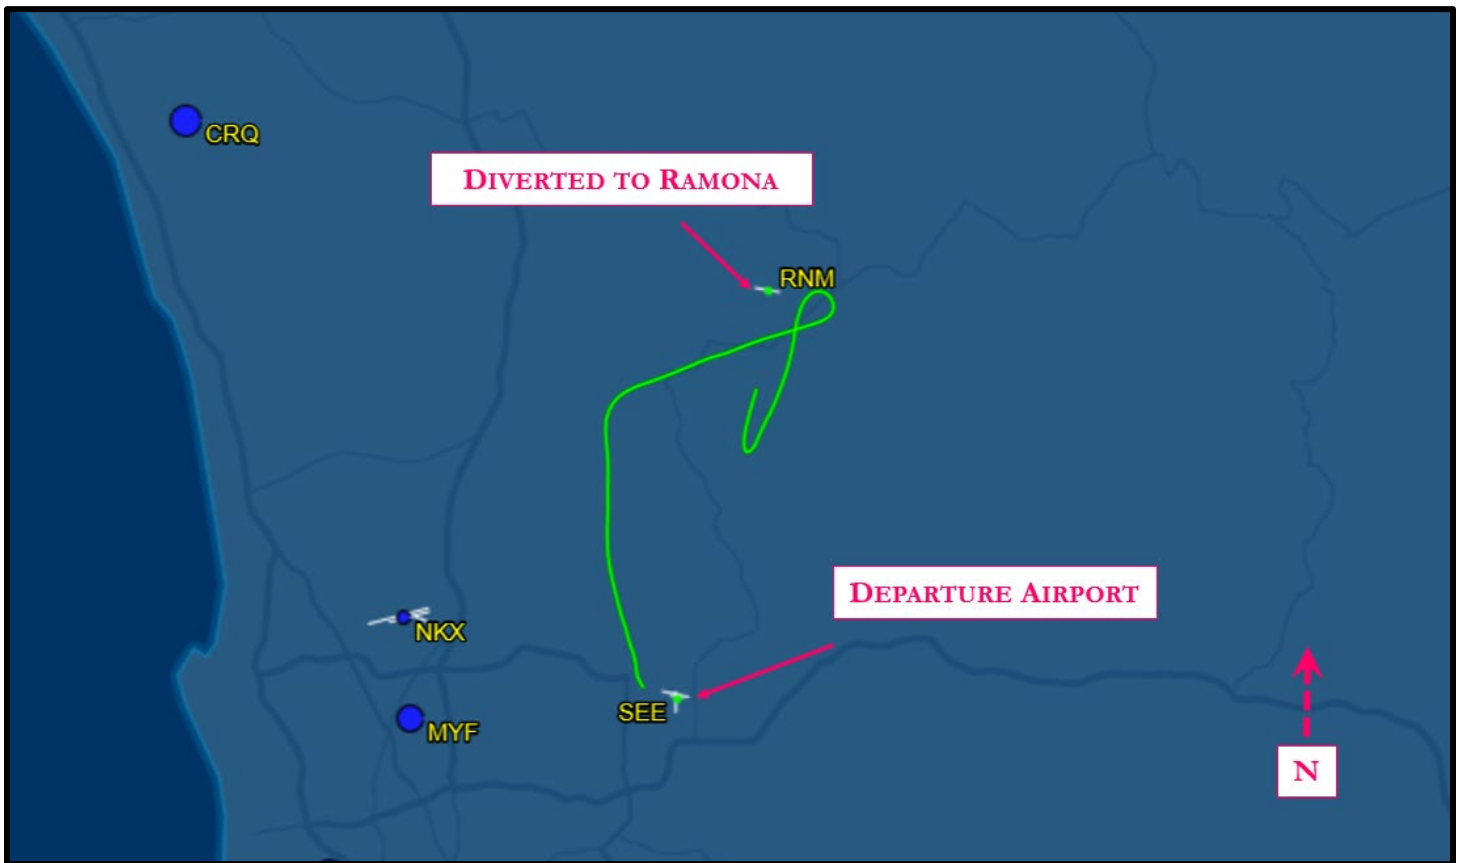
Picture 01: Flight Path According to Flight Aware

The pilot stated that he was planning on practicing a series of instrument approaches. While inbound to the Julian VOR, with the airplane about 6,000 feet mean sea level (msl), the engine rpm increased to above 3,000 and in response, he retarded the propeller control to 2,400 rpm. He thought that erratic engine rpm was a due to a propeller governor anomaly and communicated with the air traffic controller that he was terminating the practice approach. He stated his intention to return back to Gillespie Field and began the flight back. When about five miles south of Ramona, he felt the airplane shake and declared an emergency to the Ramona Air Traffic Control Tower. The airplane was unable to maintain altitude and touched down in a field about 1/8 mile short of runway 27.

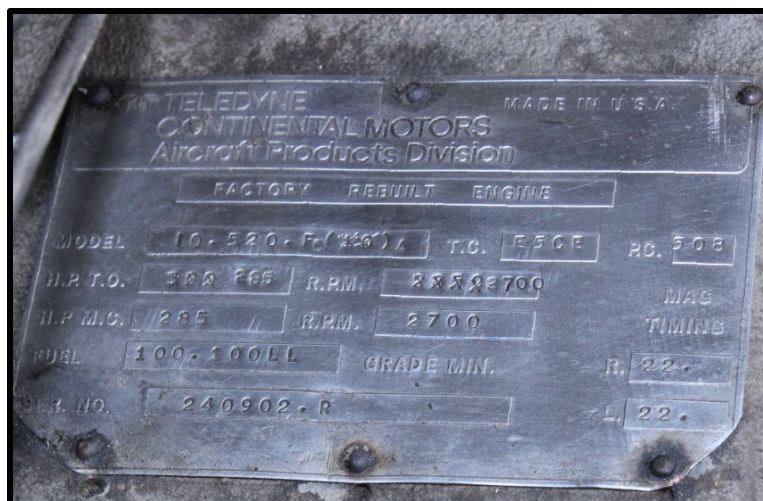
Picture 02: Data Plate from Engine

The Continental Motors IO-520-FcA, serial number 240902-R, was a Millennium overhauled engine installed in June 2003 at an airplane total time of 1,119 hours and engine total time of 1,767.7. Continuity was established from the throttle, mixture, and propeller controls in the cockpit to their respective arms in the engine compartment.

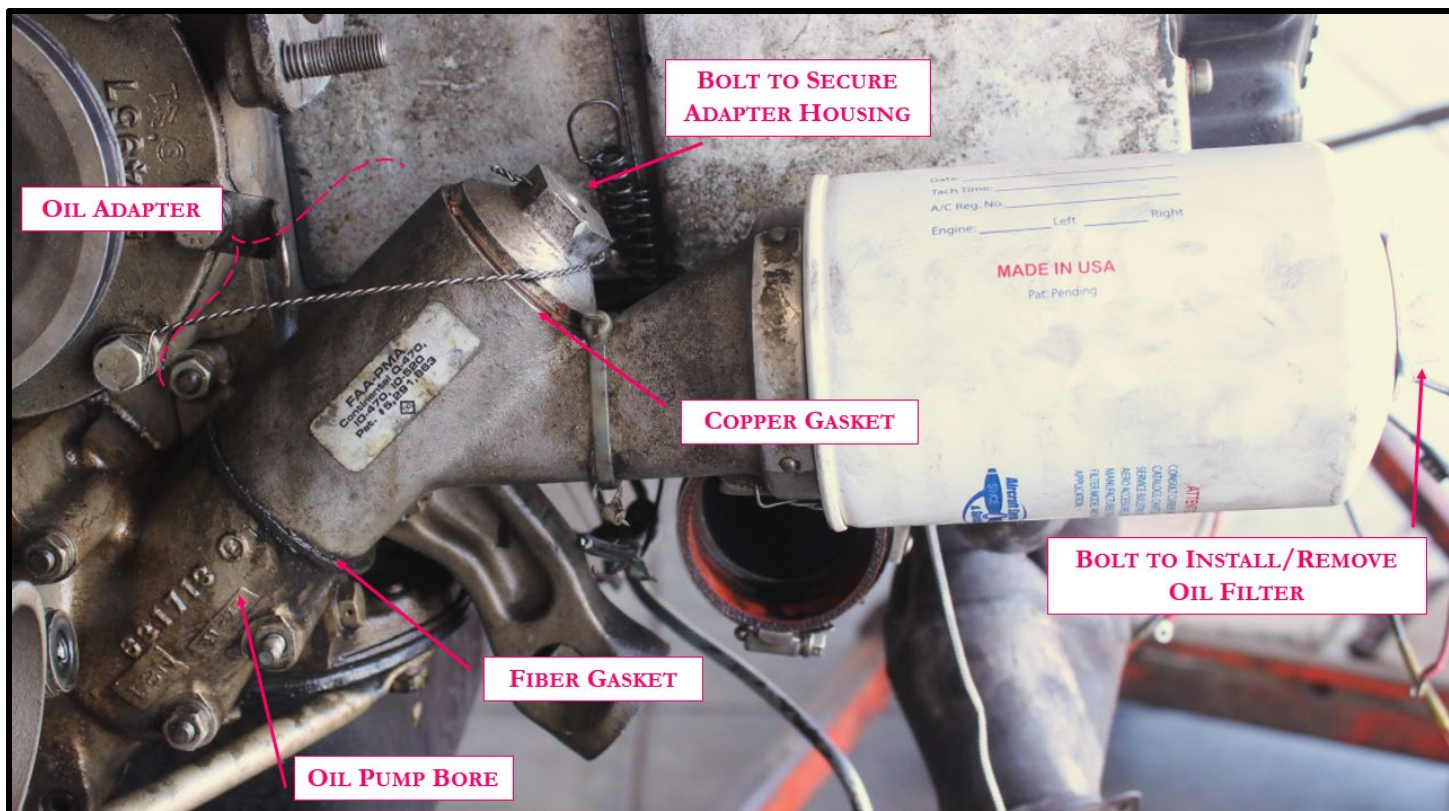
Picture 03: Oil Filter Adapter Assembly

An external examination revealed that the filter adapter was loose, and the adapter housing could be rotated about the shaft.<sup>1</sup> The crown head of the shaft and the oil filter screen bolt head both remained saftied. There was a

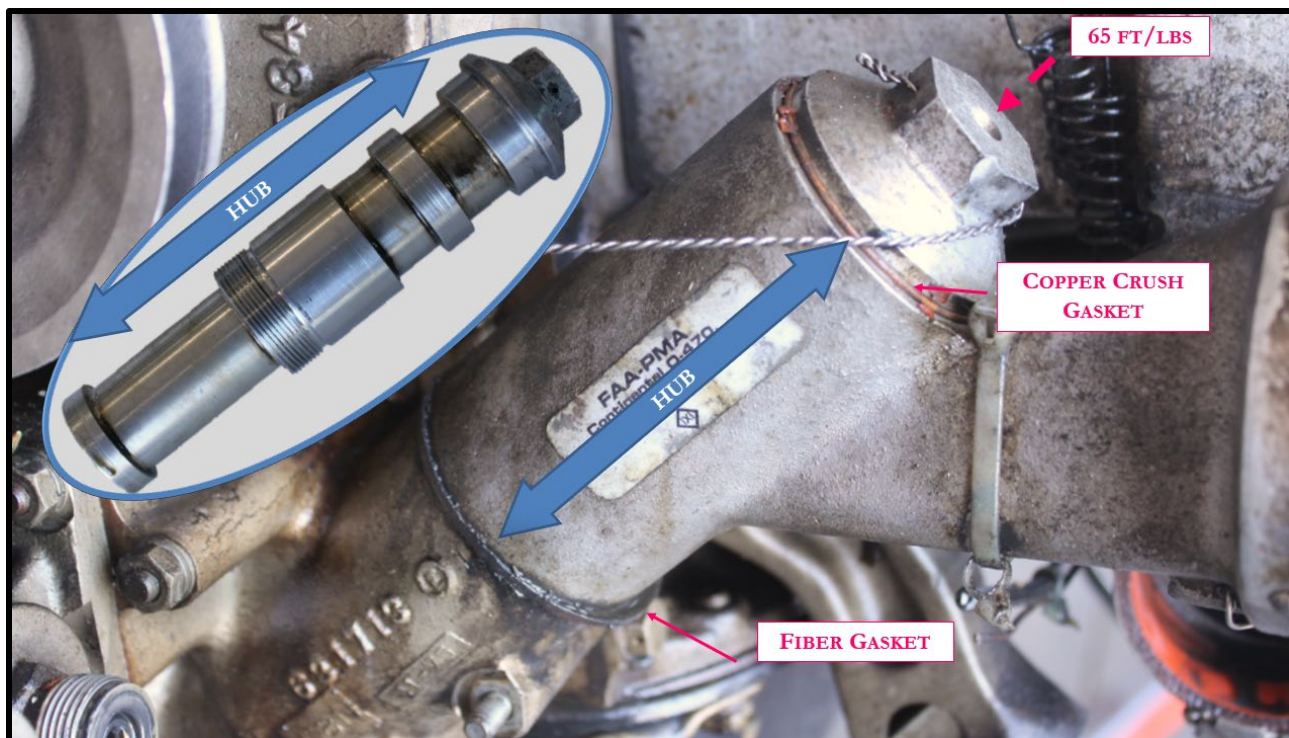
Picture 04: Oil Filter Adapter Showing Hub and Gasket

A closer examination revealed that the fiber gasket, located between the oil pump casting and the adapter was protruding with the outside edge extending beyond the castings. Additionally, a tear could be seen in the gasket where the adapter housing abutted the engine case. Investigators removed the safety wire and attempted to assess the breakaway torque of the adapter. A torque wrench was used to determine that the breakaway torque was 9 foot-pounds

Removal of the adapter revealed that the fiber gasket was completely split and contained several lips where it appeared the gasket had been pinched between the engine case and the adapter housing. The copper crush gasket was intact.

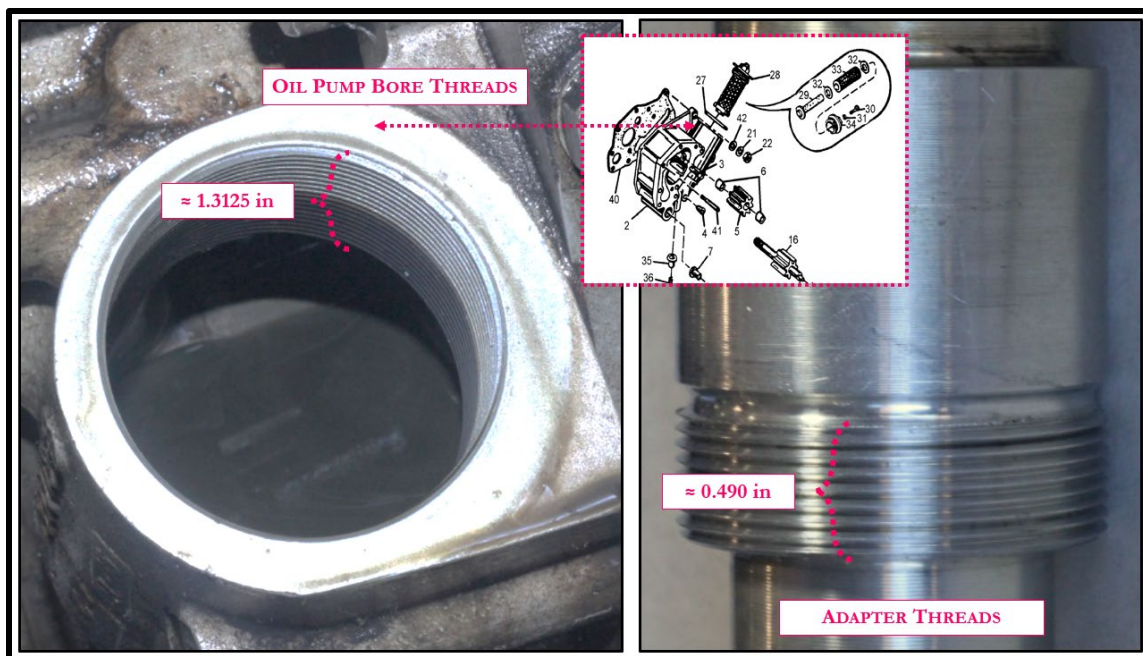
Picture 10: Threads of Oil Pump and Adapter

The threads on the upper area of the hub, adjacent to the annular groove were rough.

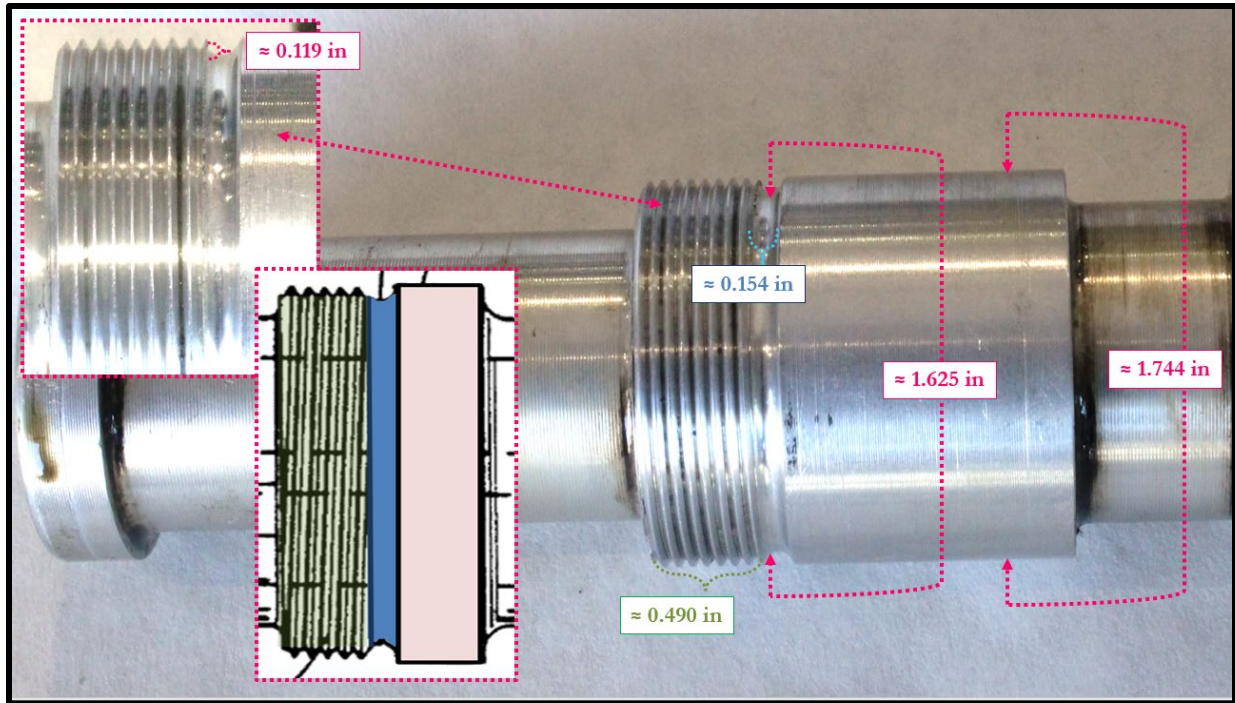
Picture 12: Hub Measurements

<sup>4</sup> The clearance between the hub and the fiber gasket was about 0.031 inch clearance.
