## OIL FILTER ADAPTER RESEARCH

On May 01, 2019 a fatal accident occurred in Mill Creek, California (WPR19FA126). The oil had egressed the engine at a high velocity from the F&M the oil filter adapter. Just over a month later, on June 10, 2019 another accident that occurred in Romana, California (WPR20LA166). The same teams responded to both accidents: Zoë Keliher (NTSB investigator-in-charge IIC), Michael Council (Continental Aerospace Technologies), and Henry Soderlund (Textron Aviation – Cessna).

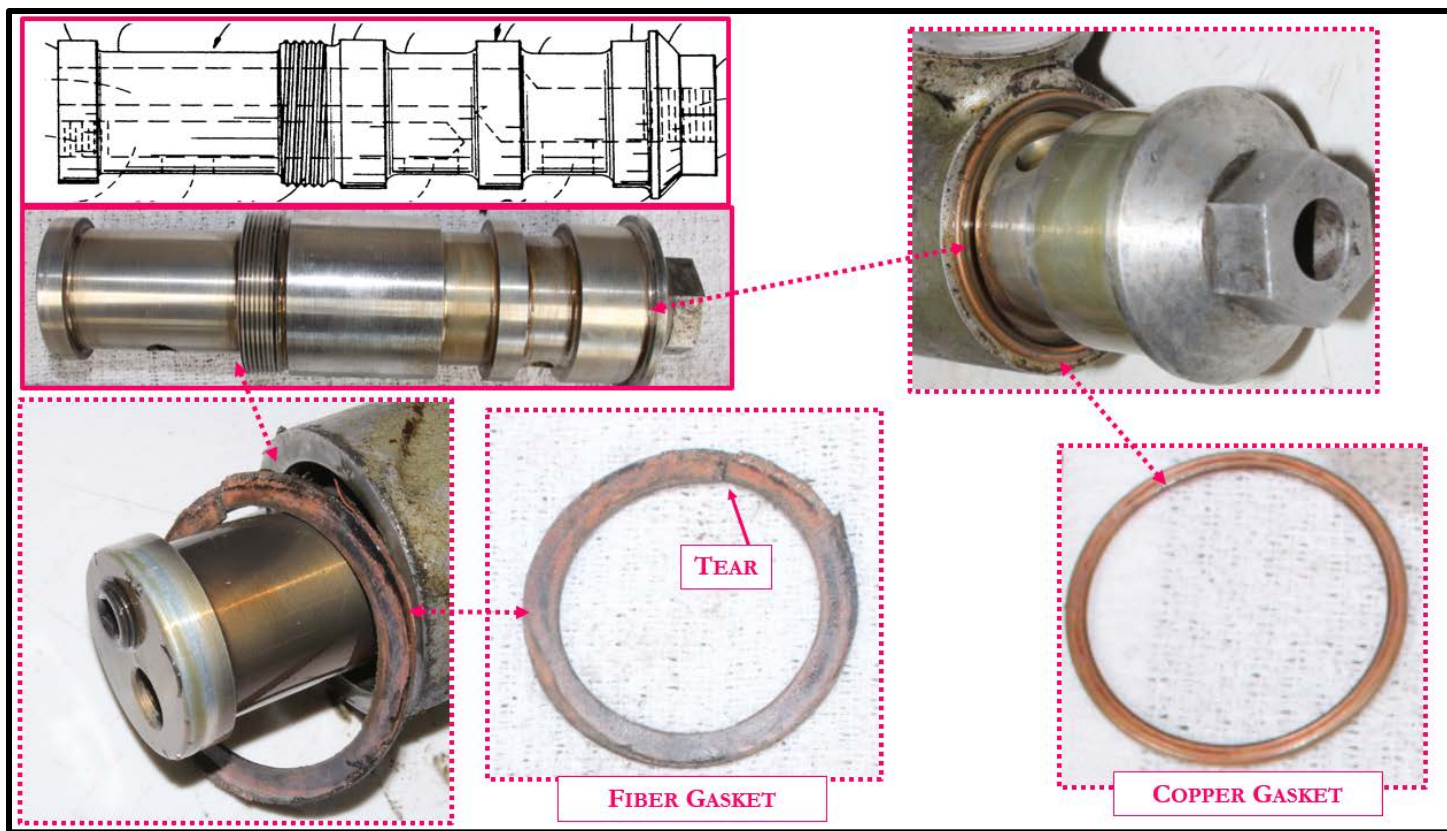
Figure 6: Oil Filter Adapter Shaft and Gaskets

The tear in the fiber gasket was located on the flange closest to the forward by the cylinder. It is unknown which gaskets were on the accident airplanes, because the batch or lot number was not in the logbooks or stamped on the part.

Gaskets rely on both friction and compressive force (seating stress) to prevent gasket blowouts from occurring, which is a tearing in the fiber material consistent with the accident gasket. One of the signatures of uneven gasket compression is flange serration impression differences around the gasket, which in the oil filter adapter would likely be a crescent indentation in the gasket material from the circular flange shape of the adapter sleeve housing and the oil pump housing.

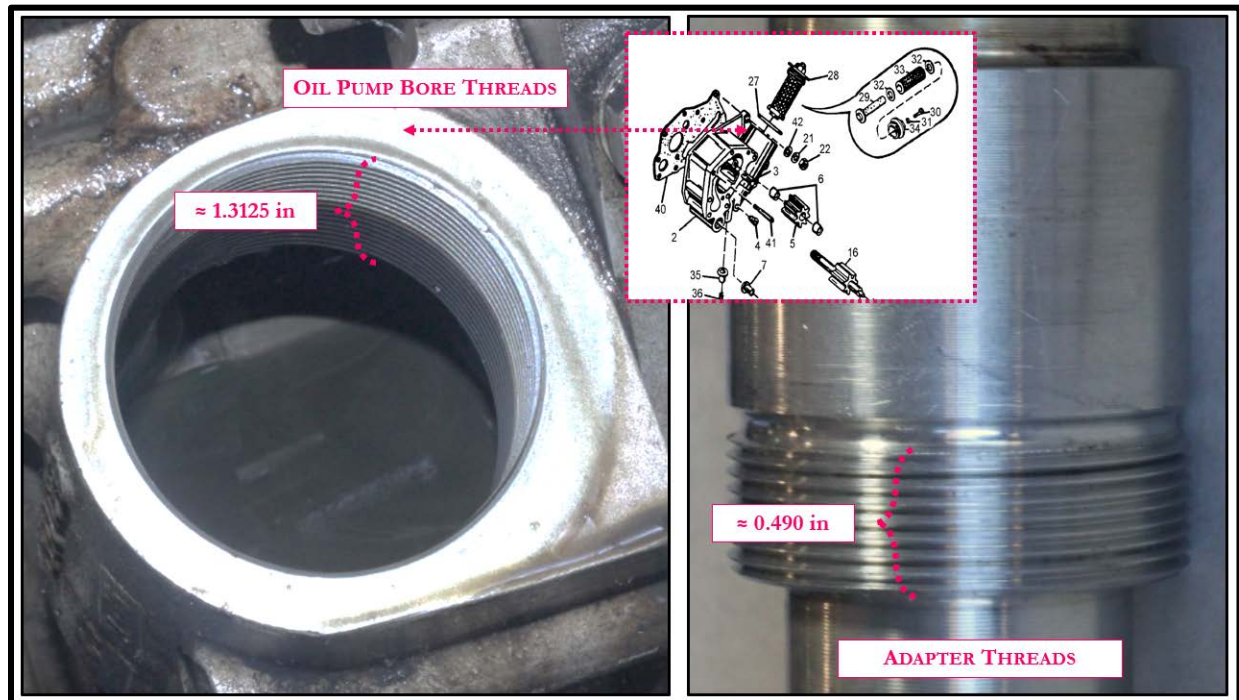
Figure 17: Threads of Oil Pump and Adapter

The threads on the upper area of the hub, adjacent to the annular groove were rough.

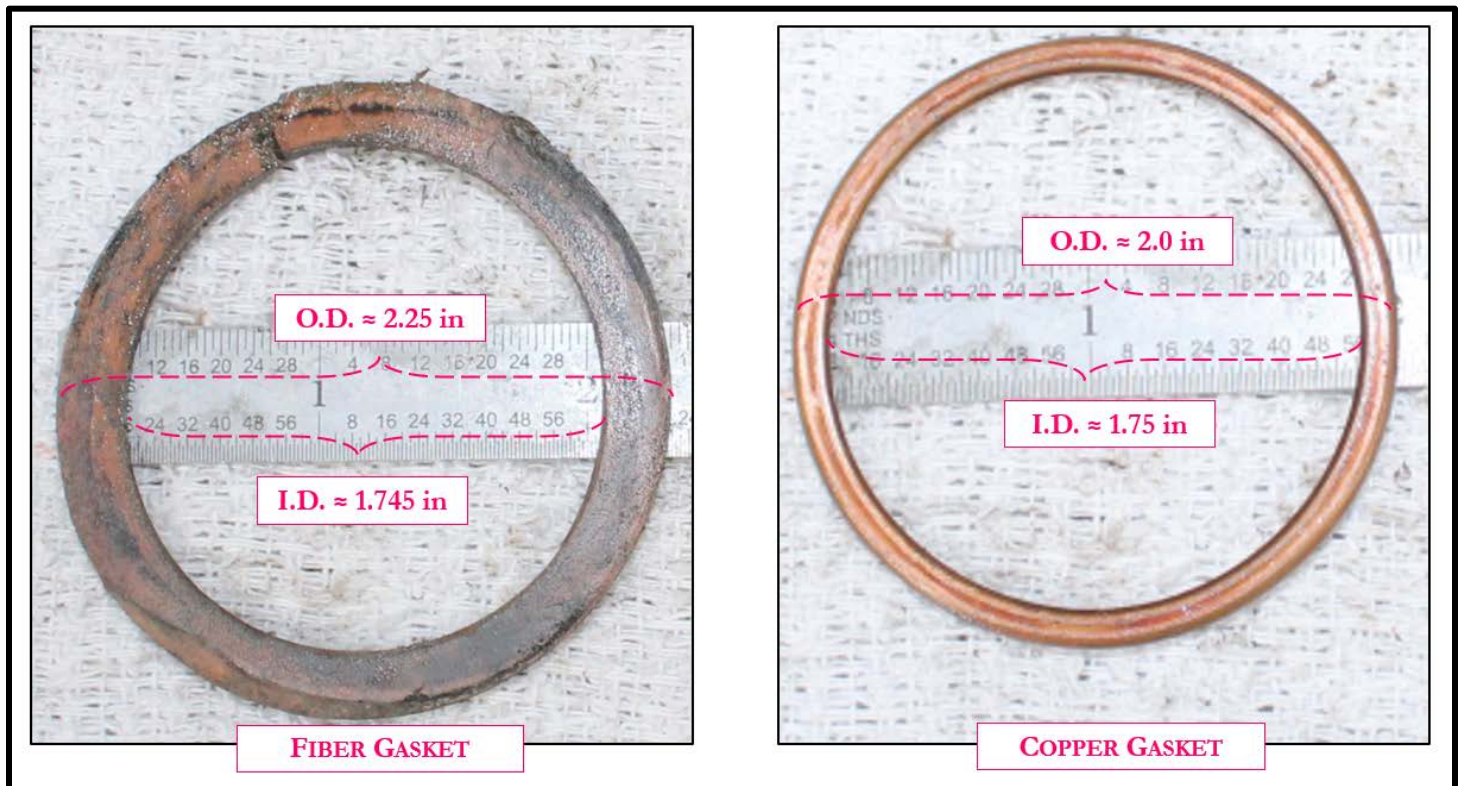
Figure 28: Measurements of Fiber vs. Copper Gasket

Based on the patent, forum discussions, and changes in F&M instructions, it is likely that the oil filter adapter was originally designed and sold with two AN900 copper crush gaskets. The original Continental oil screen required copper gasket MS35769-48 (OD 2.0 in, ID 1.75 in, ring width 0.688 in, thickness 0.094 in), which is likely the same gasket that was used for the adapter. GPI stated that fiber gaskets supplied to F&M were OD 2.25 in ID 1.745 in, ring width 0.505 in, thickness 0.063 in. The annular groove was 0.125 in wide and the depth is unknown.

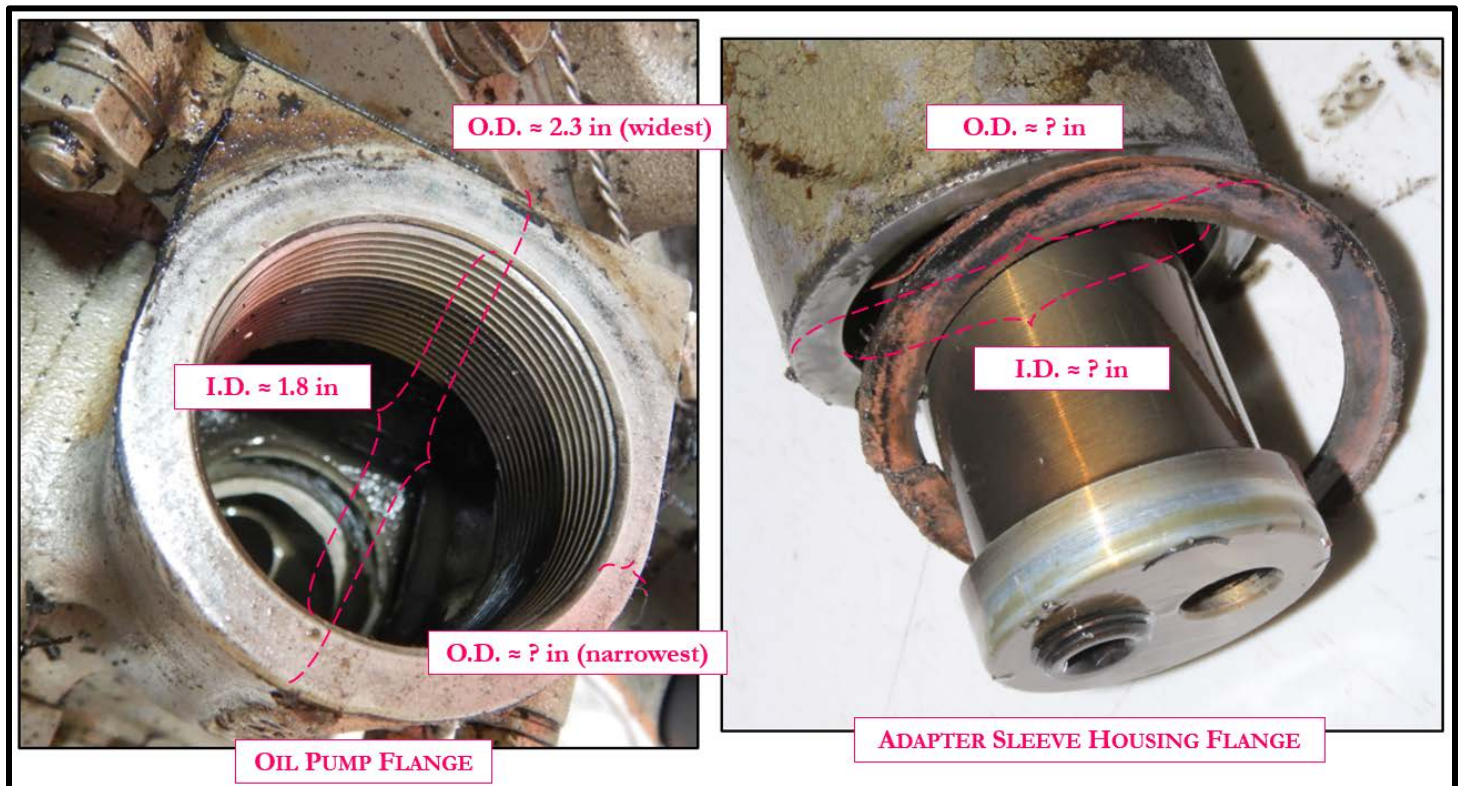
Figure 30: Measurements of Flange on Oil Pump and Adapter Sleeve Housing

The oil pump housing flange measured about 2.3 in at the widest portion and the flange width thickness varied; the narrowest portion, where the bottom lip was the thinnest, gave an unknown OD and ID, but the OD is presumably less than 2.3 in. The width of the flange then is an estimated 0.5 in. The oil adapter sleeve housing flange OD and ID are unknown.

The gasket had numerous impressions and markings consistent with the crescent shape of the flanges.
