**NATIONAL TRANSPORTATION SAFETY BOARD**

**ENGINE EXAMINATION REPORT**

**WPR19LA195**

**Cessna T210 – N6330N**

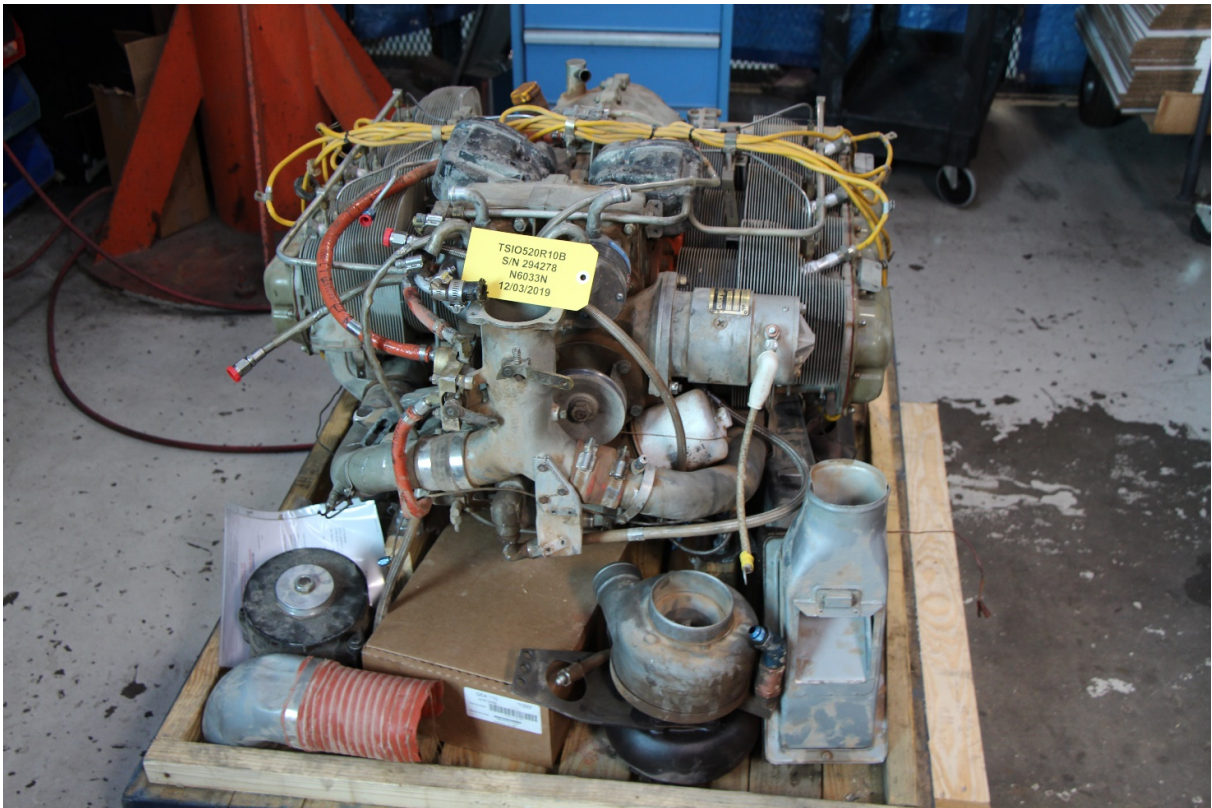
*Photograph 5: Engine after Crate Removed*

The engine was shipped from a maintenance facility in St. George, Utah to CMI's facilities in Mobile, Alabama via crate and bonded shipment. Upon receipt the engine was immediately logged and placed in bonded/secure storage and was not opened. The crate was viewed by the IIC as unopened and subsequently photographed and opened for examination. The oil sump was partially crushed. The waste gate controller mounting bracket was fractured and the alternator bracket was broken. Additionally, the "B" nut at the mixture control/throttle body was loose.

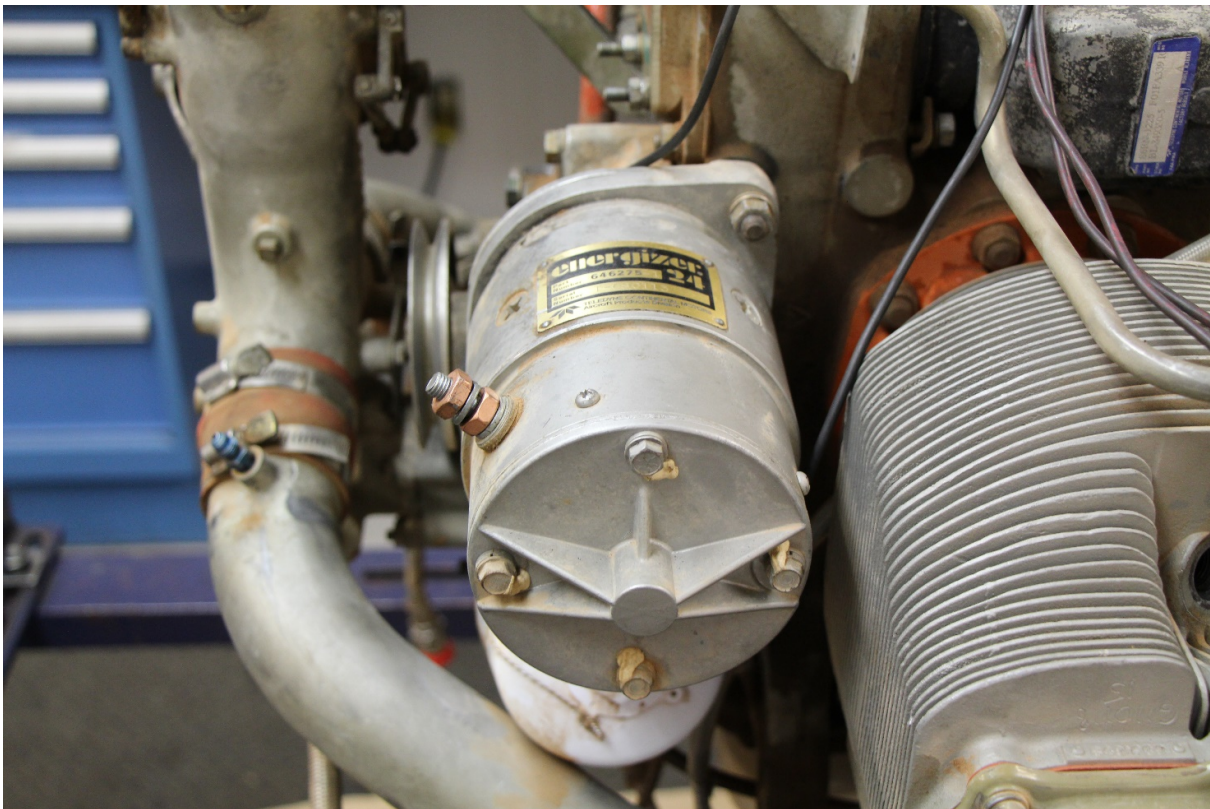
*Photograph 6: Starter Motor*

The starter motor was manufactured by Teledyne Continental Motors; part no. 646275, serial no. T-080113.

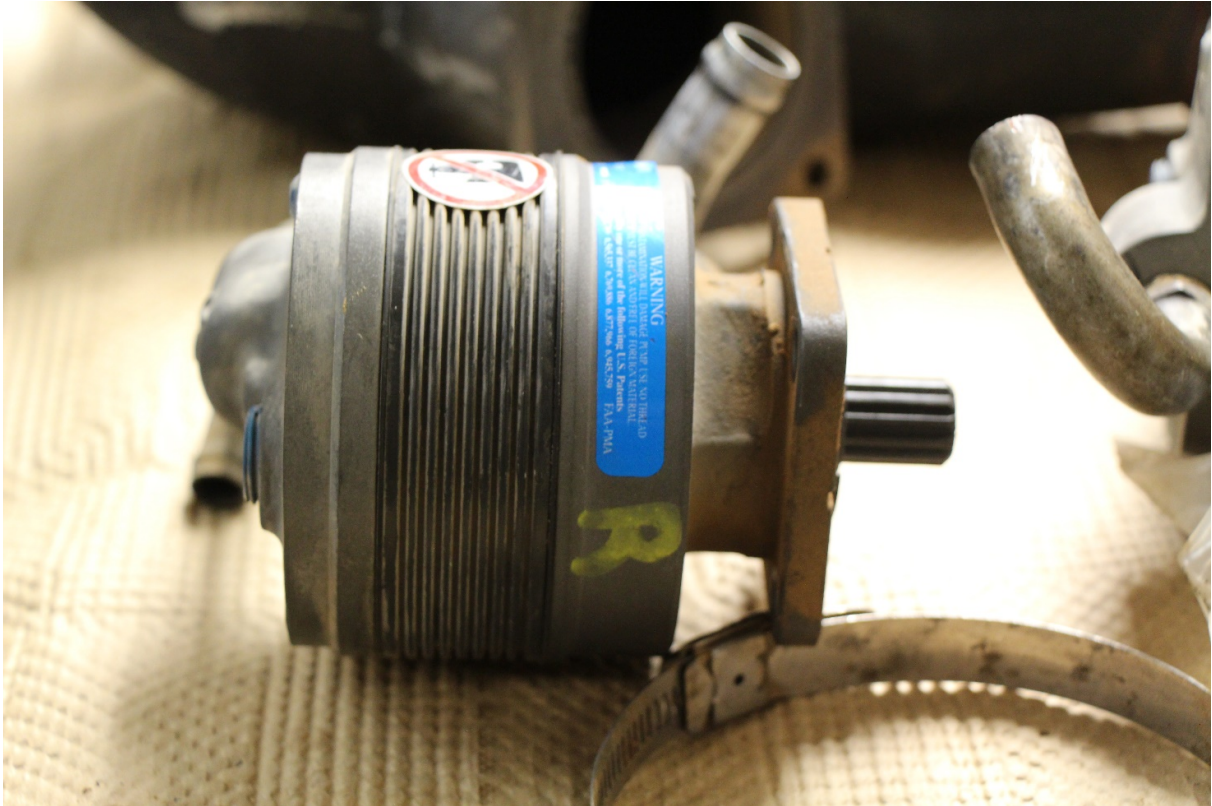
*Photograph 7: Right Vacuum Pump*

The engine was equipped with two vacuum pumps. The right side vacuum pump was manufactured by Tempest, part no. AA3216CW, serial no. 049F19. The left side vacuum pump was manufactured by Tempest, part no. AA3216CW, serial no. 049F12.

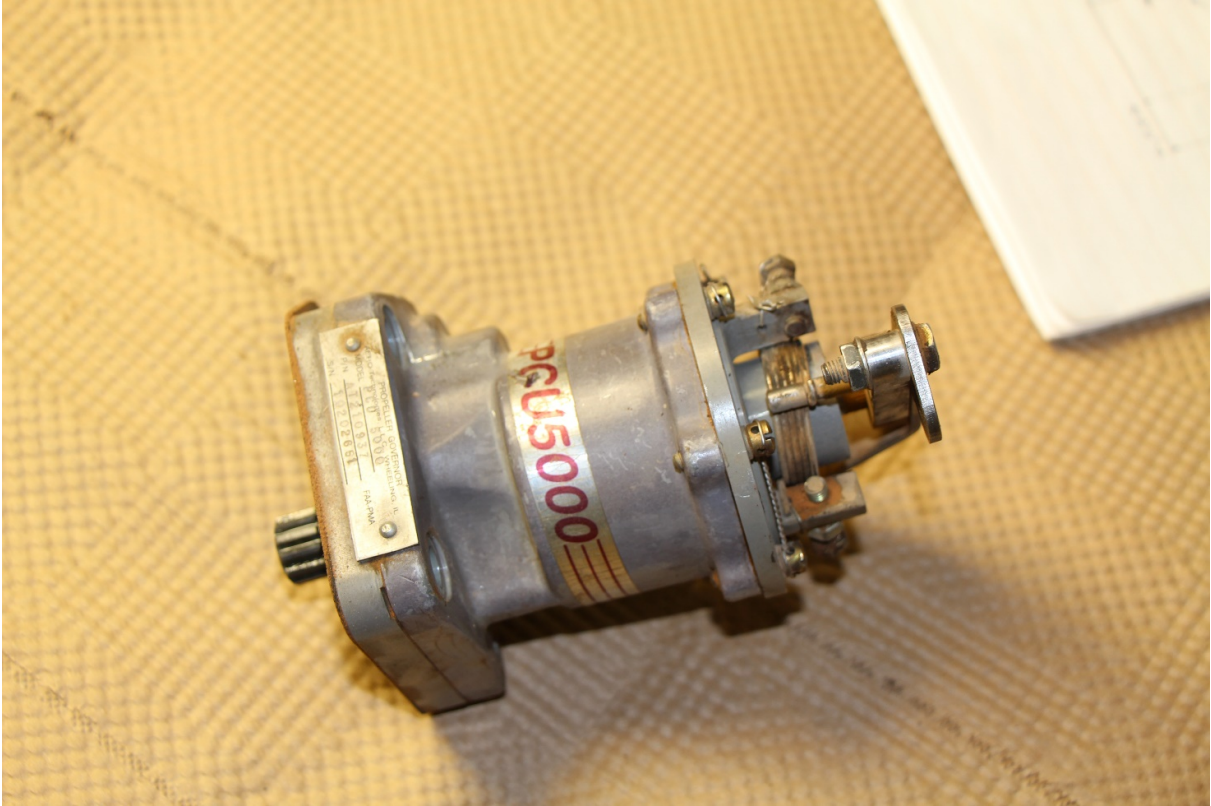
*Photograph 10: Propeller Governor*

The propeller governor was manufactured by Aero Technologies, part no. AT210937, serial no. 10202651.

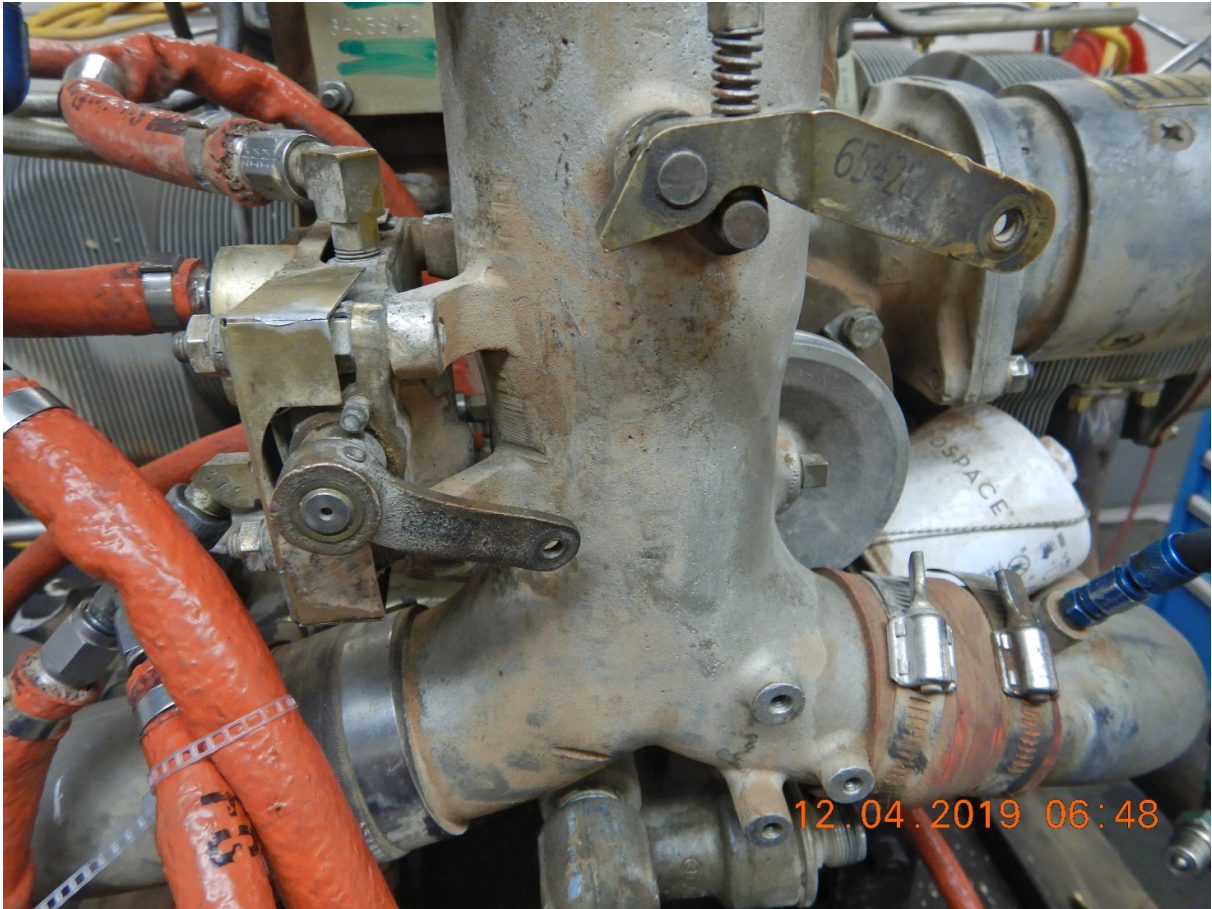
*Photograph 11: Throttle Body*

The metering unit was manufactured by TCM, part no. 640563-16A3, serial no. A07FA308R.

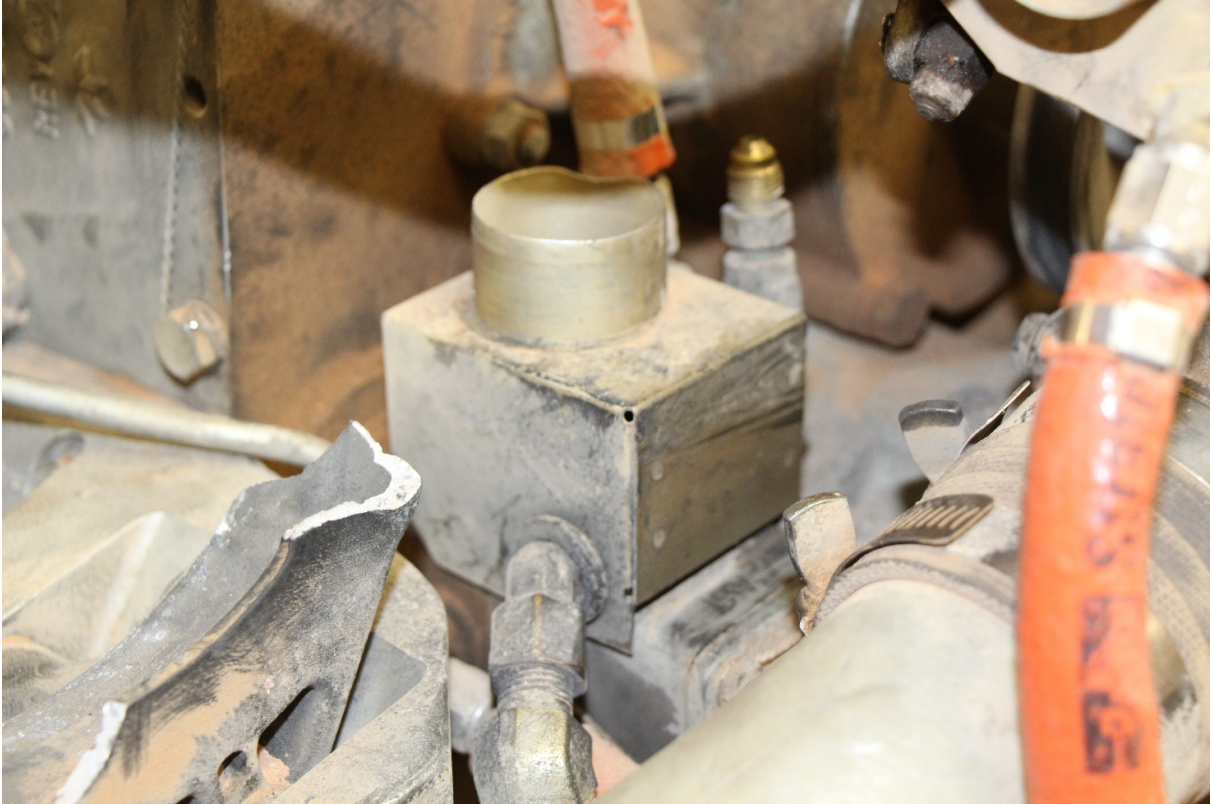
*Photograph 12: Fuel Pump*

The fuel pump was manufactured by TCM, part no. 646768-1, serial no. B01FA369R.

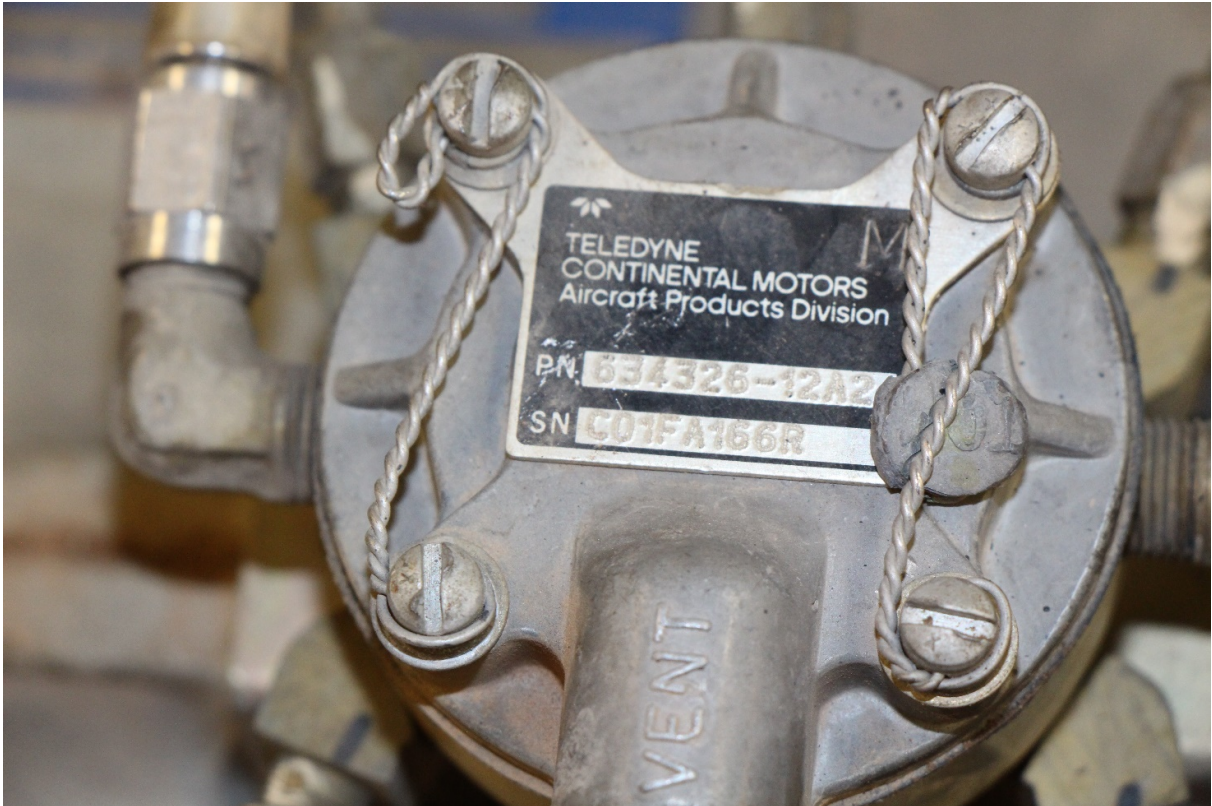
*Photograph 15: Fuel Manifold*

The fuel manifold was manufactured by TCM, part no. 634326-12A2, serial no. C01FA166R.

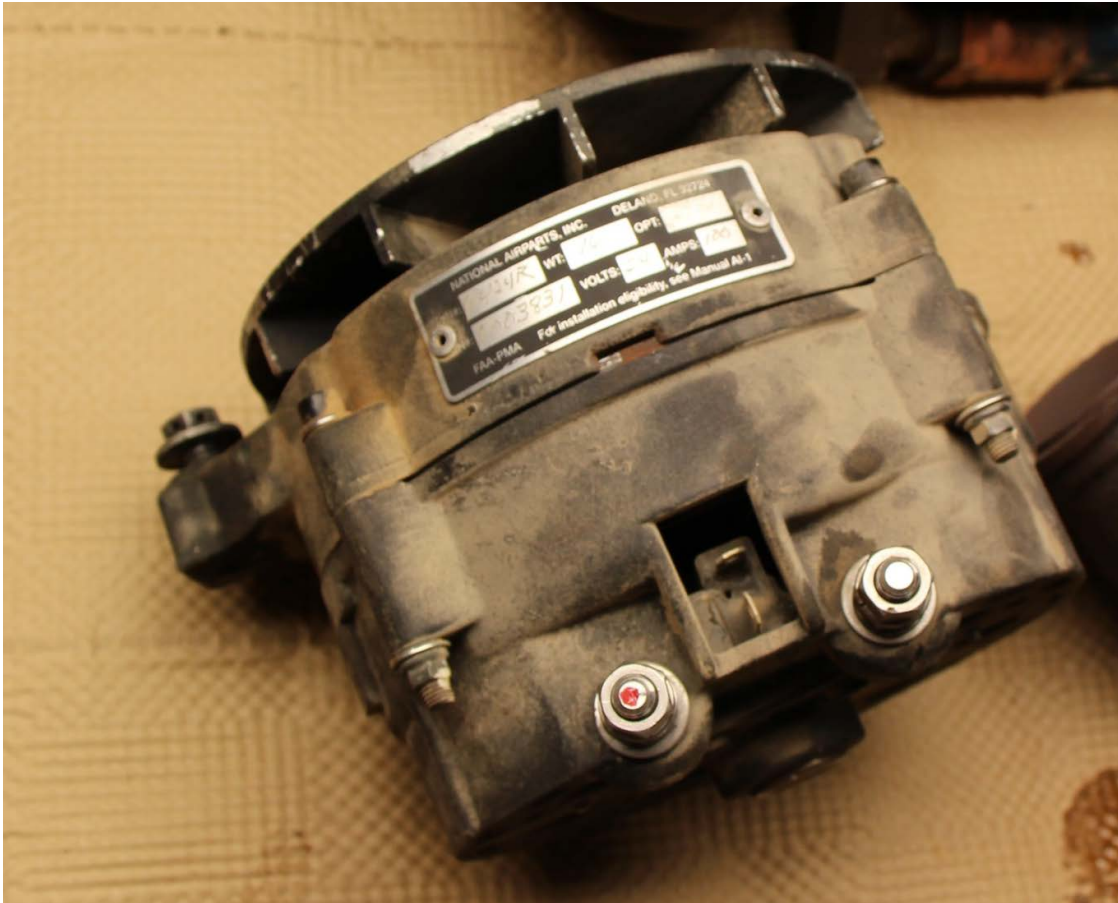
*Photograph 16: Alternator*

The alternator was manufactured by National Airparts, Inc., part no. F424R, serial no. F003831.
