# ENGINE EXAMINATION REPORT

| ENGINE MODEL | IO-520-A5B |
| AIRCRAFT MAKE & MODEL | Cessna 206 |
| FILE NUMBER | 19-053 |

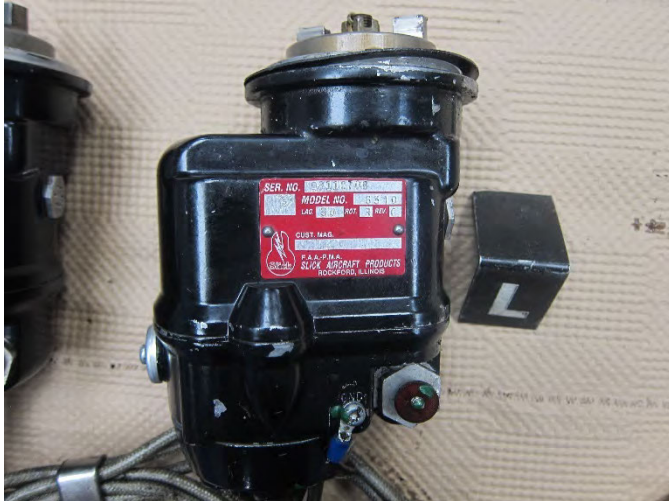
| LEFT MAGNETO | Manufacturer: Champion Slick | P/N: 6310 | S/N: 98110708 |
|---|---|---|---|
| Condition: | The left magneto remained in place with torque putty applied to the attaching hardware. A slip stripe was applied to the base of the magneto and the mounting area, with no evidence of magneto rotation observed. Removal of the magneto revealed no pre-event anomalies. | | |

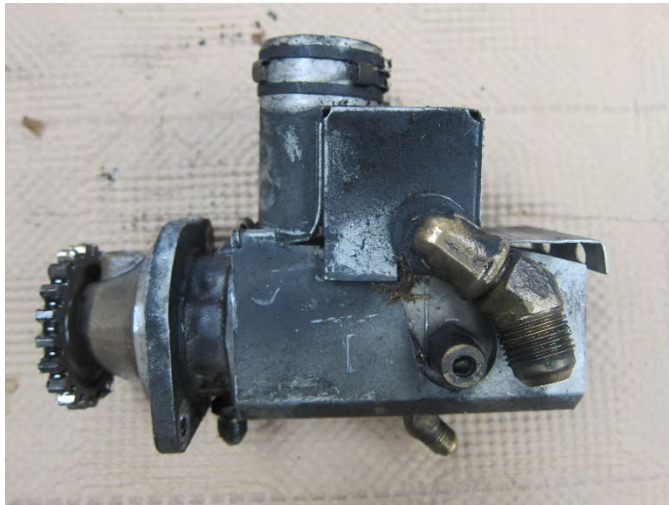
#### FUEL PUMP

The engine-driven fuel pump remained secured to the backside of the engine. The pump shroud was coated in black dirt (likely from the alternator drive belt). Removal of the pump revealed no pre-event anomalies with the coupling or drive gear.

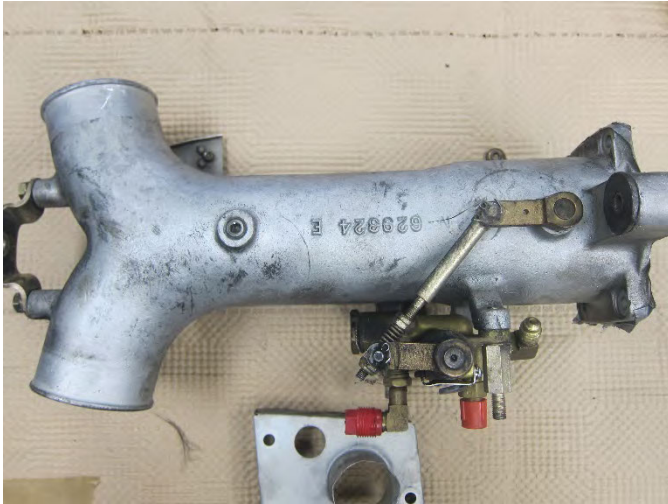
| <b>THROTTLE BODY METERING UNIT</b> | Manufacturer: Continental | P/N: 629703-2 | S/N: K058833AR |

| Condition: | The throttle body remained secured to the backside of the engine and the bronze control levers remained pinned to the throttle and mixture controls shafts. No pre-vent anomalies were observed externally. | | |

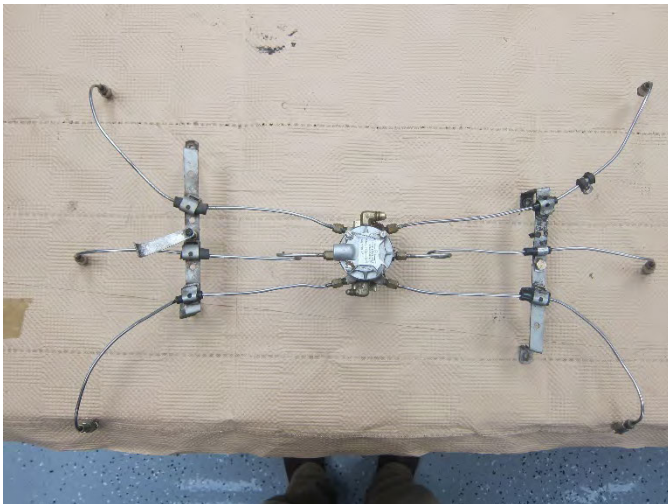
| <b>FUEL MANIFOLD VALVE</b> | Manufacturer: Aircraft Accessories of Oklahoma | P/N: 631351-15A3 | S/N: M9014 |

| Condition: | The fuel manifold valve remained secured to the topline of the engine with the fuel lines to and from the housing secured in place. | | |

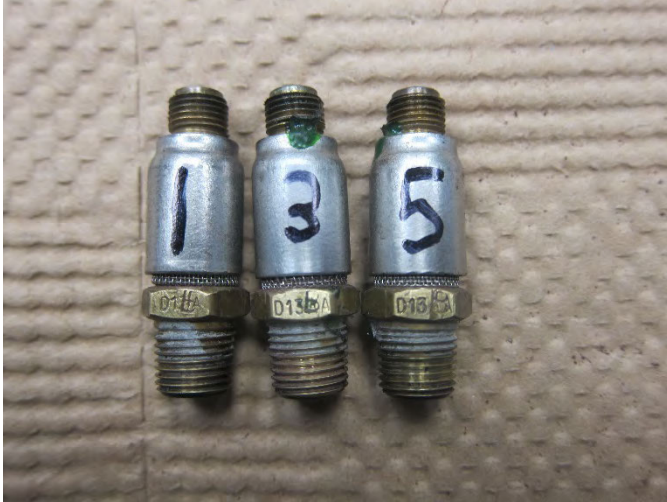
## FUEL NOZZLES AND LINES

The fuel lines and nozzles remained secured to their respective cylinders. No external pre-event anomalies were noted.

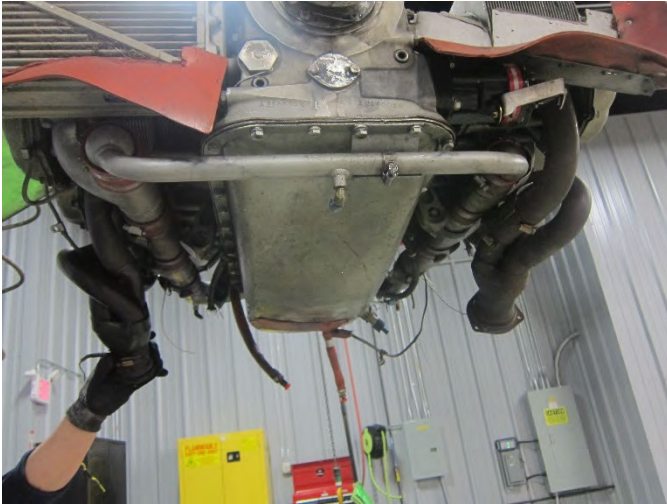
#### OIL SUMP

Condition: The oil sump remained secured to the bottom side of the engine. Removal of the sump revealed numerous pieces and parts had been released from the engine's internal components.

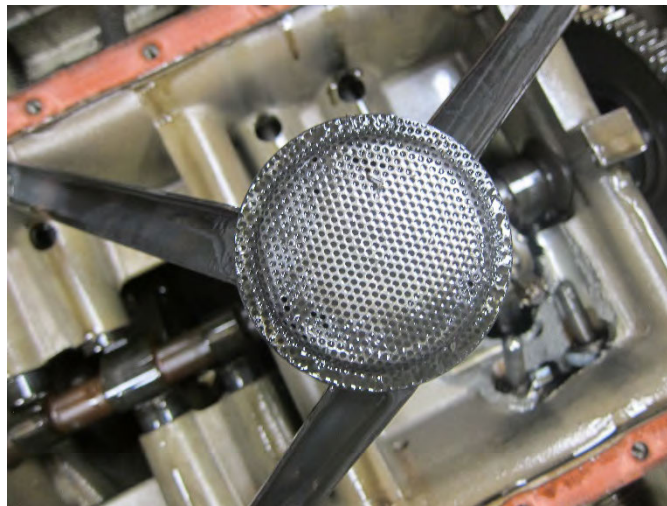
#### OIL PICKUP TUBE & SCREEN

Condition: The oil pickup tube and screen were unobstructed, though some metallic debris was noted on the screen.

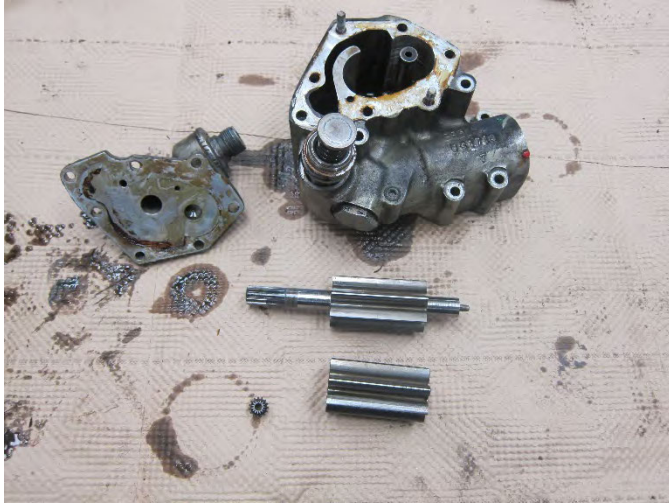
The oil pump displayed circumferential scoring on the pump cavity walls, indicative of hard particle passage. Additionally, the oil pressure relief valve face showed evidence of hard particle impingement.

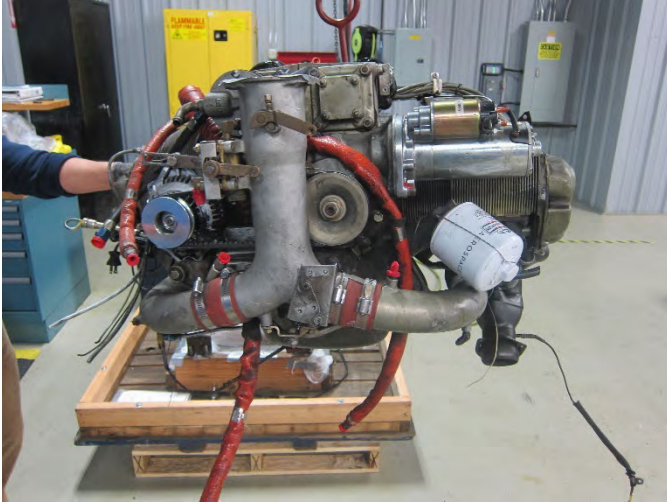
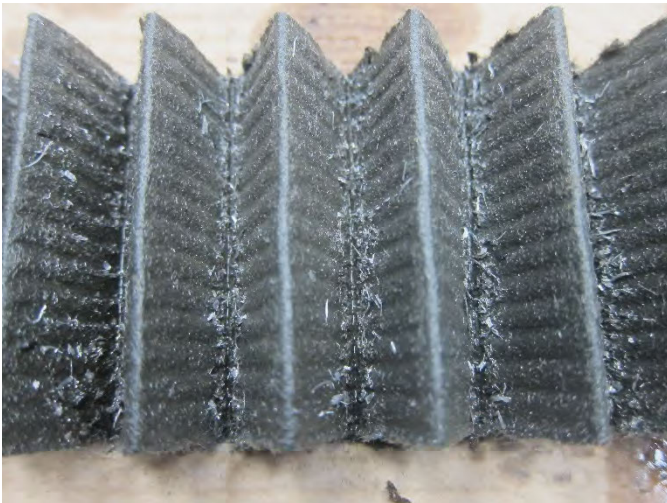
The oil filter remained secured to the adapter and had a tachometer time of 6,984.7 and a date of 8-6-19 hand-written on the side. The filter was cut open to reveal metallic debris within the filter pleats.

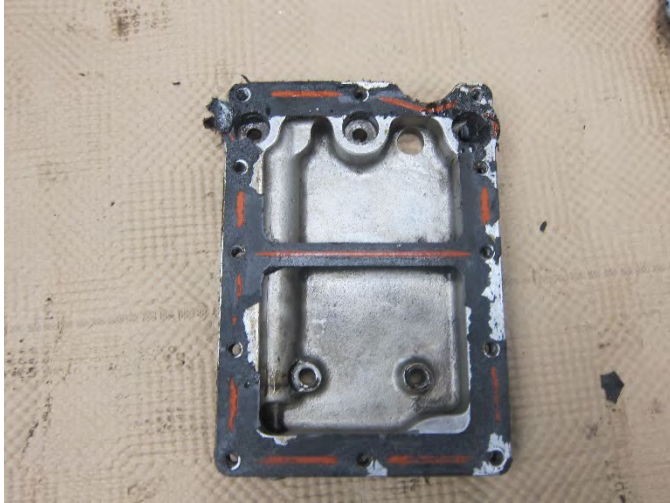
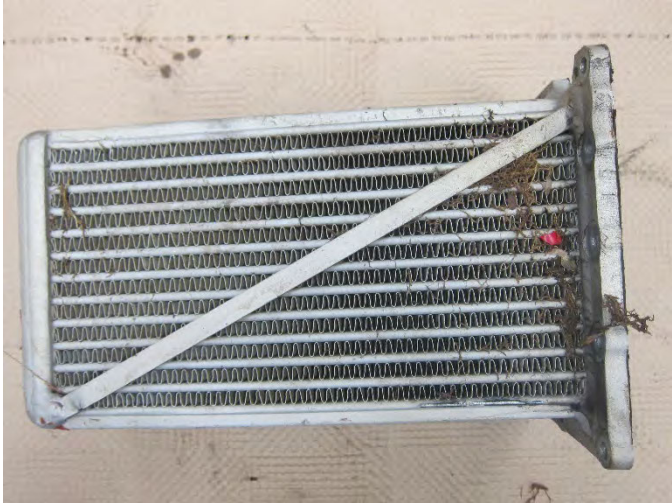
| OIL COOLER | Manufacturer: Pacific Oil Cooler Harrison Service | P/N: 8520732 | S/N: 117 (W.O. 114714) |

| Condition: | The oil cooler remained attached to the engine and no pre-event anomalies were noted with the unit. | | |

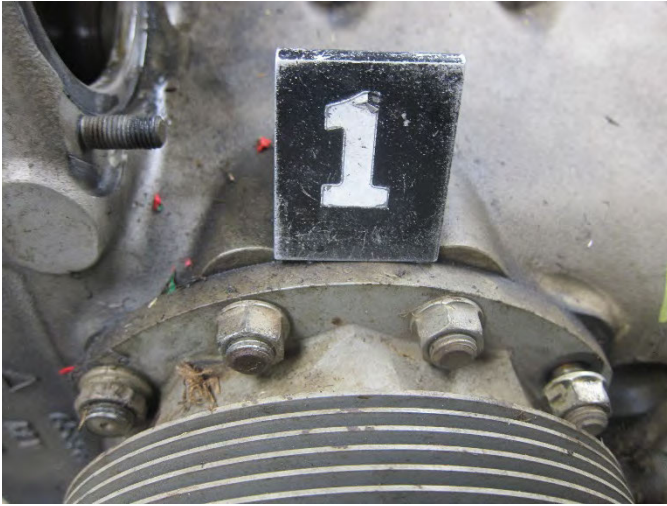
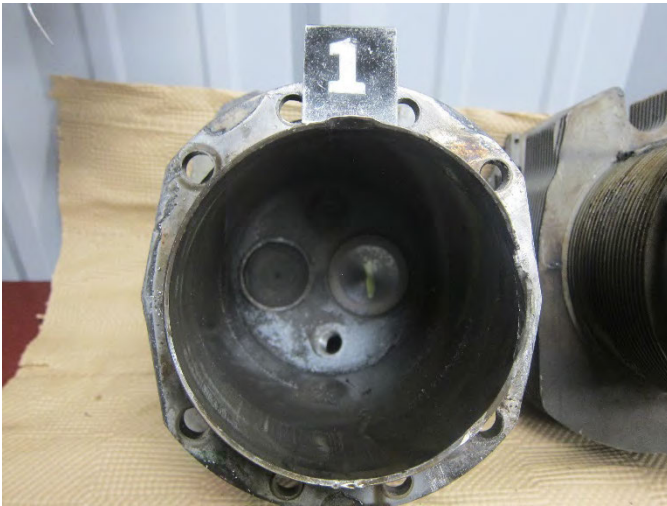
Condition: The cylinder remained attached to the crankcase and no torque putty was observed on the attaching hardware. One of the cylinder mounting studs was displaced outward from base of the cylinder. Removal of the cylinder revealed that the #1 piston displayed a semicircular impact impression consistent with a valve strike and it also sustained mechanical damage to the skirt. There were no pre-event anomalies noted with the rockers, valves, valve springs, and valve seats.

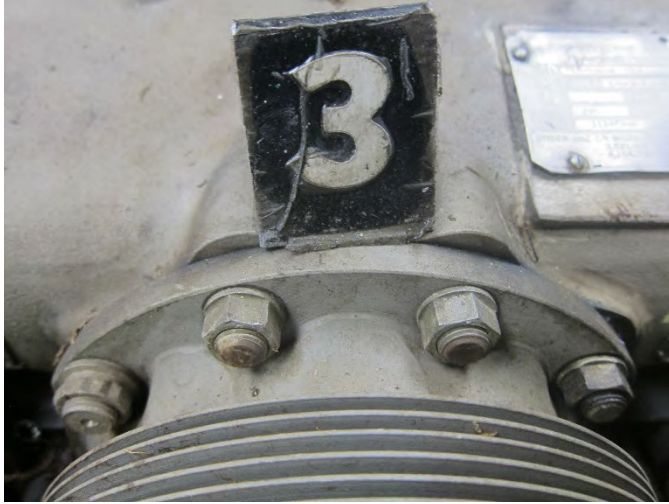
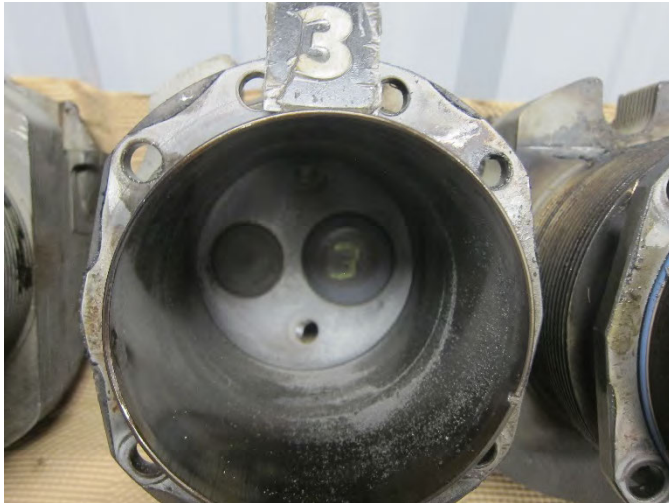
The cylinder remained attached to the crankcase and no torque putty was observed on the attaching hardware. Removal of the cylinder revealed no pre-event anomalies with the cylinder, piston, rockers and springs, or valves and valve seats.

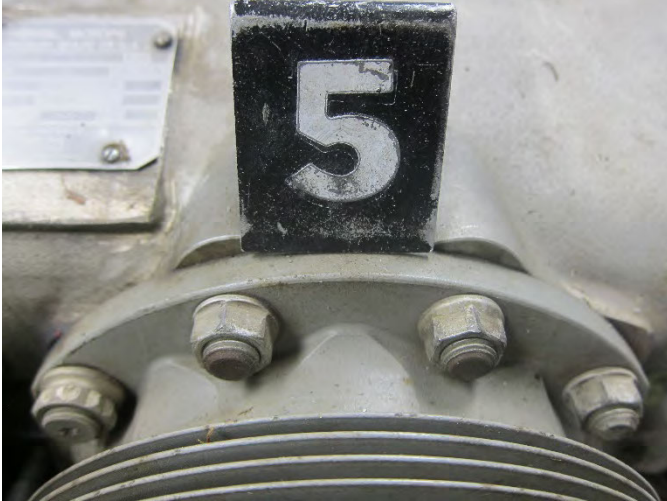
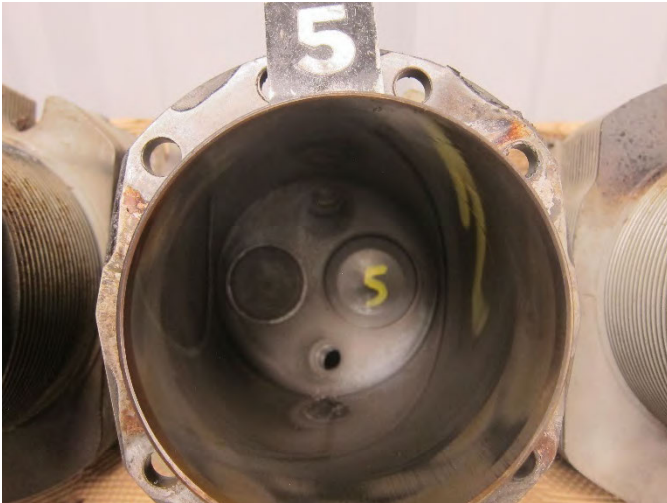
The cylinder remained attached to the crankcase and no torque putty was observed on the attaching hardware. Removal of the cylinder revealed no pre-event anomalies with the cylinder, piston, rockers and springs, or valves and valve seats.

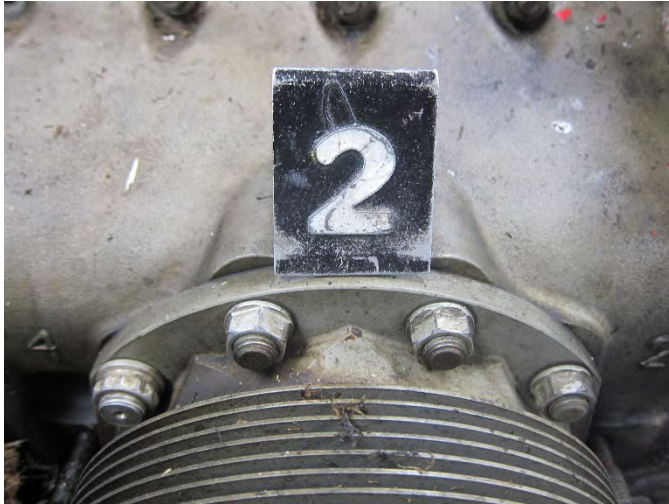
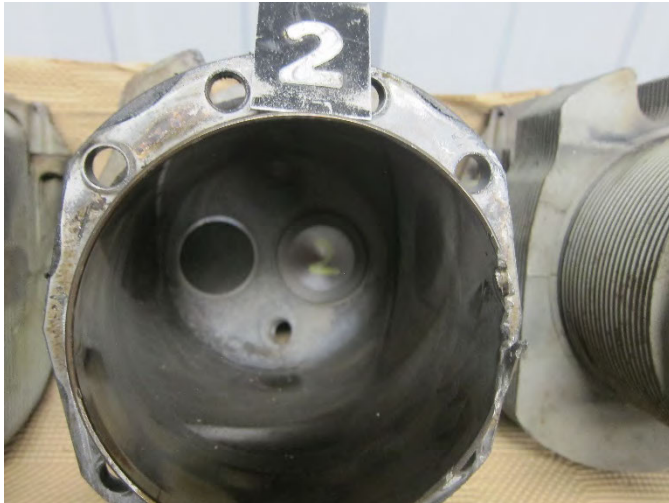
Condition: The cylinder remained attached to the crankcase and no torque putty was observed on the attaching hardware. Removal of the cylinder revealed that the #2 piston displayed a semicircular impact impression consistent with a valve strike and it also sustained mechanical damage to the skirt. There were no pre-event anomalies noted with the rockers, valves, valve springs, and valve seats.

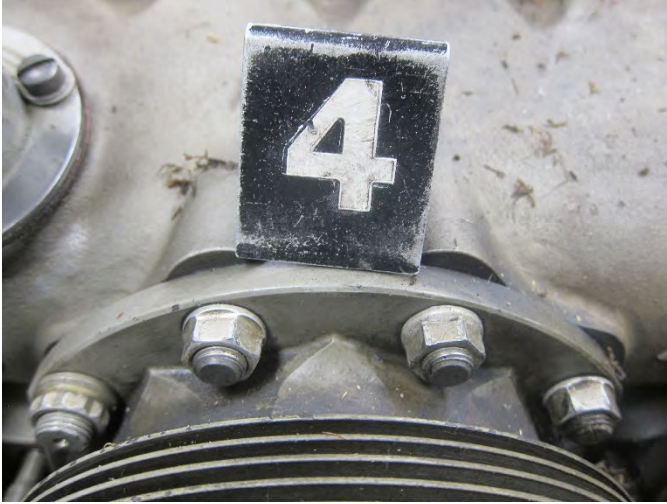
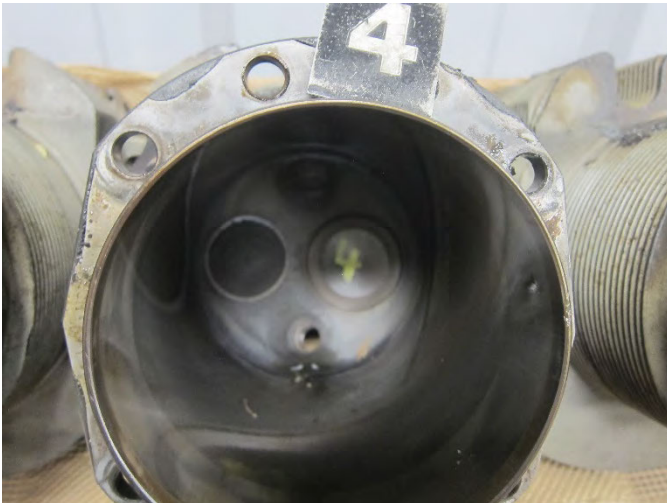
The cylinder remained attached to the crankcase and no torque putty was observed on the attaching hardware. Removal of the cylinder revealed no pre-event anomalies with the cylinder, piston, rockers and springs, or valves and valve seats.

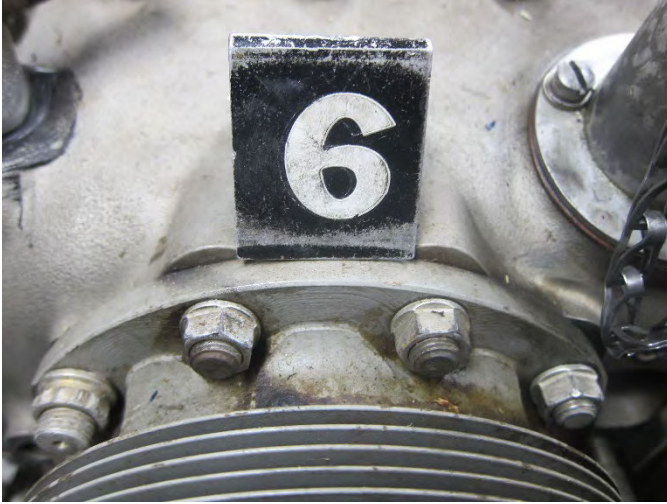
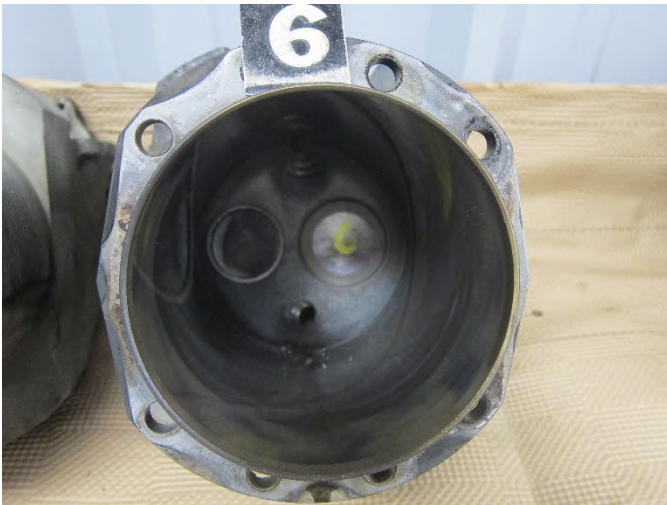
The cylinder remained attached to the crankcase and no torque putty was observed on the attaching hardware. Removal of the cylinder revealed no pre-event anomalies with the cylinder, piston, rockers and springs, or valves and valve seats.

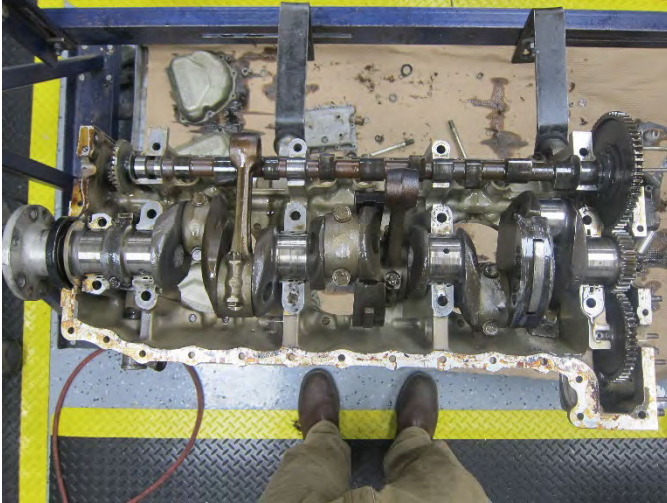
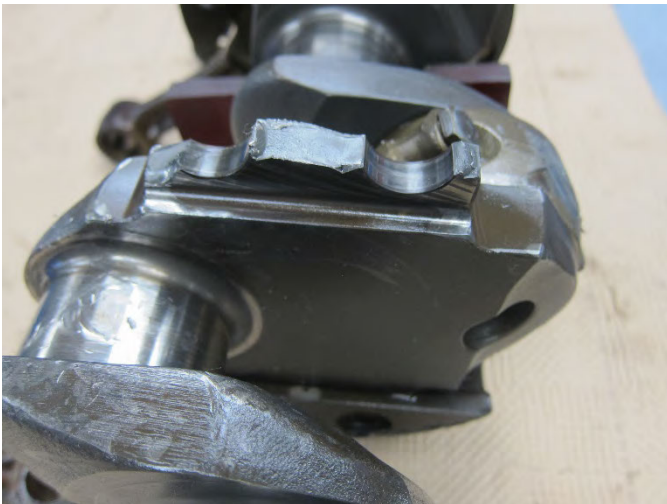
The crankshaft remained intact with the exception of the #2 bottom hanger blade, which was fractured. The #2 bottom counterweight was separated and fractured in numerous pieces. The #2 top counterweight sustained mechanical damage.

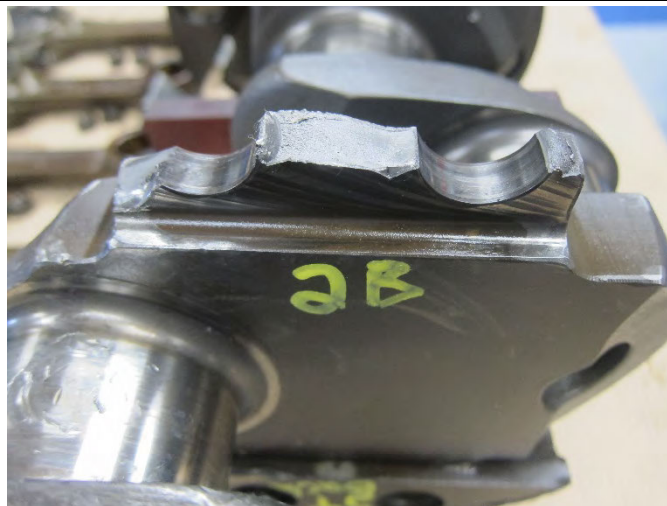
## COUNTER WEIGHTS

The #2 bottom counterweight hanger blade was fractured, and the counterweight was fractured in numerous pieces. Pieces of the fractured counterweight, two counterweight pins, 4 counterweight plates, and 4 counterweight snap rings were located in the oil sump. The hanger blade fracture surfaces were flat with visible beach marks consistent with fatigue cracking. However, it is presumed that the fatigue cracking was resultant damage caused by a separate initiating event. One of the 4 counterweight plates displayed a lack of mechanical deformation damage, though it was fractured into 5 pieces. All five pieces were located in the sump and loosely reassembled for documentation. A deep groove, the approximate diameter of a counterweight pin, was observed on one side of all the pieces. In comparison to the other plates, this one plate displayed a significantly deeper wear groove from the counterweight pin.

The #2 bottom hanger blade was fractured, and the #2 bottom counterweight was separated and fractured in numerous pieces. The hanger blade fracture displayed a flat surface with visible beach marks consistent with fatigue cracking. However, it is presumed that the fatigue cracking was a result of a missing counterweight pin. All four of the #2 bottom counterweight's plates and snap rings, along with both pins were found in the oil sump. One of the four plates was fractured into 5 pieces and displayed a relative lack of deformation damage. It also displayed a deep circular groove consistent in circumference as the counterweight pin circumference. Metallurgical examination of the hanger blade and the counterweight pieces is pending.

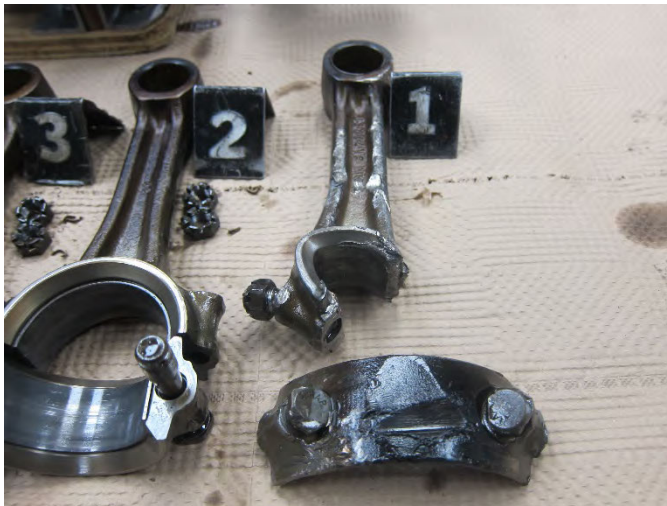
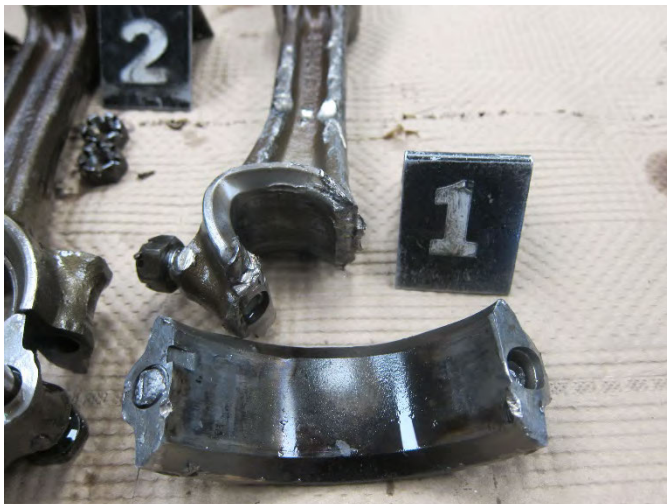
**Condition:** The bearing halves were located in the oil sump. They sustained mechanical deformation damage.

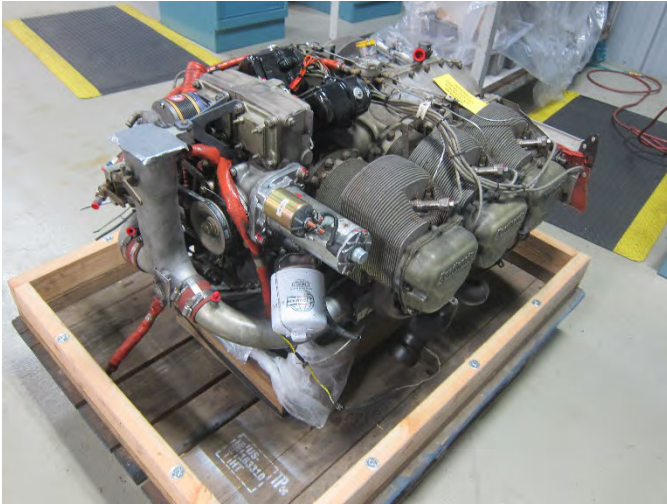
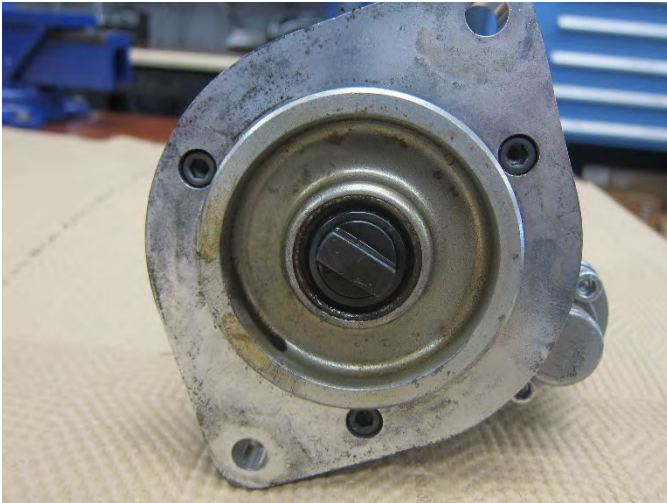
| STARTER | Manufacturer: Sky-Tec | P/N: C12ST5 | S/N: 2C5-141514 |
|---|---|---|---|
| Condition: | The starter motor remained attached to the adapter and exhibited normal operating signatures. | | |
