## INVESTIGATION SUPPORT MATERIAL SUPPLEMENT

### HISTORY OF FLIGHT

On October 23, 2019, at 1553 mountain standard time, a Robinson R44 II Raven, N225JM, sustained substantial damage after impacting terrain following an auto-rotation in Las Vegas, Nevada. Binner Enterprises LLC, owned the helicopter and Airwork Las Vegas was operating the helicopter under the provisions of 14 *Code of Federal Regulations* (CFR) Part 91. The airline transport pilot and passenger survived the impact, but later succumbed to their injuries. The personal local flight departed from North Las Vegas Airport, Las Vegas, Nevada, about 1535. Visual meteorological conditions prevailed and no flight plan had been filed.

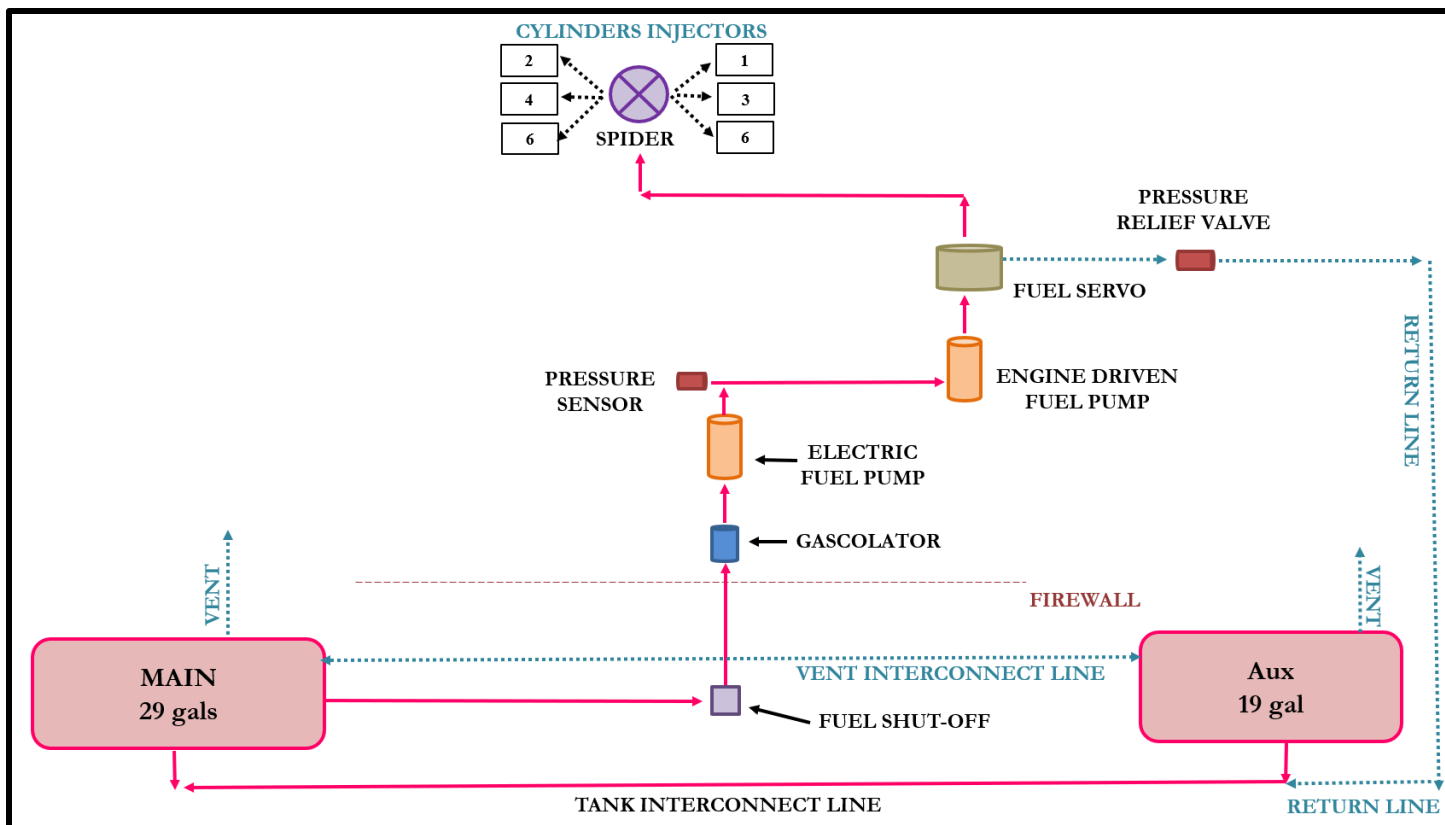
Picture 17: Fuel System

Investigator removed the gascolator at the accident site. The bowl was full with a liquid consistent in odor with that of 100LL AVGAS, but the color was an orange-yellow; there was some debris in the bowl that was akin to a gelatinous consistency (the liquid was captured in glass bottles for possible future testing). During recovery fuel began to pour from the system where the T had broken at the return line to the aux tank. Investigators cut the interconnect line and clamped it for recovery purposes.
