## **NATIONAL TRANSPORTATION SAFETY BOARD**

# **AIRFRAME AND ENGINE EXAMINATION**

**WPR20FA016**

Location: Jordan Valley, Oregon  
Date: October 25, 2019  
Aircraft: Enstrom 280F, Registration N280F, Serial Number 1501  
NTSB IIC: Elliott Simpson

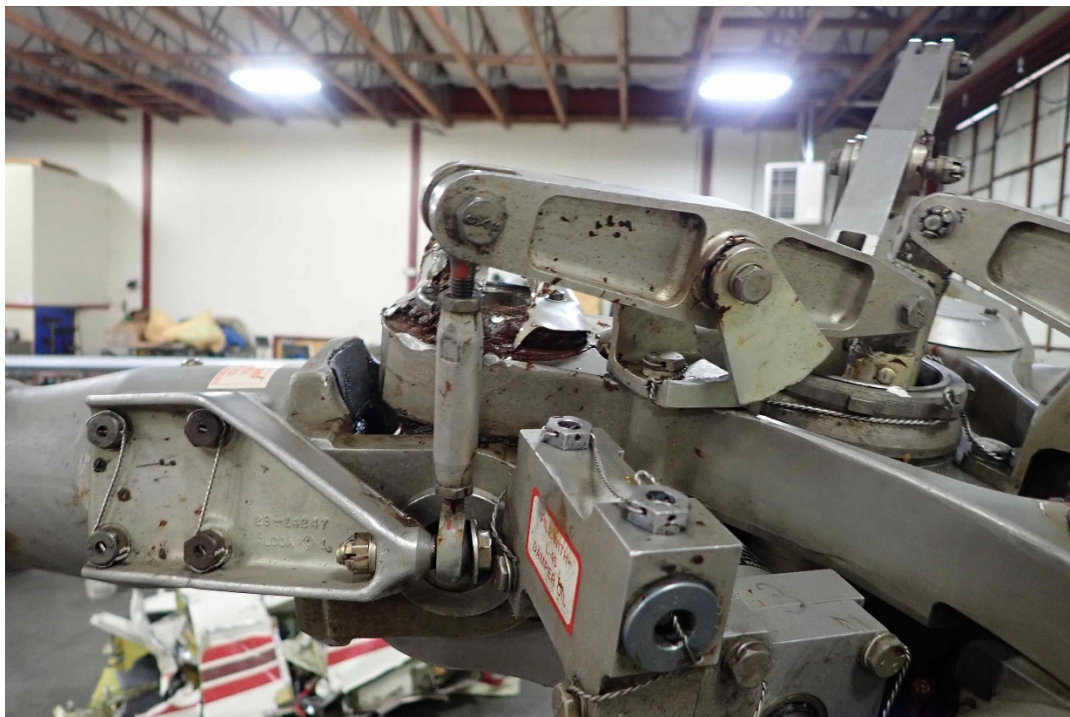
Photo 13 – Number One Blade Grip Assembly

The number one main rotor blade grip was level, but the lead-lag hinge cover had torn (photo 12), and gouges were observed on the pitch horn, indicating the blade had pitched up to approximately 90°. The pivot bracket for the walking beam had broken in an upwards direction, which was further consistent with a movement to high pitch (photo 13). The damper had partially opened; and the two bottom bolt heads in its cap had detached (photo 14). According to the Enstrom representative, such damage is consistent with rapid deceleration of the rotor blade after one of the other two blades strikes a solid object (such as the ground) while significant energy remains within the rotor system. The rotor blade was bent upward approximately 30° in a curve starting near the root (photo 15). It was also bent opposite the direction of rotation by about 5°; the bend appeared to start roughly 5 feet inboard from the tip. The top rivets on the tip cap were sheared, and most of the trailing edge had opened from the inboard trim tab to the tip. Chordwise abrasions and mud were present on the leading edge cap strip on the outboard 2 ft section of the blade.

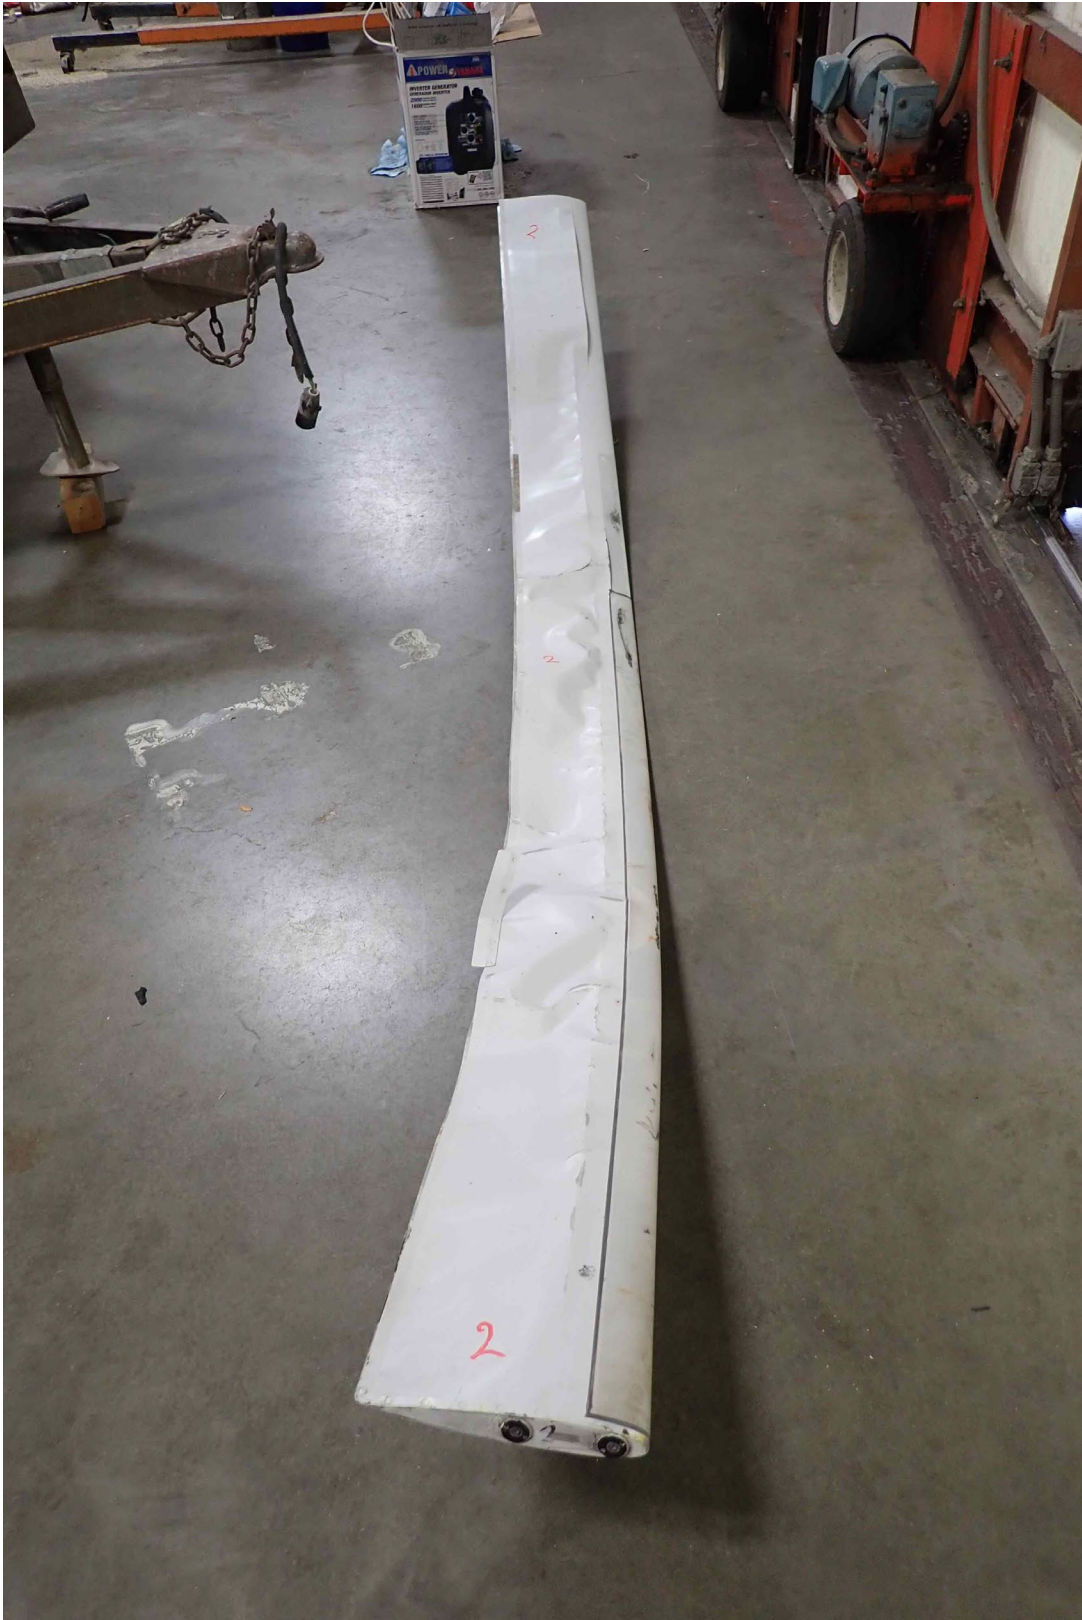
Photo 17 – Number Two Blade

The number two main rotor blade grip was pitched up about 75°, and the walking beam pivot bracket had broken (photo 16), and the damper was mostly compressed. The blade was bent upward approximately 40° in a curve starting near the root, and bent about 10° opposite the direction of rotation approximately in a curve starting at the inboard trim tab (photo 17). The tip cap was in place, and the trailing edge was open for the entire blade length; the inboard trim tab was detached. There were no observable rotational scratches to the upper blade surface, and 45° chordwise abrasions were present on the leading edge cap strip and the underside of the blade, starting 4 ft inboard from the tip (photo 18).

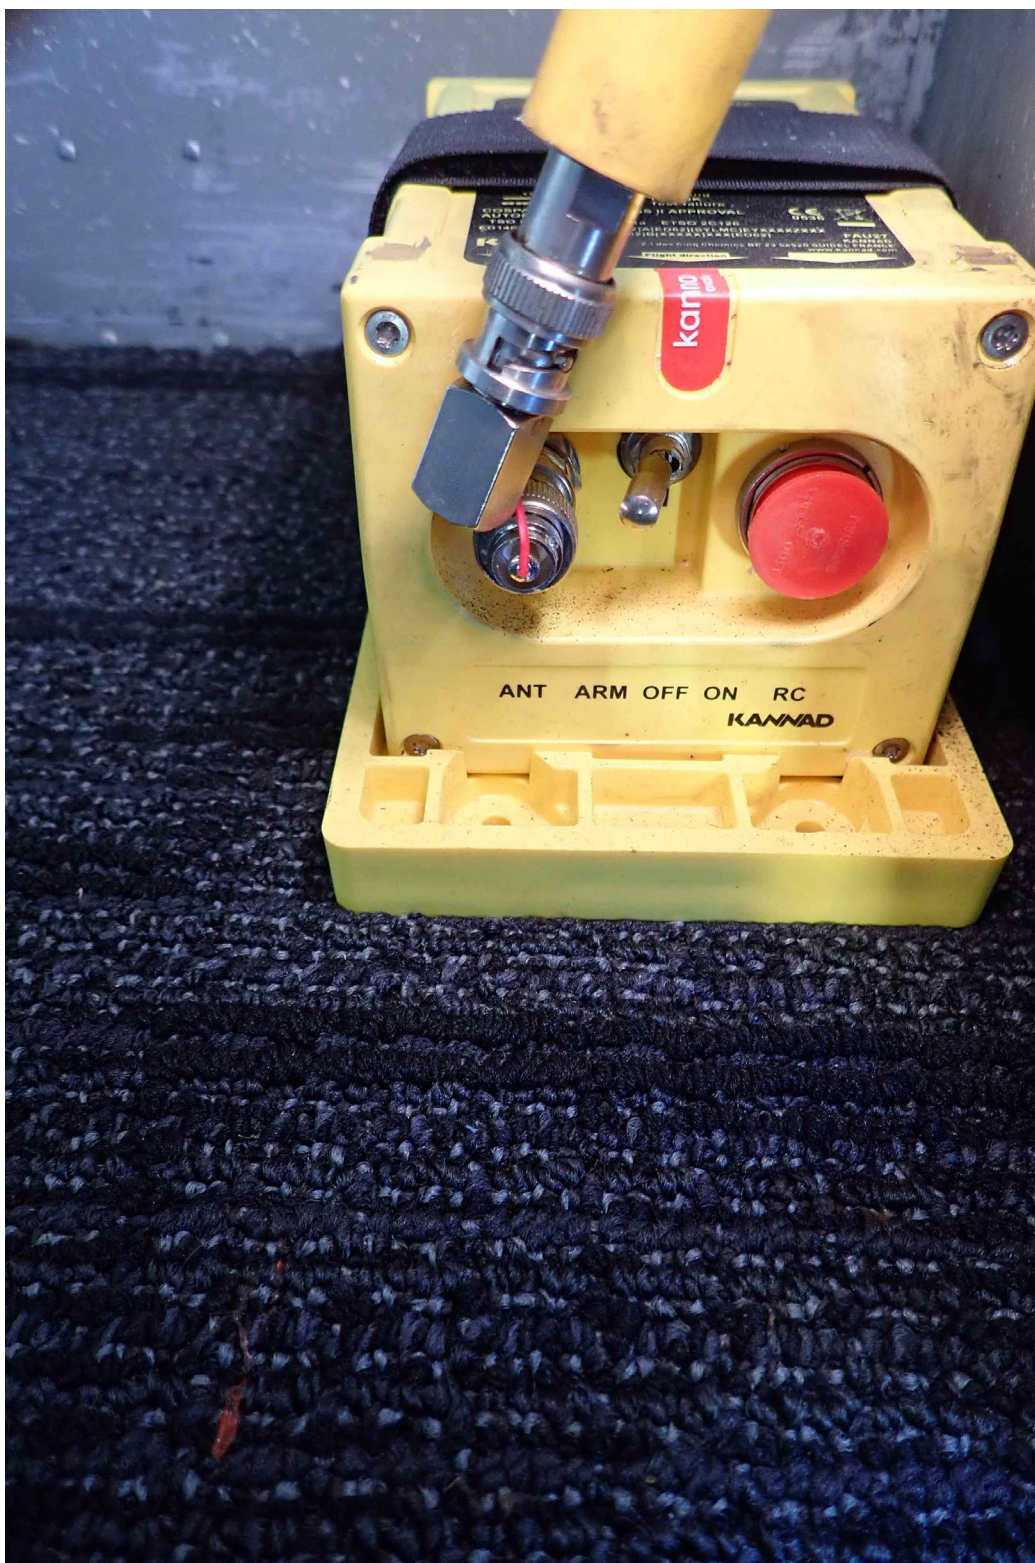
Photo 26 – ELT

The ELT was emitting an audio tone at the accident site. The airframe was cut open to facilitate access, and the ELT was found mounted to the left side of the floor within the baggage compartment. The unit was not utilizing an external antenna but instead its own antenna which had been mounted to the left baggage door wall. The antenna had disconnected from the ELT BNC connector, with only the red core wire remaining connected (photo 26). Fine brown deposits were present around the area of the BNC connector. It could not be determined if the BNC connector “shield” had dislodged during the accident, or as the cabin door skin was cut open to gain access. Irrespective, with the red core wire still connected, the unit should still have been able to transmit a signal.

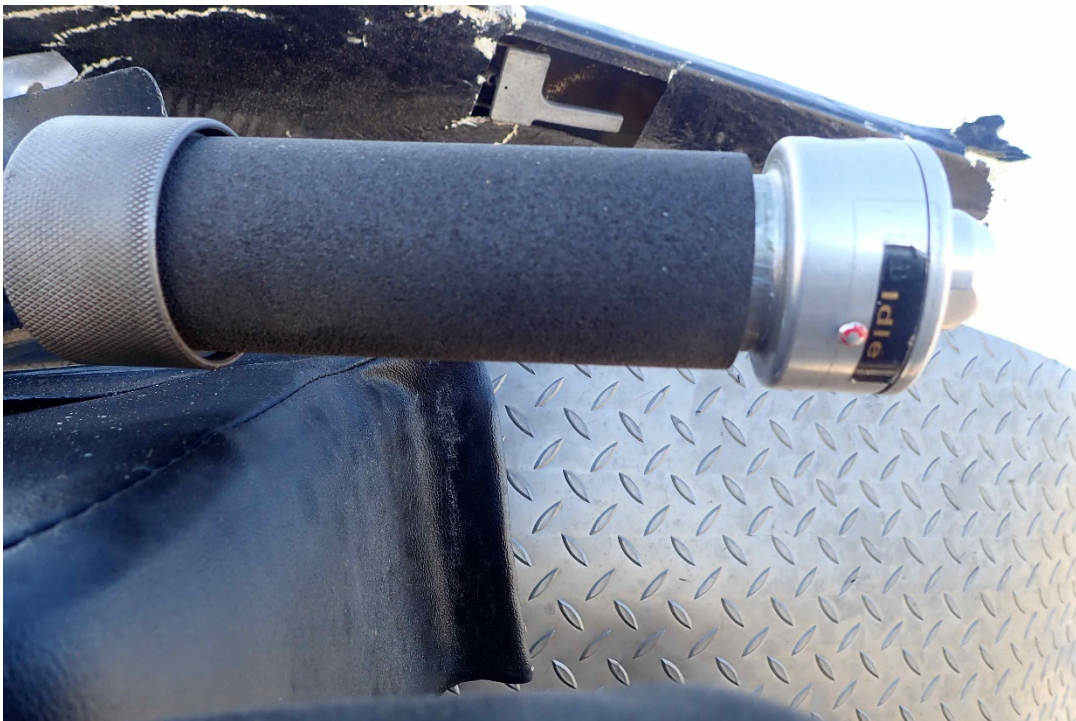
Photo 28 – Throttle Control

The engine sustained minimal damage during the accident sequence. There was no evidence of crankcase breach or catastrophic internal failure. The throttle and mixture controls were continuous from their respective control arms through to the cabin controls. At the accident site, the throttle was found just short of the idle position (photo 28), and the mixture control was about 1 inch short of the full forward position (photo 29). The inlet air filter was free of obstruction, and the filter assembly spring-loaded alternate air and backfire doors could be opened by hand. The induction air inlet tube, which connected the air filter assembly to the fuel injection servo inlet (attachment 1) sustained impact damage and was impinged against the bent airframe structure on impact (photo 30). The tube also exhibited multiple areas where the rubber surface had chaffed and delaminated away from the steel wound spring core (photo 31). The tube was retained for further examination.
