## ENGINE EXAMINATION REPORT

| ENGINE MODEL | O-470-R |
| AIRCRAFT MAKE & MODEL | Cessna 182F |
| FILE NUMBER | 19-146 |

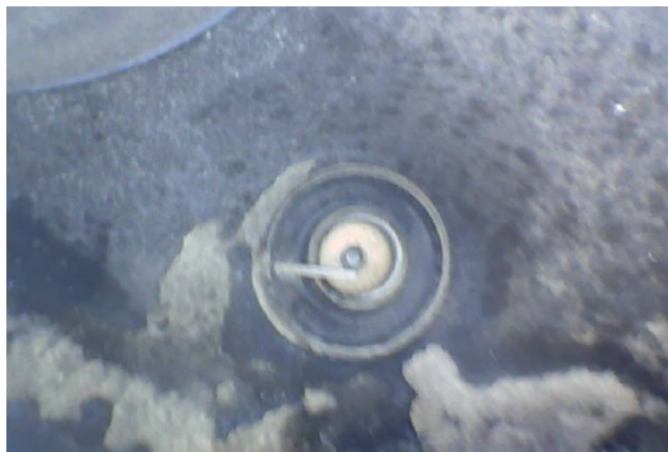
#1 Bottom Spark Plug

The spark plugs remained installed in their cylinders and were undamaged. The top spark plugs were removed for examination and the bottom spark plugs were examined using a lighted borescope. The spark plug electrodes displayed normal operating and wear signatures.

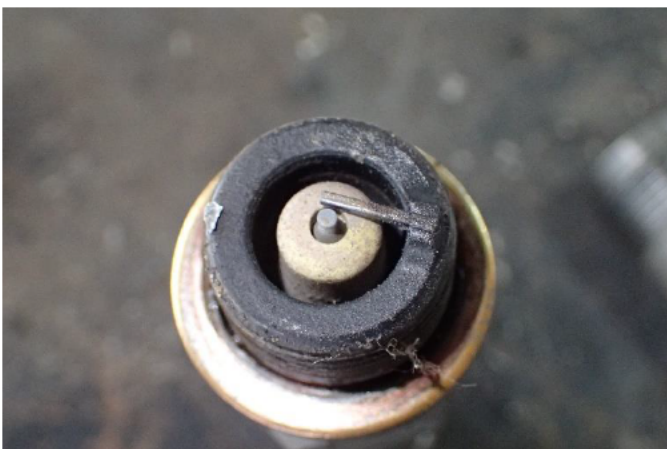
#2 Top Spark Plug

The ignition harness remained attached to both magnetos and to each spark plug. The #2 top spark plug ignition lead end displayed impact damage signatures and was partially severed. During magneto operation, it was observed that each ignition lead was capable of conducting a spark from the magneto to each ignition lead end or to the severed portion of the #2 top spark plug.

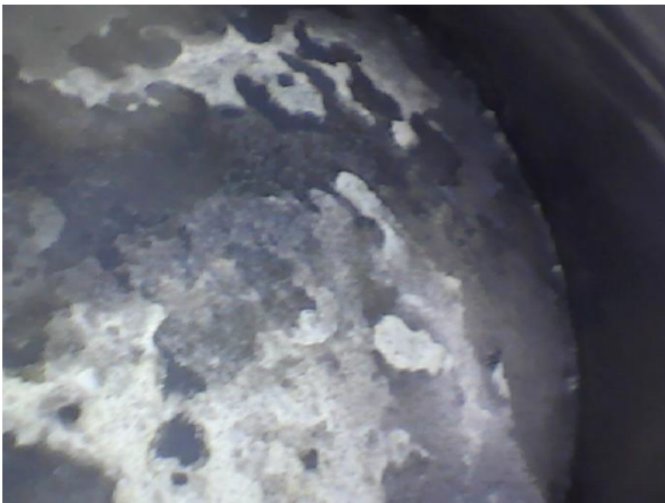
#1 Piston

The piston faces were inspected using a lighted borescope. The piston faces displayed normal operating and combustion signatures. During crankshaft rotation all of the pistons operated normally.
