## **NATIONAL TRANSPORTATION SAFETY BOARD**

# **ACCIDENT SITE EXAMINATION SUMMARY**

**WPR20FA079**

| Aircraft: | N1682G, American Champion-7KCAB |

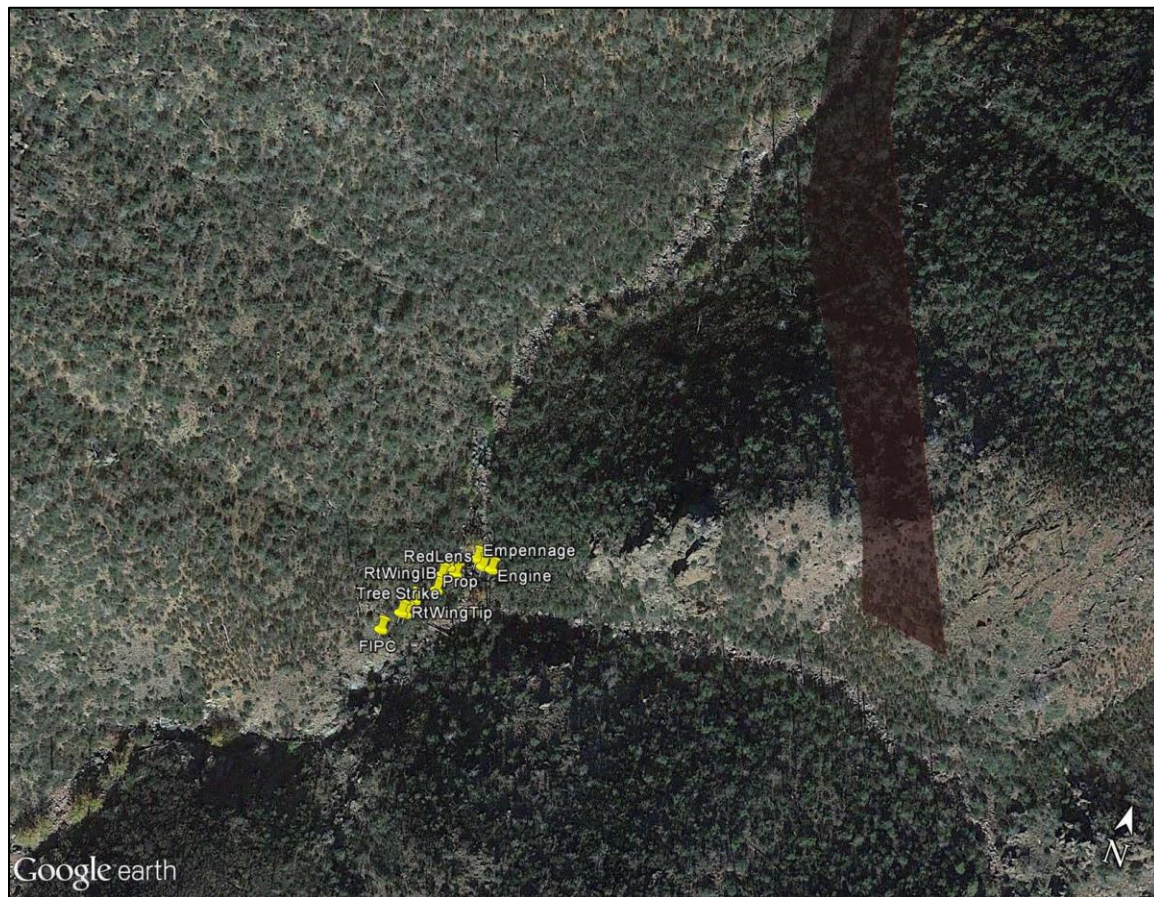
Figure 2-Google earth view of the accident site and radar track

Examination of the accident site was on January 25<sup>th</sup>, 2020. The Federal Aviation Administration (FAA), Piper Aircraft and the NTSB-IIC were airlifted by the Arizona Department of Public Safety from PAN to the accident site. The accident site is located near the top of the City River Canyon in the Mazatzal Mountain Range, about 10-1/2 miles southwest of PAN. The canyon runs downslope to the north and the sides of the canyon are about 40-45 degree slope. The eastern side of the canyon rises to about 300 ft, the western side rises to about 400 ft and the southern side rises to about 800 ft above the accident site. At the bottom of the canyon, two small streams fork together at the accident site. The stream is about 6 ft across and has an average depth of about 6 inches.
