# NATIONAL TRANSPORTATION SAFETY BOARD

## MATERIALS LABORATORY FACTUAL REPORT

Report No. 20-039

Place : Hillsboro, Oregon  
Date : April 6, 2020  
Vehicle : Robinson R44 II, N725GT  
NTSB No. : WPR20LA119  
Investigator : Maja Smith, ASI-WPR

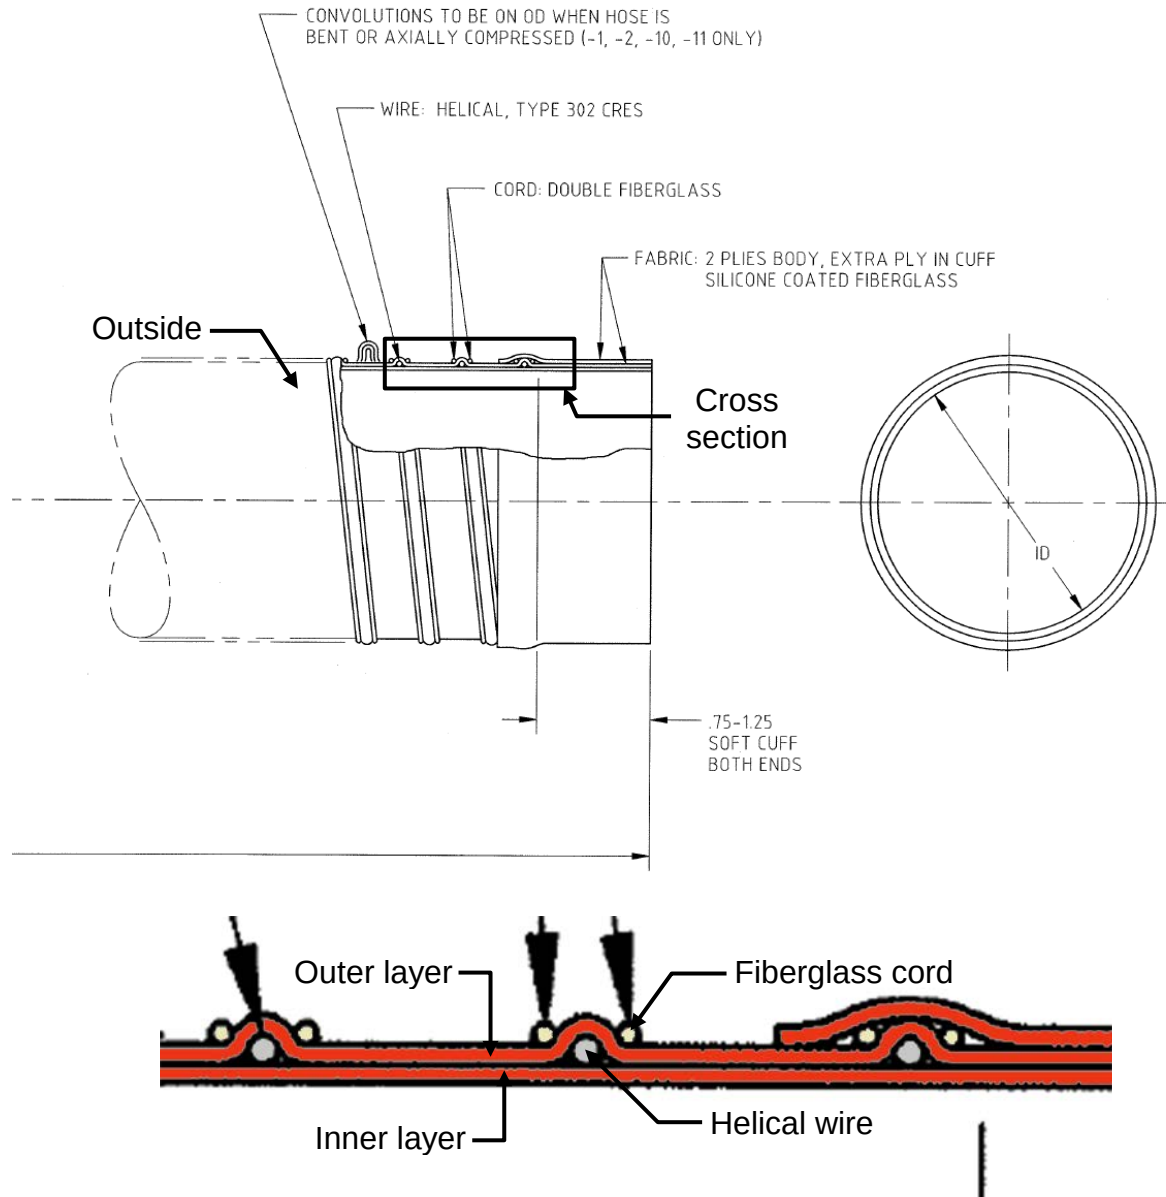
**Figure 2:** Schematic drawing of the SCEET duct tube. The upper image shows the side view and axial view. The lower image shows a close up view of the cross section with labels for the individual components that make up the tube. Color has been added to the lower image for visualization purposes.
