**Date of Accident:** April 20, 2020

**NTSB File No.:** WPR20LA128

**Aircraft:** Piper PA-31T1 Cheyenne

**PROPELLER TEARDOWN REPORT**

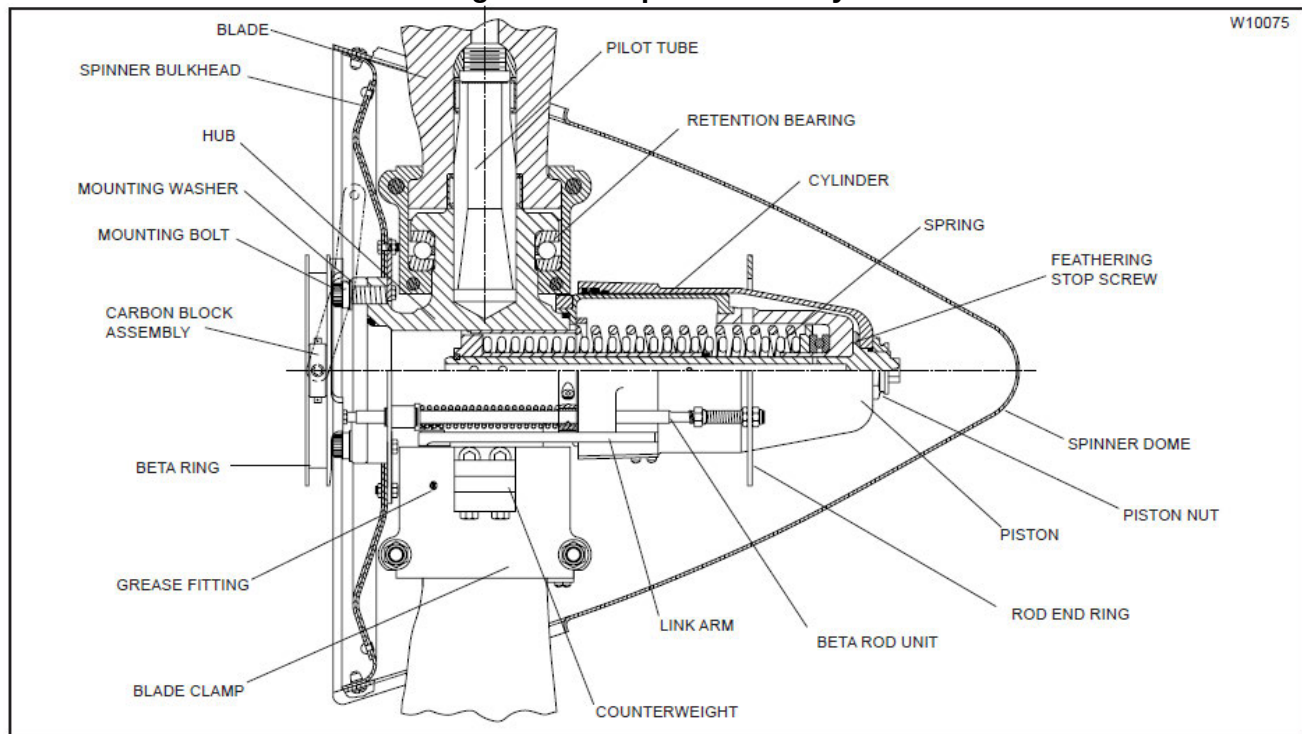
**Figure 1 – Propeller Cutaway Sketch**

**Propeller Description:** The propellers examined are used on the PT6A-11 powered PA-31T1 Cheyenne and are 93.5" diameter, 3-blade, single-acting, hydraulically operated, constant speed models with feathering and reversing capabilities. Oil pressure from the propeller governor is used to move the blades to the low pitch (blade angle) direction. Blade mounted counterweights and feathering springs actuate the blades towards the high pitch direction in the absence of governor oil pressure. The propeller incorporates a Beta mechanism that actuates when blade angles are lower than the flight idle position. The blades are of aluminum construction. The hub and blade clamps are steel. Propeller rotation is clockwise as viewed from the rear. A propeller cutaway sketch is shown in Figure 1.

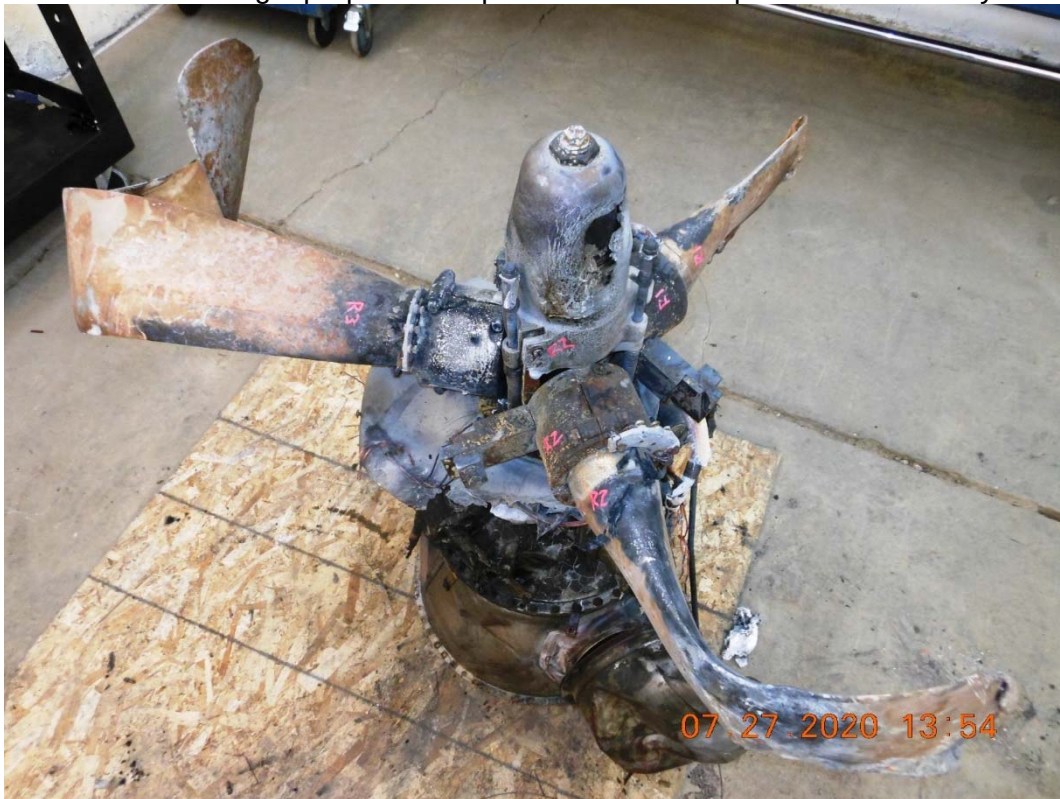
**“As Received” Condition:** The propeller was presented for examination while still attached to the engine propeller shaft flange as shown in Photo #2. All mounting hardware appeared intact and present. The beta arm was in the proper position under the guide pin and the beta block was in the beta ring. The de-ice slip ring potting compound was consumed and the slip rings were resting loose around the mounting flange area. No attempt was made to remove the propeller from the engine propeller flange. The piston was in the feathered position. The propeller exhibited extensive thermal damage. The beta guide ring was mostly consumed. The piston had a hole burned/melted through adjacent to R2. Blade R1 was thermally consumed ~13” outboard of the clamp and was in the feathered position. Blade R2 was thermally consumed ~21” outboard of the clamp and was in the feathered position. Blade R3 bent/curled aft and opposite rotation and also in the feathered position. Blade R3 had leading edge gouges and buckling wave bends along the trailing edge. There were no visible slip indicators on the clamps but blade R3 appears to have been forcibly slipped toward low pitch. All three link arms were present and attached at both the link screw and link pin locations. The beta guide rod collar was gouged by all three link arms in a similar fashion. The spinner dome was mostly consumed and all three counterweight assemblies were present and secure. Photo #7 shows the propeller prior to disassembly with components numbered.

**Piston:** The piston was in the feathered position when presented for examination with a hole burned through the piston wall adjacent to blade R2. The piston nut was intact but loose. There were a few circumferential marks on the internal surface likely made by contact with the top corner of the cylinder during initial impact and following impact sequence (see Photo #9). The marks measurements and interpretation are presented in the following Table #1.

Photo #7 – Right propeller components numbered prior to disassembly

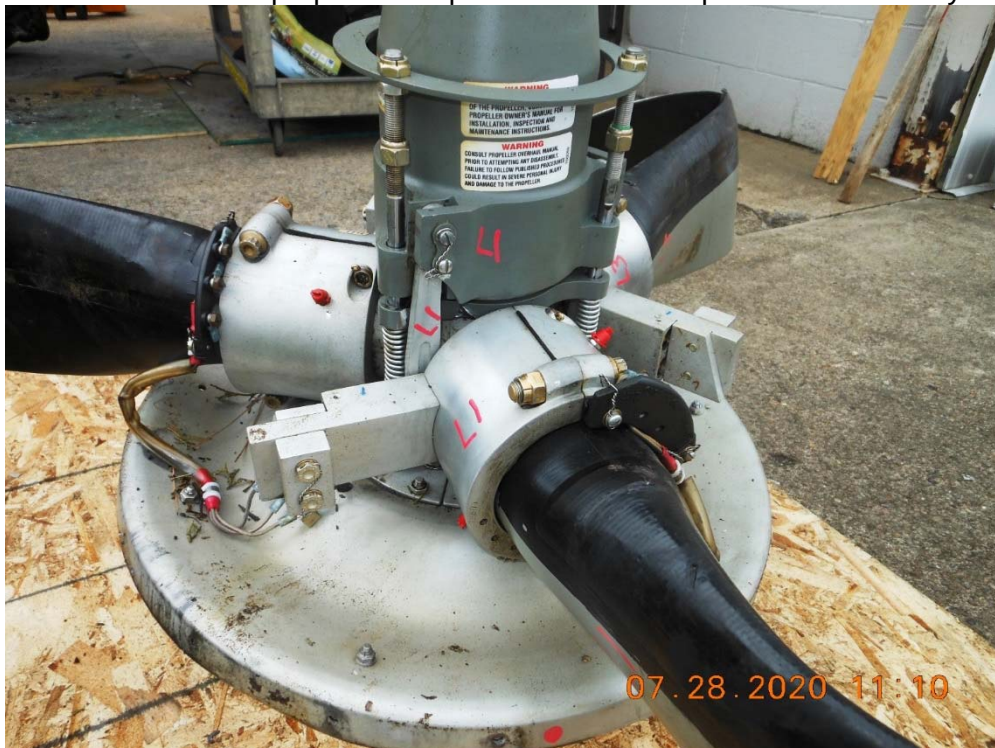
**“As Received” Condition:** The propeller fractured from the propeller shaft during the impact sequence, was recovered and shipped with the engines to PWC Engine Services in Bridgeport, WV for examination as shown in Photo #3. Because the propeller separated from the main wreckage it was not subjected to the post-crash fire as shown in the on-scene photos. The spinner dome was intact but dented. All three blades and clamps were in the feathered position. There were no slip indicators on the clamps. All three blades exhibited similar bending and twisting; curled aft, opposite rotation and toward low pitch. All three blades exhibited leading edge gouging and chordwise/rotational scoring on the camber side, outboard half of the blade. There were gouges in the guide collar from the link arm/link screws indicating forceful rotation toward low pitch. The beta ring was intact and all propeller mounting hardware was present and lockwired on the mount flange. The propeller is shown in Photo #17 with the spinner dome removed and components numbered prior to disassembly.

Photo #17 – Left propeller components numbered prior to disassembly
