**Report No.: 20-042**

**FMR Aviation LLC  
Piper PA-31T1, Aircraft Registration No. N926K  
Billings, Montana  
April 20, 2020  
PT6A-11  
Left Engine Serial No. 10234  
Right Engine Serial No. 10239**

**NTSB Identification: WPR20LA128**  
**TSB Identification: A20F0083**  
**P&WC File No.: 20-042**  
**RFA No.: 20SIE00091**

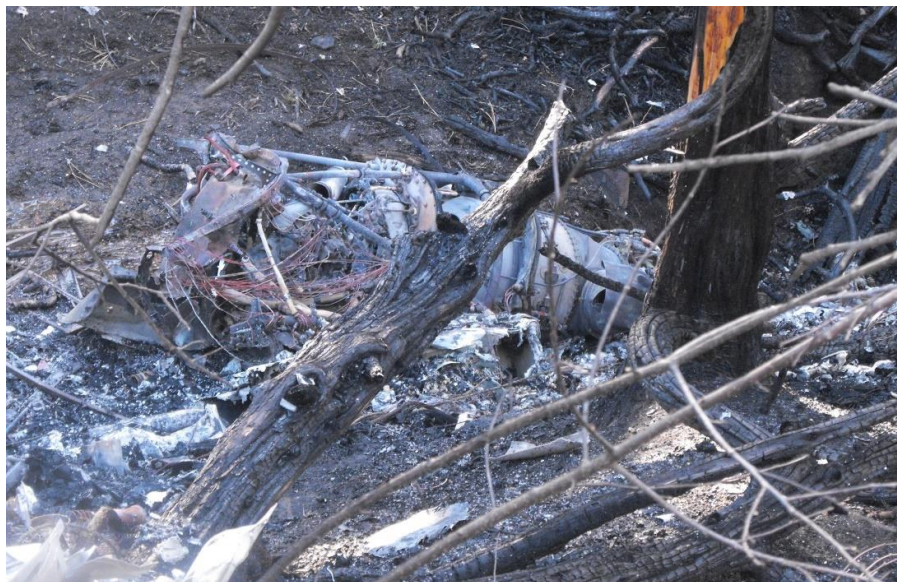
Photo No. 2, courtesy of the FAA

An overview of the accident site shows that left hand engine was orientated approximately 90 degrees opposite the directional orientation of the aircraft, suggesting it was most likely impact separated (Ref. Photo No. 1, red oval). The right hand engine was orientated in the same direction as the aircraft (Ref. Photo No. 1, blue oval). The left hand engine was situated in an upright orientation (Ref. Photo No. 2). The engine and propeller were received in a sealed shipping container (Ref. Photo No. 3). The exterior of the engine exhibited impact damage and thermal damage from the post impact fire (Ref. Photo No. 4). The propeller shaft was impact fractured, separating the propeller from the engine. All three propeller blades were bent and the exterior of the propeller did not exhibit any thermal damage (Ref. Photo No. 5). The bottom portion of the front reduction gearbox housing was partially consumed by the post impact fire. The accessory gearbox housings and portions of the inlet case were consumed by the post impact fire. The heater, fuel control housing and portions of the fuel pump were consumed by the post impact fire. The fire had separated the engine data plate from the inlet case. The data plate showed the engine was a PT6A-11 and the serial number was PC-E 10234 (Ref. Photo No. 6).

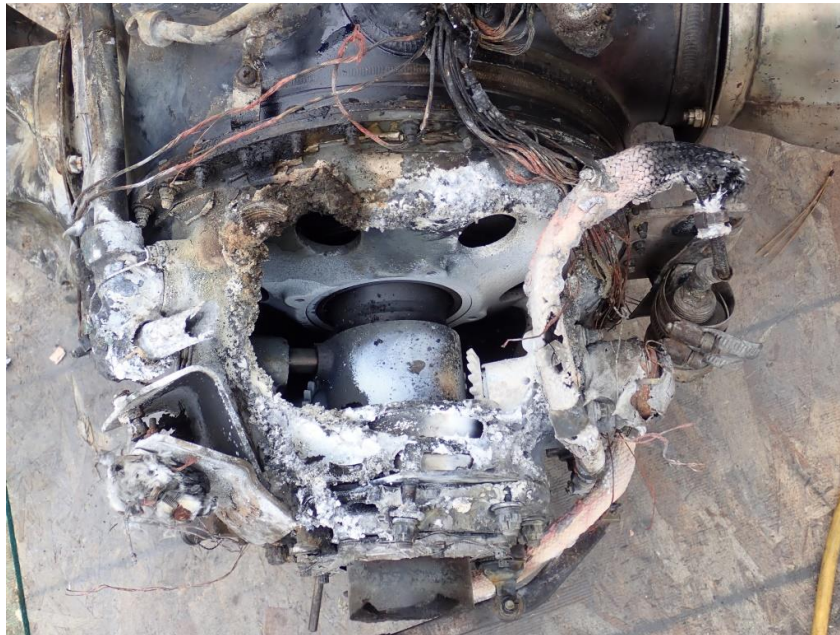
Photo No. 8

**Reduction Gearbox (RGB):** The propeller shaft was impact fractured and the gearbox mounted accessories were thermally damaged from exposure to the post impact fire (Ref. Photo No. 7). The bottom section of the gearbox was burned exposing several of the internal components (Ref. Photo No. 8).

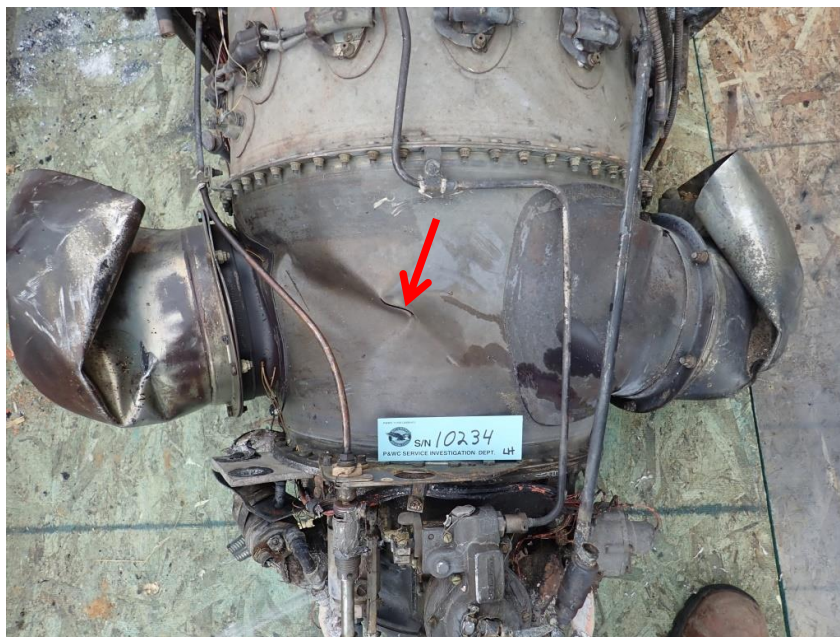
Photo No. 9

**Exhaust Duct:** The duct was partially coated in soot, was impact compressed, and it exhibited a crack at the 12 o'clock position along a creased region (Ref. Photos No. 9, red arrow & 10).

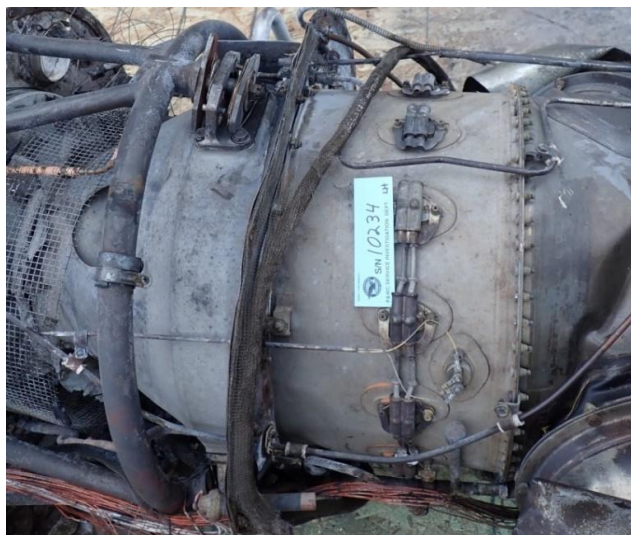
Photo No. 11

**Gas Generator Case:** The case was coated in soot and it exhibited a bent region adjacent to the right hand engine mount (Ref. Photos No. 11 & 12).

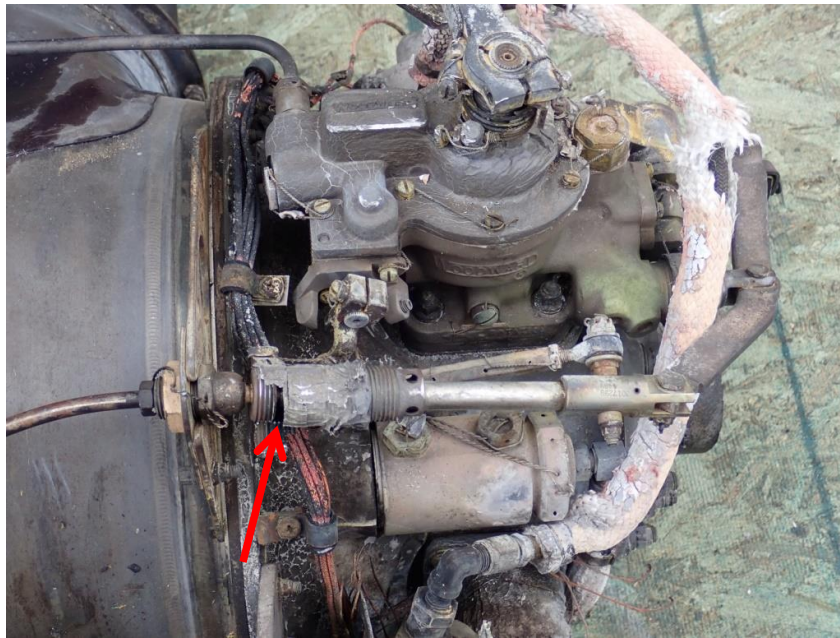
Photo No. 15

- 3.1.2 **Power Control Linkage and Reversing Linkage:** The reversing lever guide pin was bent (Ref. Photo No. 14, red arrow). The end airframe cable was attached to the propeller speed control lever (Ref. Photo No. 14, blue arrow). The low pitch stop adjuster was thermally damaged partially separating the front push-pull swivel joint casing from the low pitch adjusting stop reversing mechanism (Ref. Photo No. 15, red arrow). The wire rope was in place and the remaining linkage was in place and secure. The CAM box was discoloured from corrosion due to heat exposure (Ref. Photo No. 16, red arrow). The airframe power control cable was attached to the CAM lever (Ref. Photo No. 16, blue arrow). The connecting rod between the CAM and the fuel control arm was in place (Ref. Photo No. 17). A comparison between Photo No. 14 that was taken during the engine examination to Photo No. 18 that was taken at the accident site, show the propeller speed control had moved during the engine recovery and/or handling for shipment. A comparison between Photo No. 16 that was taken during the engine examination to Photo No. 19 that was taken at the accident site, show the CAM box components are in slightly different positions.

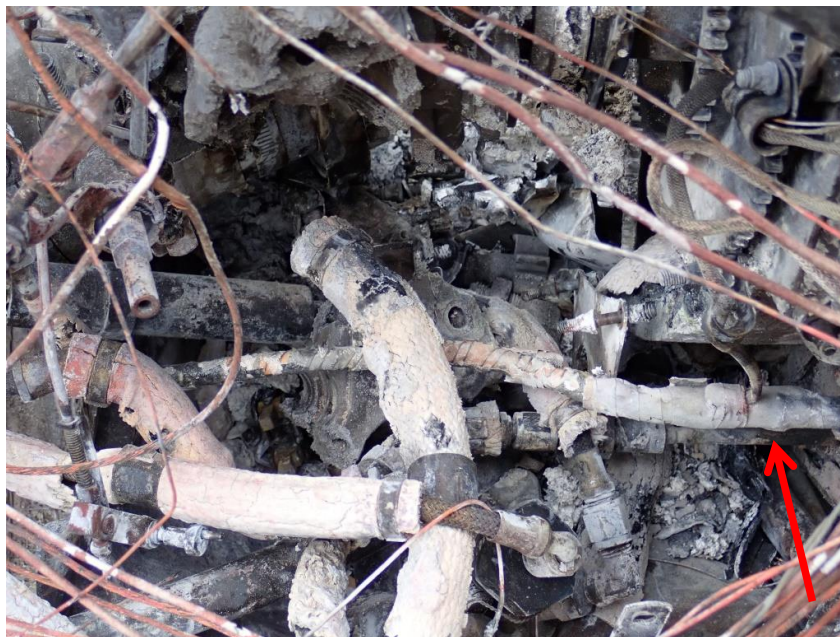
Photo No. 21

**Compressor Discharge Air (P3):** The exterior coating was burned off of the insulated section. The line was in place from the fuel control fitting to the gas generator case port (Ref. Photos No. 20 & 21, red arrows).

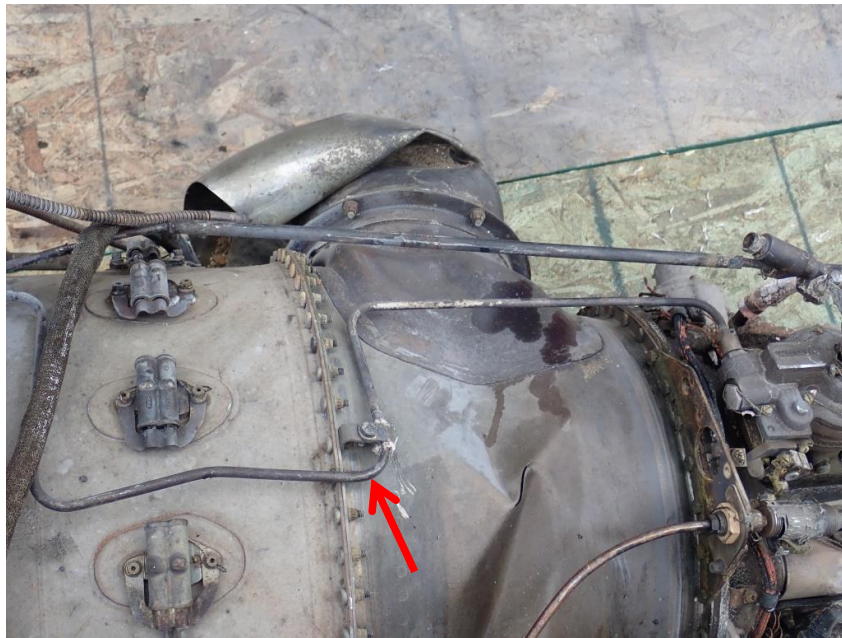
**Power Turbine Control (Py):** The exterior coating was burned off of the insulated section. The line was in place from the fuel control fitting to the propeller governor fitting (Ref. Photo No. 22 & 23, red arrows). The connections at the propeller governor and the center fire seal were tight/torqued.

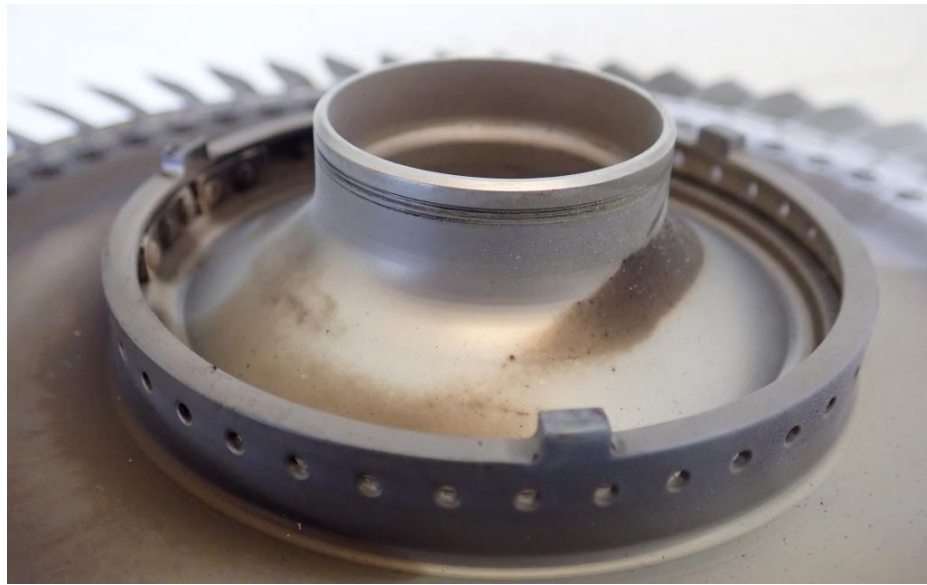
Photo No. 29, view of the downstream side

**Compressor Turbine:** The downstream side of the compressor turbine disc and blades exhibited circumferential scoring from contact with the power turbine vane (Ref. Photo No. 27 & 28). The hub adjacent to the retention bolt bore was rubbed from contact with the lip of the inner baffle (Ref. Photo No. 29). The upstream side of the turbine did not exhibit any visible damage (Ref. Photo No. 30). The blade tips exhibited some polished regions from contact with their respective shroud (Ref. Photo No. 31).

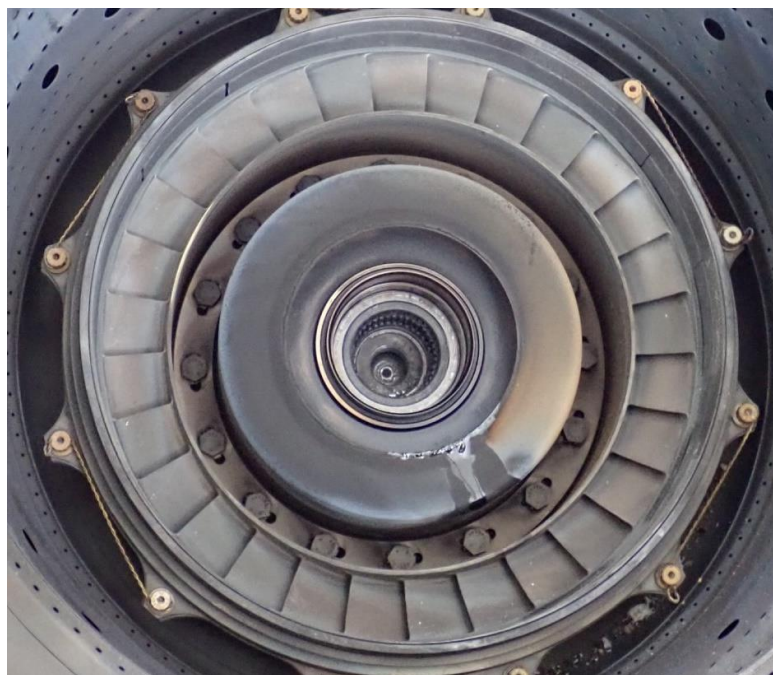
Photo No. 32, view of the downstream side

**Compressor Turbine Vane:** The vane was not removed for the purpose of this investigation. The visible section of the vane did not exhibit any visible damage (Ref. Photo No. 32).

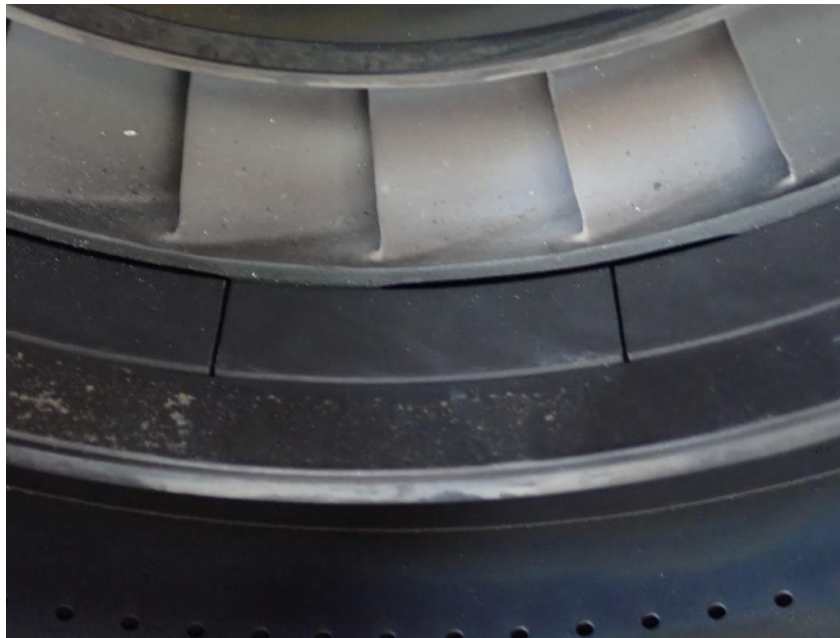
Photo No. 33

**Compressor Turbine Shroud:** The shroud exhibited some rubbing as viewed through the soot buildup coating the surface (Ref. Photo No. 33).

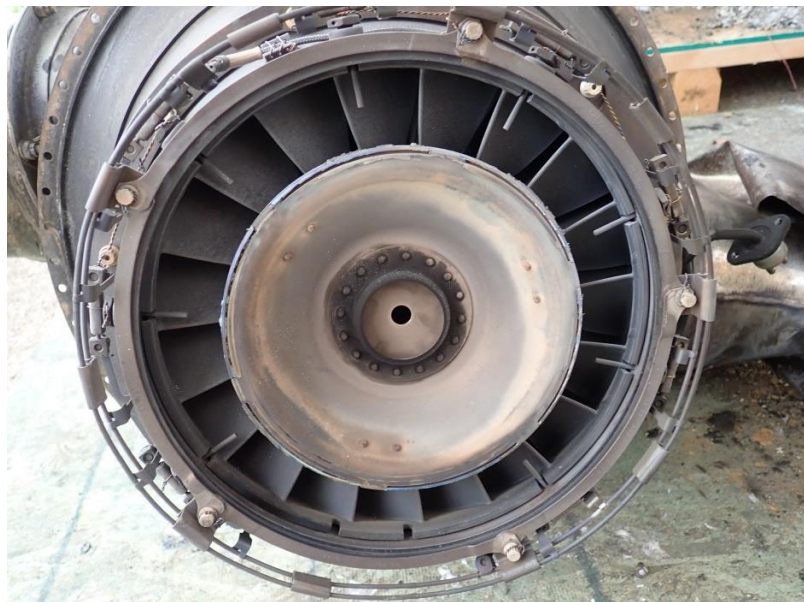
Photo No. 35

**Inter Turbine Temperature Probes, Busbar, and Harness:** The probes, busbar, and harness were in place and no visible damage was evident (Ref. Photo No. 35).

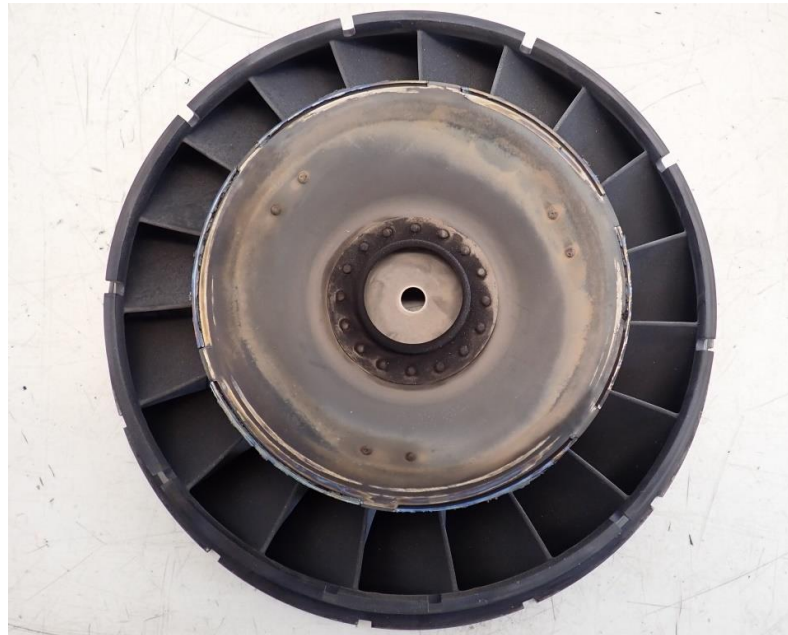
Photo No. 36, view of the upstream side

**Power Turbine Vane and Baffle:** The upstream side of the vane inner rim and baffle exhibited circumferential scoring from contact with the compressor turbine (Ref. Photos No. 36 & 37). The inner baffle on the upstream side exhibited circumferential scoring from contact with the compressor turbine disk (Ref. Photo No. 38). The downstream side of the baffle exhibited light circumferential rubbing from contact with the power turbine (Ref. Photo No. 39 & 40, red arrow). The baffle also exhibited static imprints of the power turbine blade platforms (Ref. Photo No. 41, blue arrow). The 10 to 2 o'clock region of the outer rim exhibited rubbing from contact with the blade tips (Ref. Photo No. 42, blue arrow). The outer rim also exhibited static imprint marks from contact with the power turbine blade tips (Ref. Photo No. 42, yellow arrow). The downstream side of the inner baffle exhibited circumferential scoring on the majority of the diameter and the lip was bent outwards at the 6 o'clock position (Ref. Photo No. 43).

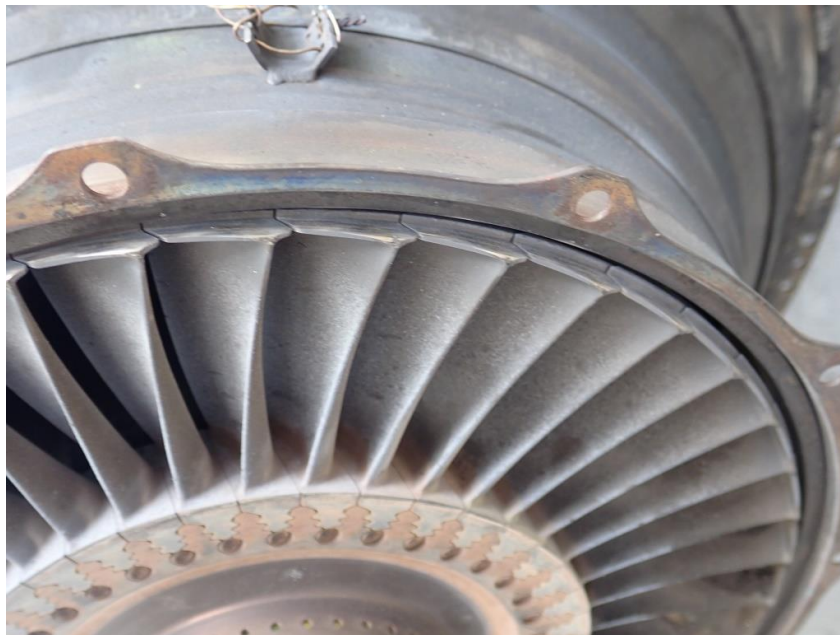
Photo No. 44, view of the upstream side

**Power Turbine:** The majority of the turbine blades exhibited some discolouration and some soot/debris buildup adhered to their surfaces (Ref. Photo No. 44 & 46). The exhaust duct was distorted resulting in a region where the turbine blades were positioned aft of their respective shroud (Ref. Photo No. 45). The upstream side of several of the blade platforms exhibited circumferential rubs from rotational contact with the power turbine vane baffle (Ref. Photos No. 46 & 47, red arrows). The disc hub adjacent to the retention bolt bore exhibited circumferential rubbing from contact with the lip of the inner baffle (Ref. Photo No. 48). The downstream side of the turbine was unremarkable except for discoloration (Ref. Photo No. 49). The blade tips exhibited rubs from contact with their respective shroud and the leading edge tips from contact with the power turbine vane (Ref. Photo No. 50).

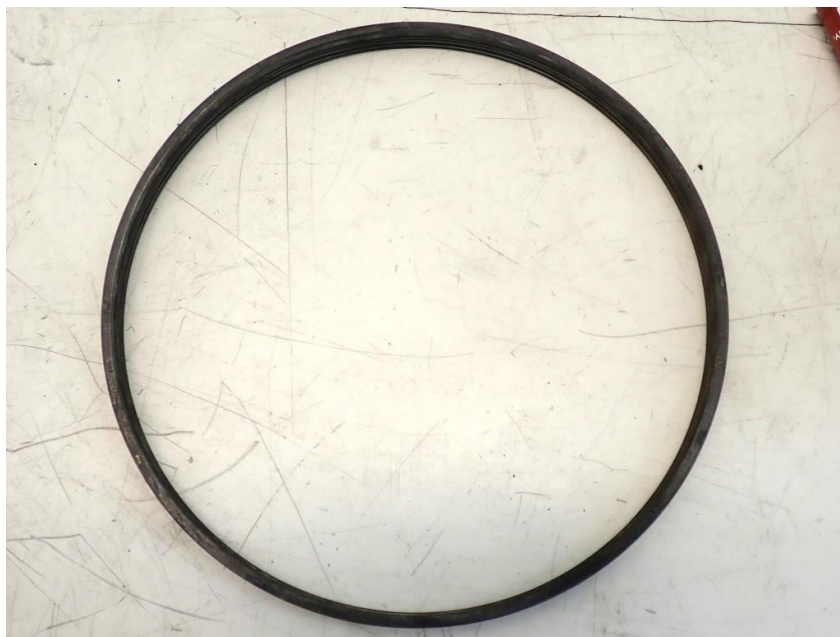
Photo No. 51

**Power Turbine Shroud:** The shroud exhibited rubs on the knife edges with the more pronounced rubbing from 6 to 10 o'clock (Ref. Photos No. 51 & 52).

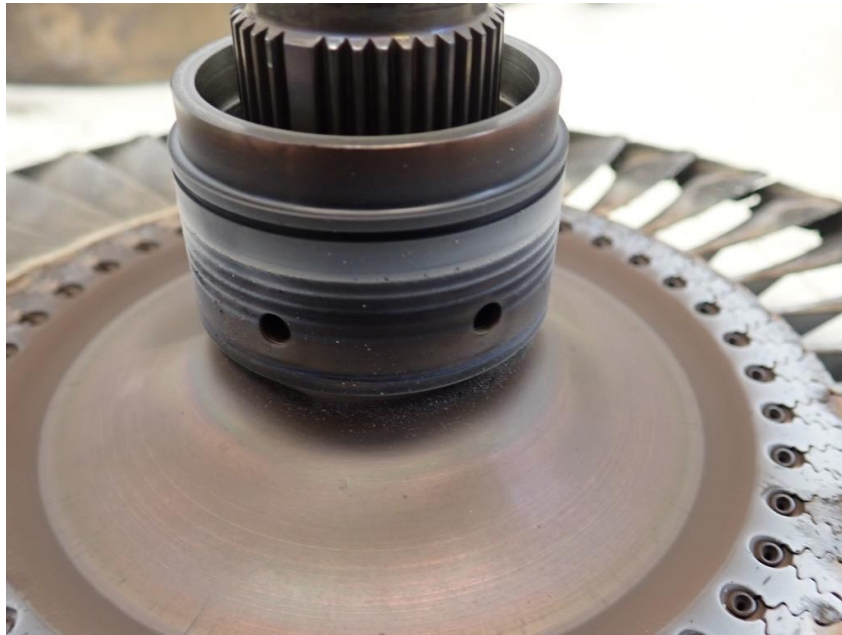
Photo No. 53

**Power Turbine Shaft and Housing:** The shaft and shaft housing were not accessed for the purpose of this investigation. The No. 3 bearing rotor air seal exhibited rubbing from contact with the No. 3 bearing stator air seal (Ref. Photo No. 53).

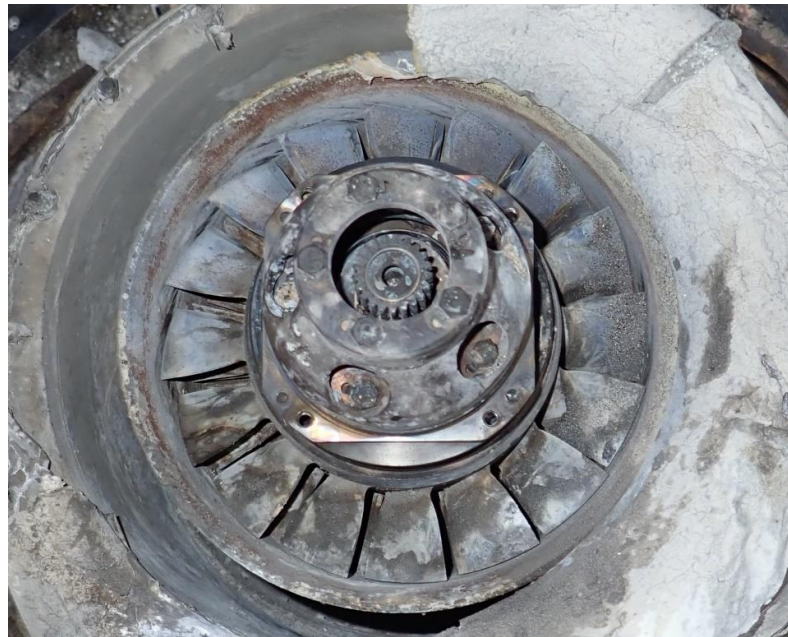
Photo No. 54

The compressor was not removed from the gas generator case or disassembled for the purpose of this investigation (Ref. Photo No. 54). The 1<sup>st</sup> stage rotor blades were discoloured and the blade tips exhibited rolled over material from contact with their respective shroud (Ref. Photos No. 55 & 56, blue arrow). The rubbing is indicative of rotation at impact. The 1<sup>st</sup> stage stator was discoloured but appeared intact (Ref. Photos No. 56, red arrow). The remaining compressor components and the No. 2 bearing were not accessed.

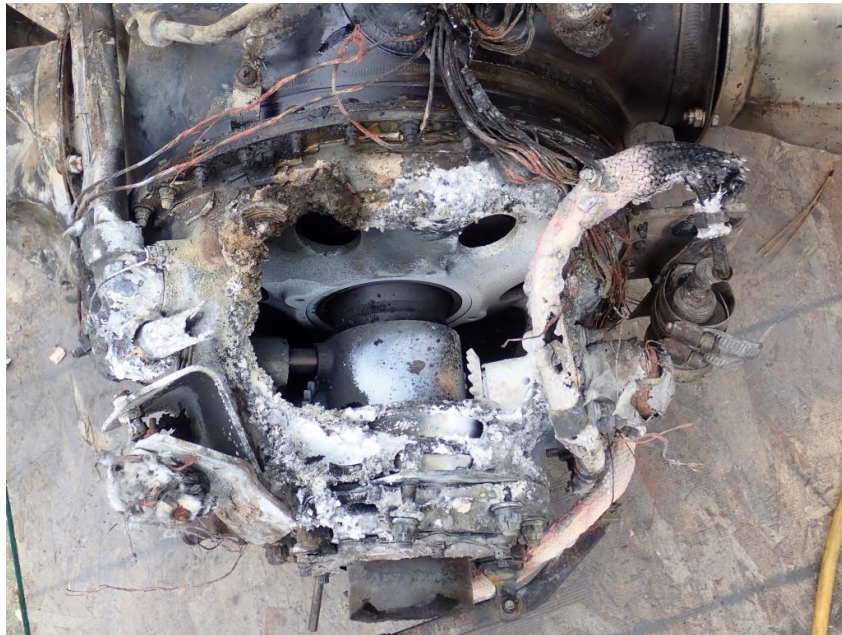
Photo No. 58

Several of the gear train components were visible through the hole burned through the bottom of the front gearbox housing including two of the bevel gears, propeller shaft sleeve, No. 5 bearing, and the portions of the 2<sup>nd</sup> stage carrier (Ref. Photo No. 58). The visible internal components were discoloured from heat exposure but were in place. The propeller shaft fracture surfaces exhibited features consistent with torsional overload (Ref. Photos No. 59 & 60). The gearbox was not disassembled for the purpose of this investigation.

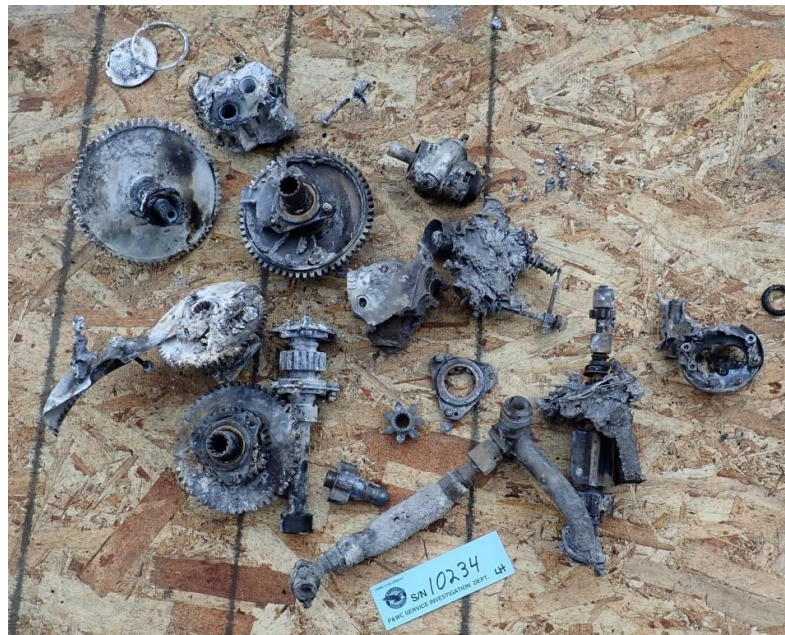
Photo No. 62

The gearbox housings were consumed by the post impact fire, exposing the spur gears, bearings and the oil pump gears (Ref. Photos No. 61 & 62). The inlet case struts were either fractured or burned away (Ref. Photos No. 63). The lower section of the oil tank was consumed in the fire (Ref. Photo No. 64, red arrows).

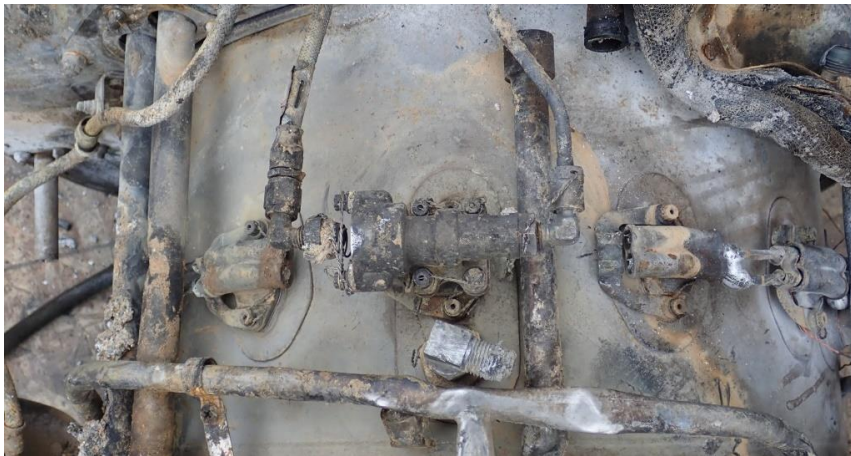
Photo No. 69

**Fuel Nozzles:** All of the nozzles were attached to their respective mounting pads on the gas generator case (Ref. Photo No. 69). The exterior of the nozzles were thermally damaged and the fuel transfer tubes were thermally damaged or consumed by the post impact fire.

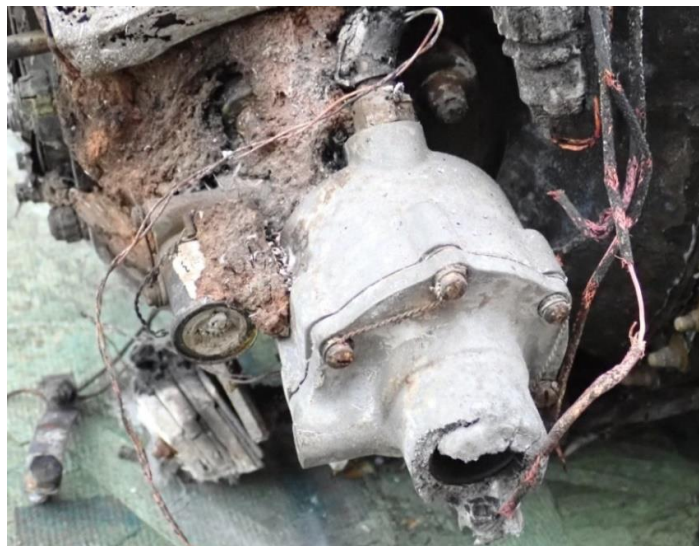
Photo No. 72

**Overspeed Governor (OSG):** The governor was mounted on its respective pad on the reduction gearbox and was thermally damaged (Ref. Photo No. 72).

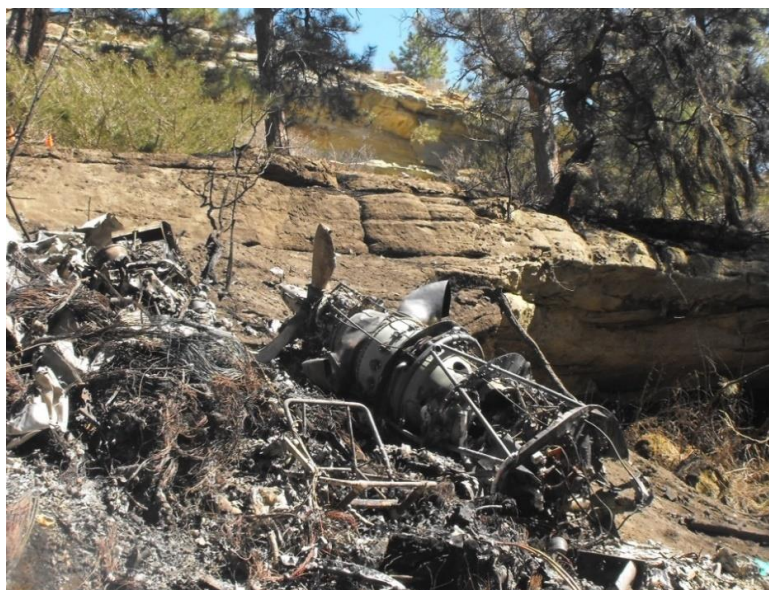
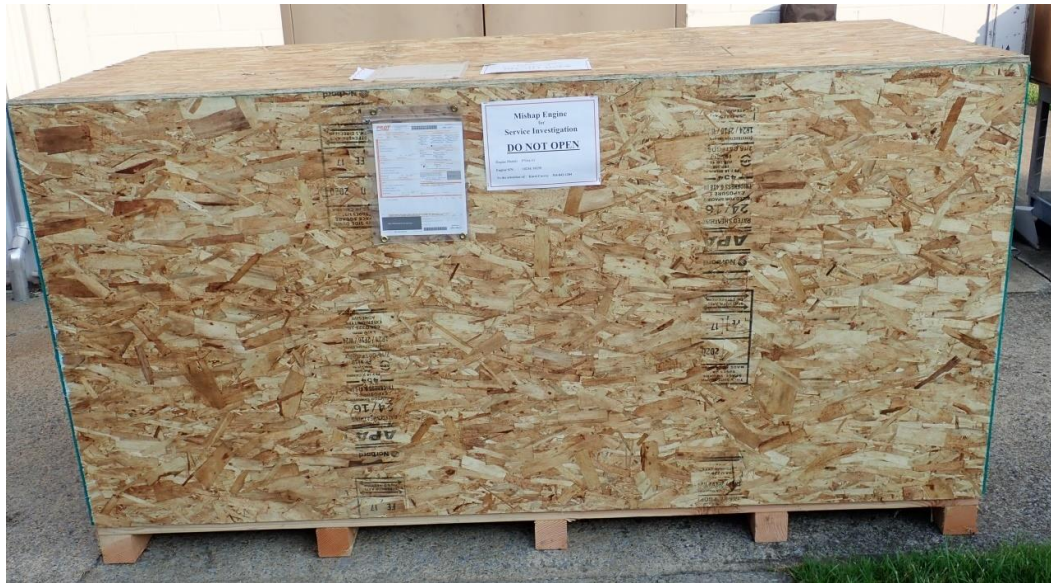
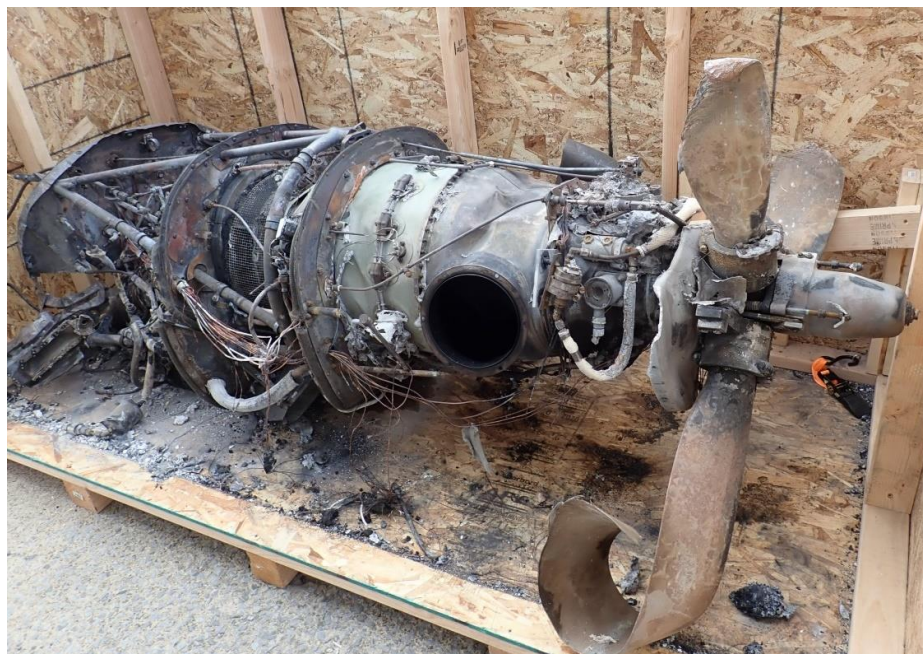
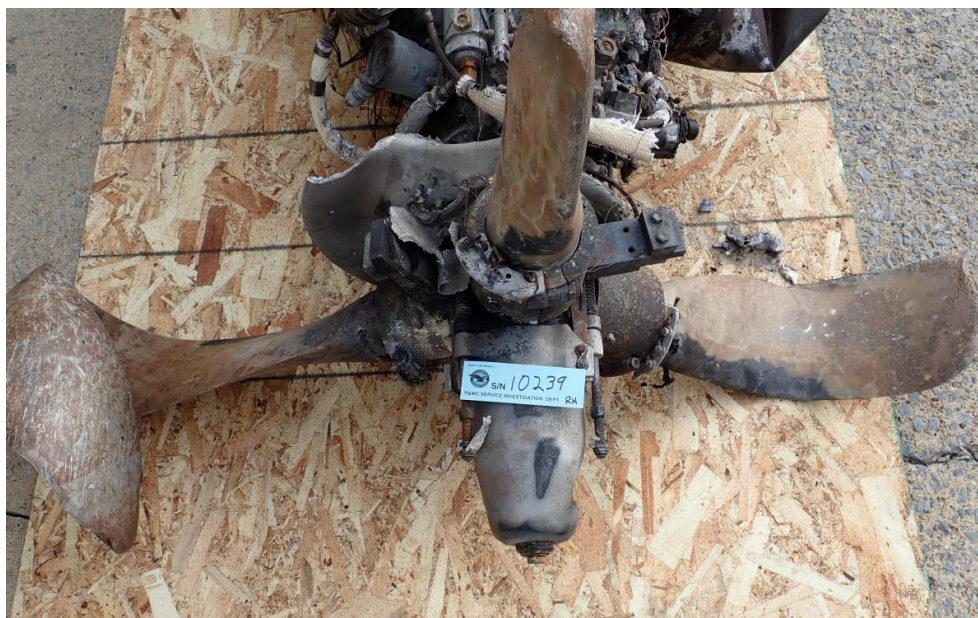
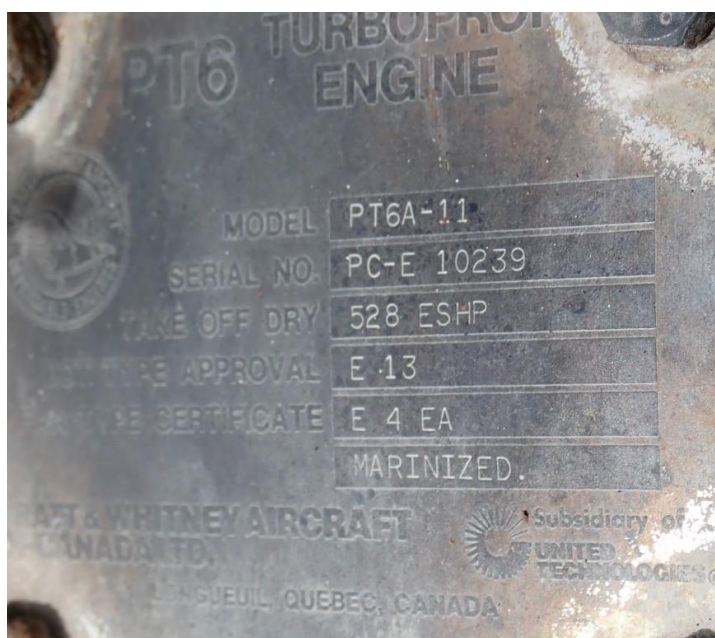
An overview of the accident site shows that the right hand engine was orientated in the same direction as the aircraft (Ref. Photo No. 73, blue oval). The left hand engine was orientated approximately 90 degrees opposite the directional orientation of the aircraft, suggesting it was most likely impact separated (Ref. Photo No. 73, red oval). The right hand engine was positioned in an upright position but it was tilted toward the left hand side at the accident site (Ref. Photo No. 74). The engine and propeller were received in a sealed shipping container (Ref. Photo No. 75). The exterior of the engine exhibited thermal damage from the post impact fire (Ref. Photo No. 76). The propeller blades exhibited thermal and impact damage (Ref. Photo No. 77). The accessory gearbox housings and portions of the inlet case were consumed by the post impact fire. The heater, fuel control housing and portions of the fuel pump were consumed by the post impact fire. The engine data plate showed the engine was a PT6A-11 and the serial number was PC-E 10239 (Ref. Photo No. 78).

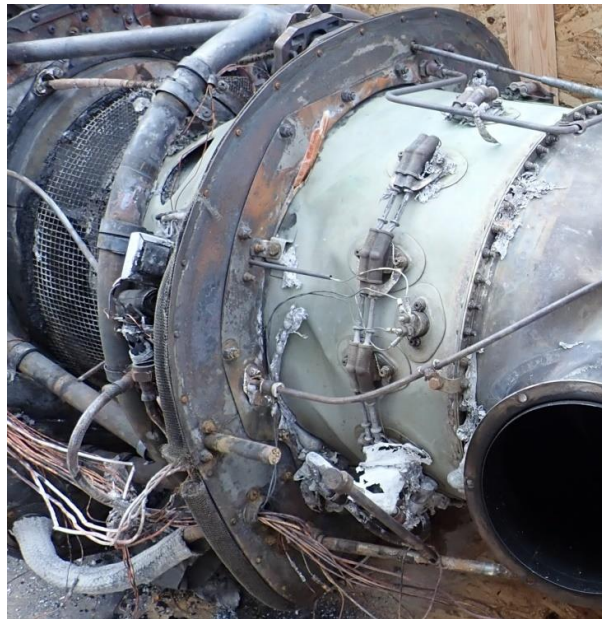
Photo No. 82

**Gas Generator Case (GGC):** The external components and engine mounts were thermally damaged and the case exhibited a bent region adjacent to the right hand engine mount (Ref. Photos No. 82 & 83).

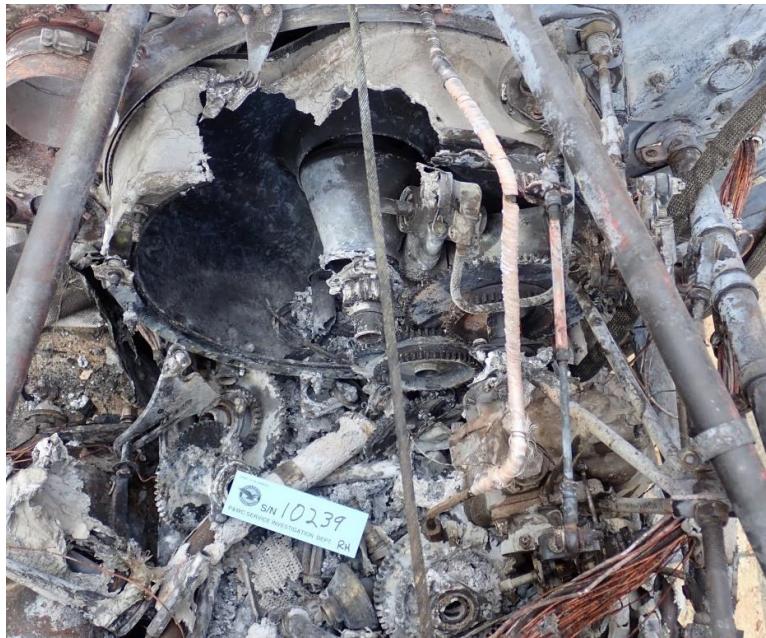
Photo No. 84

**Accessory Gearbox (AGB) and Inlet Case:** The gearbox housings were consumed by the fire, exposing the internal spur gears and scavenge pump gears (Ref. Photo No. 84). Portions of the inlet case were consumed by the fire and the inlet struts were all fractured or consumed by the fire.

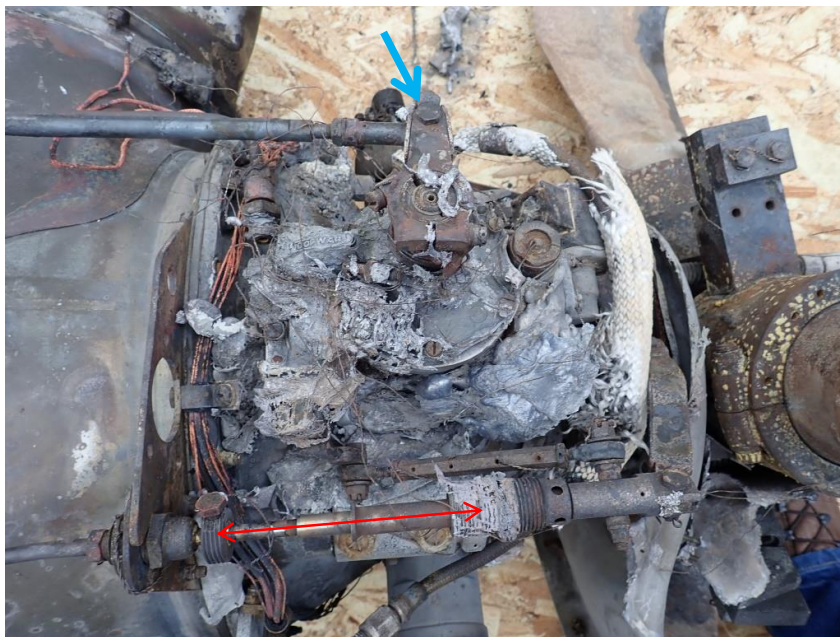
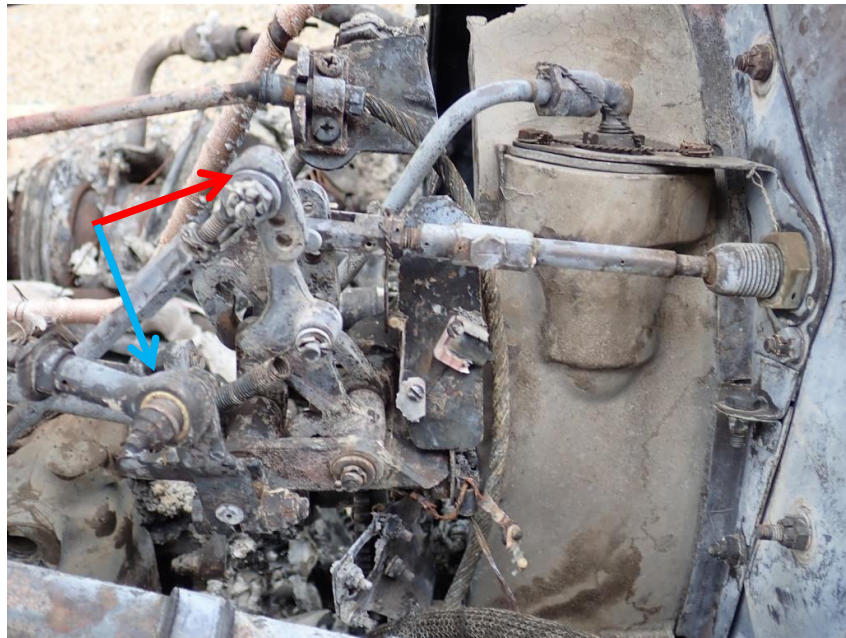
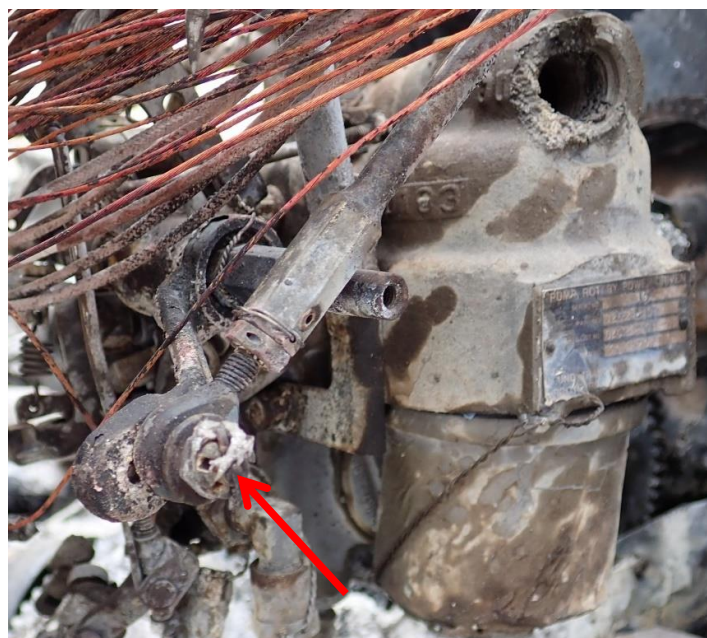
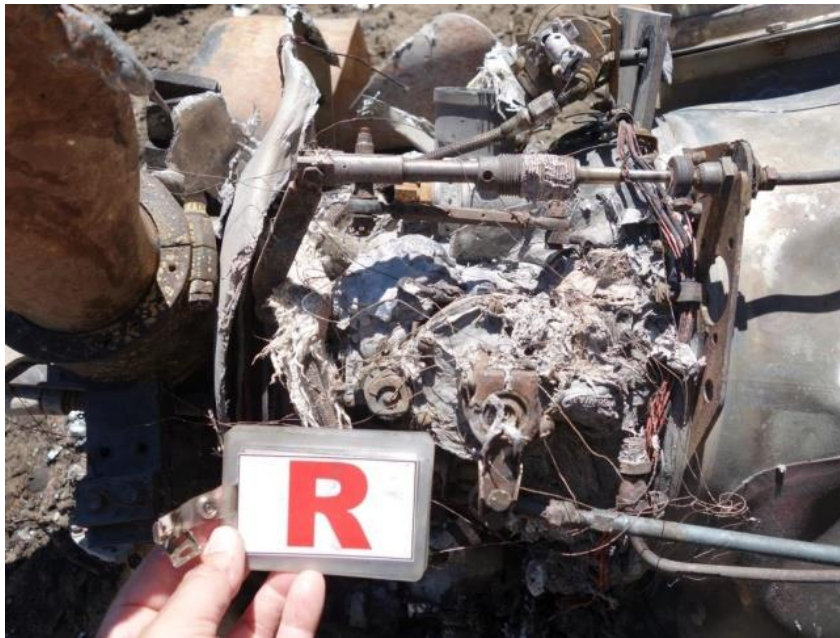
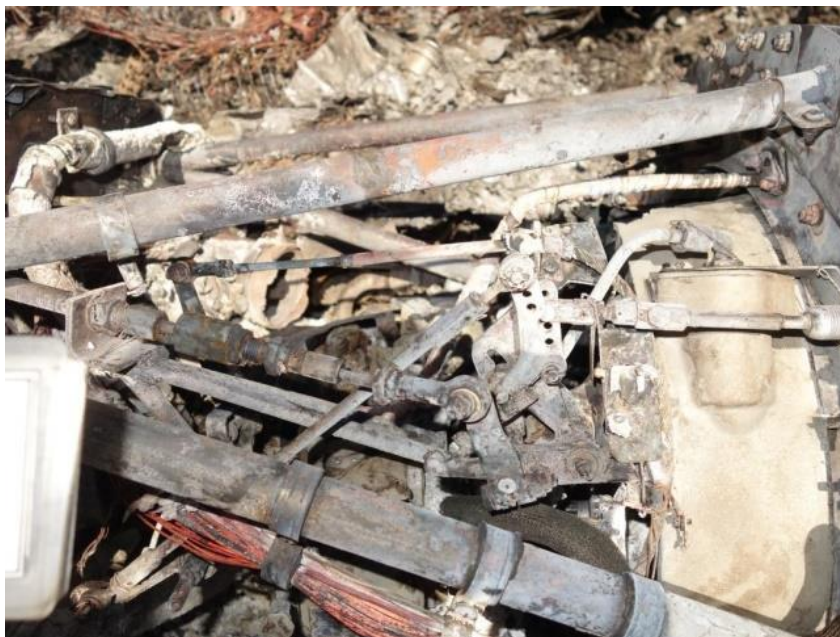
The end of the reversing lever was in position under the guide pin (Ref. Photo No. 85, red arrow). The end airframe cable was attached to the propeller speed control lever (Ref. Photo No. 86, blue arrow). The low pitch stop adjuster was consumed separating the front push-pull swivel joint casing from the low pitch adjusting stop reversing mechanism (Ref. Photo No. 86, red arrow). The wire rope was in place and the remaining linkage was in place and secure. The CAM box was discoloured from corrosion due to heat exposure (Ref. Photo No. 87, red arrow). The airframe power control cable was attached to the CAM lever (Ref. Photo No. 87, blue arrow). The connecting rod between the CAM and the fuel control arm was in place (Ref. Photo No. 88, red arrow). A comparison between Photo No. 86 that was taken during the engine examination to Photo No. 89 that was taken at the accident site show the propeller speed control appears to be in the same position. A comparison between Photo No. 87 that was taken during the engine examination to Photo No. 90 that was taken at the accident site, show the CAM box components appear to be in the same position.

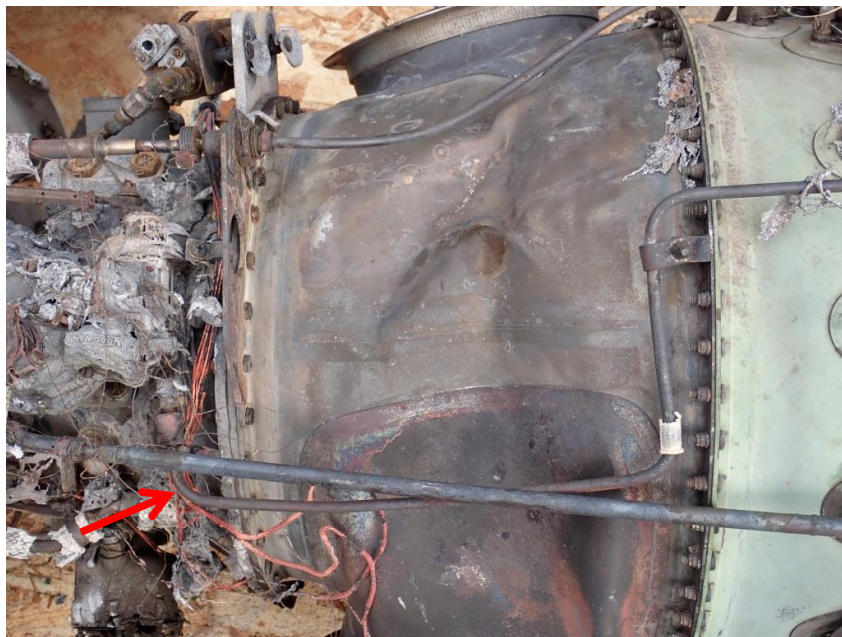
**Power Turbine Control (Py):** The exterior coating was burned off of the insulated section. The line was in place from the fuel control fitting to the propeller governor fitting (Ref. Photo No. 93 & 94, red arrows). The connections at the center fire seal were tight/torqued.

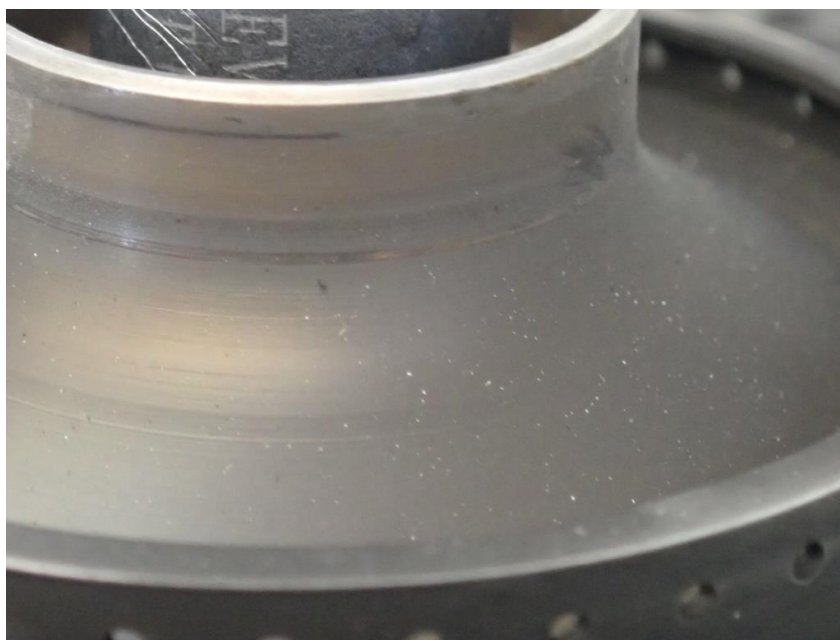
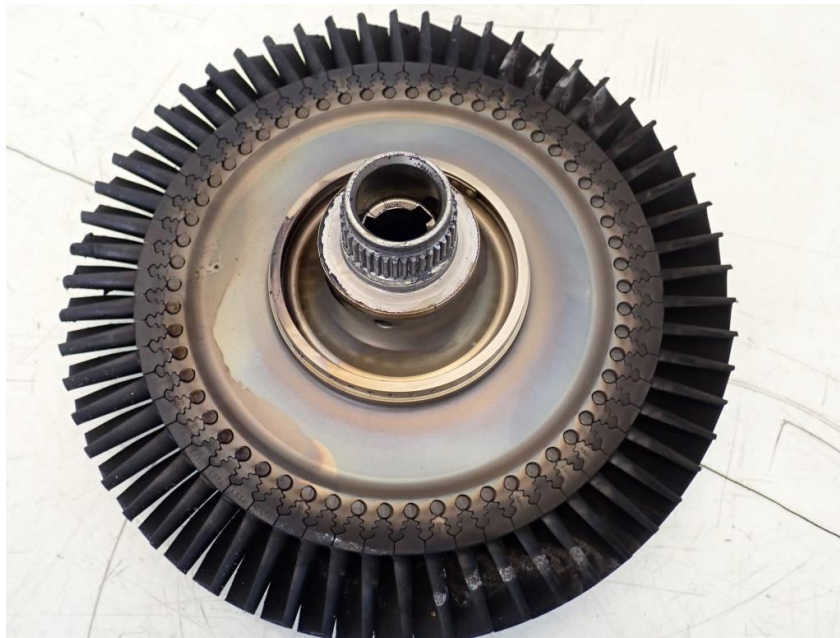
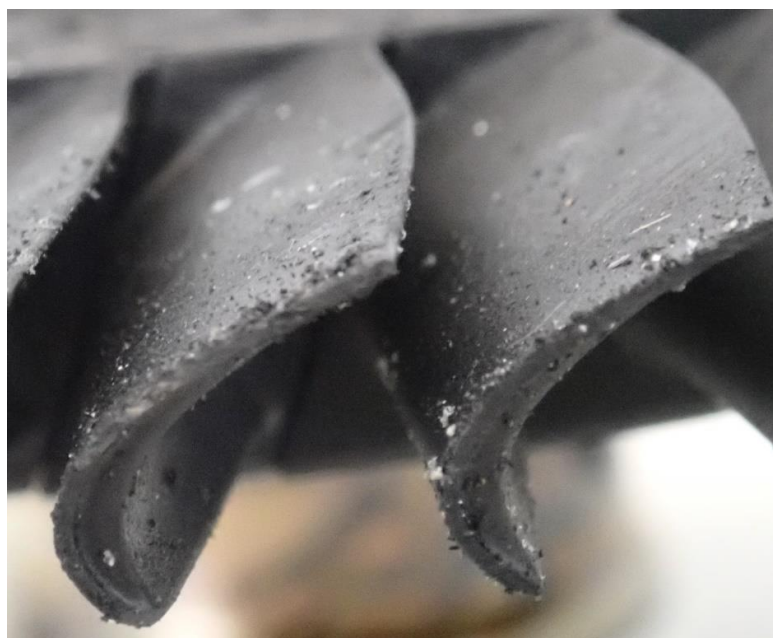
**Compressor Turbine:** The downstream side of the compressor turbine disc and blades exhibited circumferential scoring from contact with the power turbine vane (Ref. Photo No. 99 & 100). The hub adjacent to the retention bolt bore exhibited some localized score marks from contact with the lip of the inner baffle (Ref. Photo No. 101). The upstream side of the turbine did not exhibit any visible damage (Ref. Photo No. 102). The blade tips exhibited some polished regions from contact with their respective shroud (Ref. Photo No. 103).

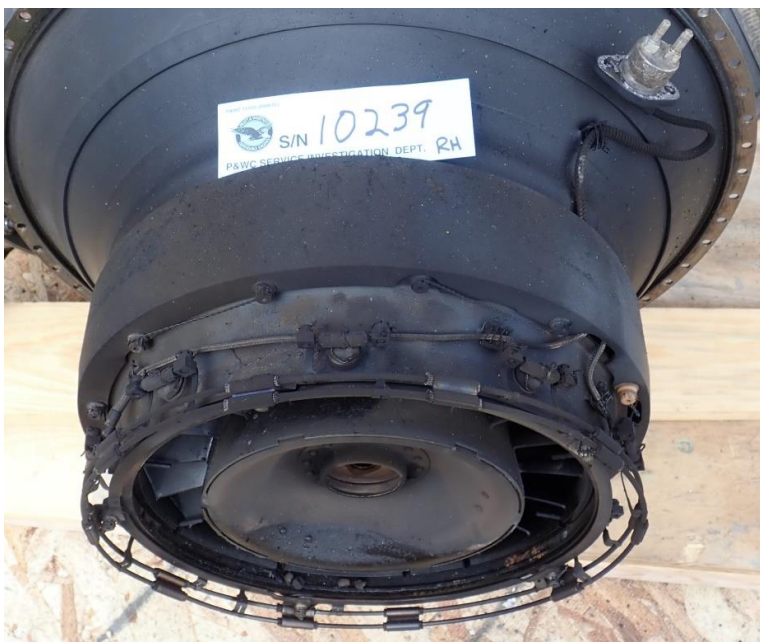
Photo No. 107

**Inter Turbine Temperature Probes, Busbar, and Harness:** The probes, busbar, and harness were in place and no visible damage was evident (Ref. Photos No. 107 & 108).
