**Report No.: 20-042**

**FMR Aviation LLC  
Piper PA-31T1, Aircraft Registration No. N926K  
Billings, Montana  
April 20, 2020  
PT6A-11  
Left Engine Serial No. 10234  
Right Engine Serial No. 10239**

**NTSB Identification: WPR20LA128**  
**TSB Identification: A20F0083**  
**P&WC File No.: 20-042**  
**RFA No.: 20SIE00091**

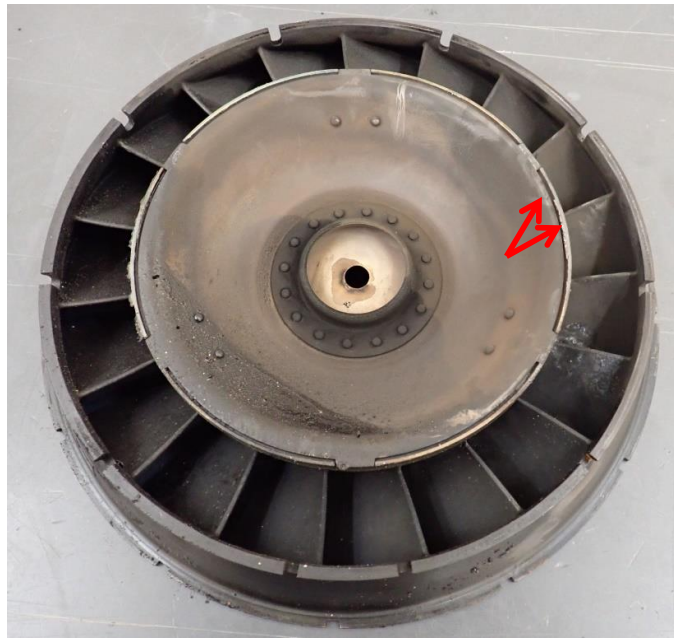
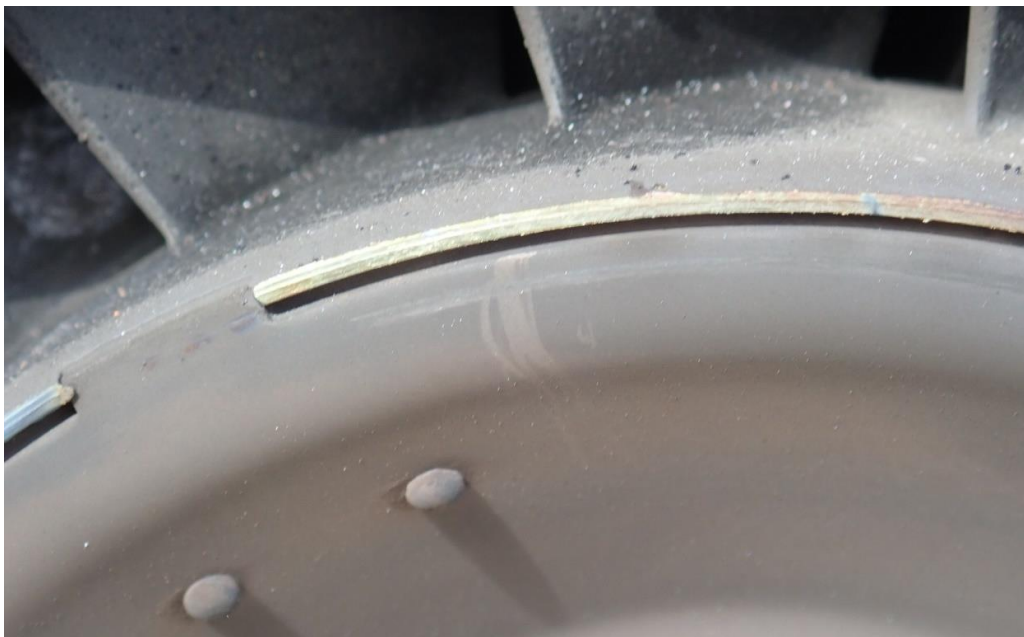
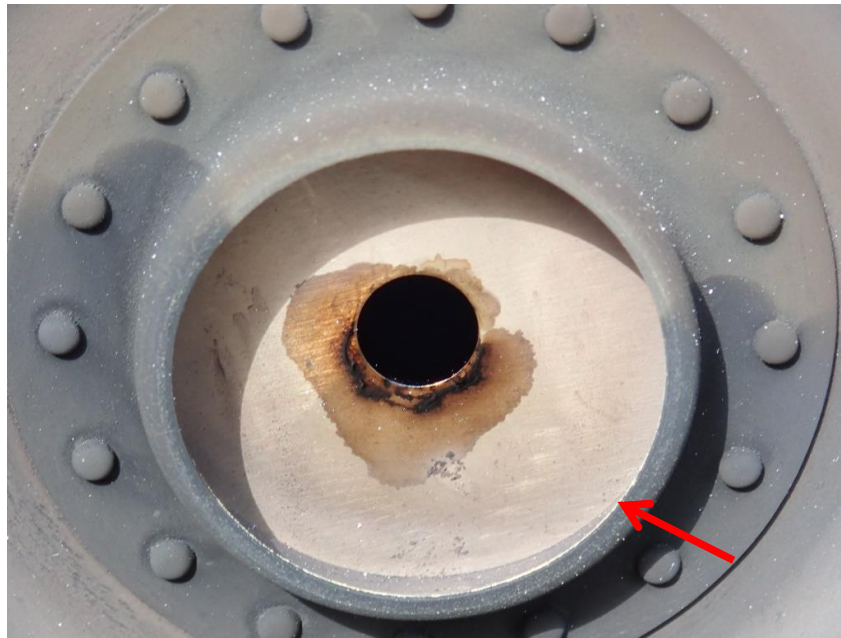
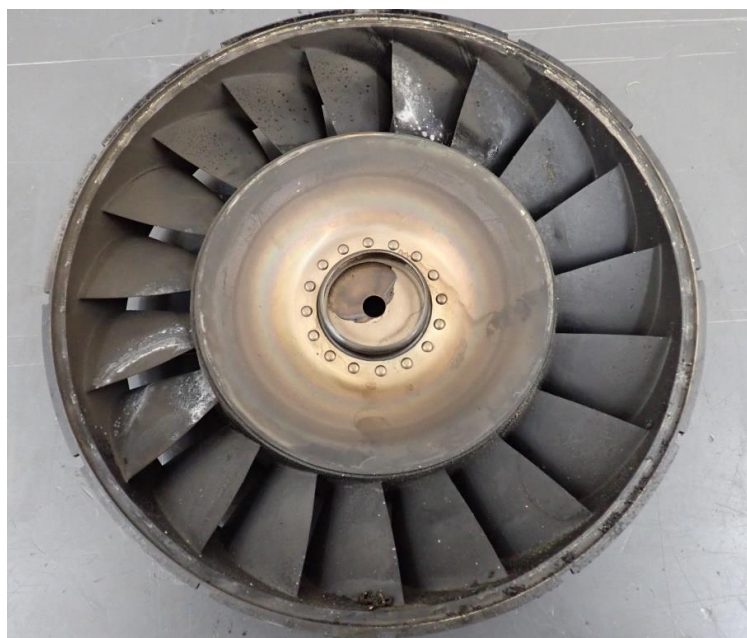
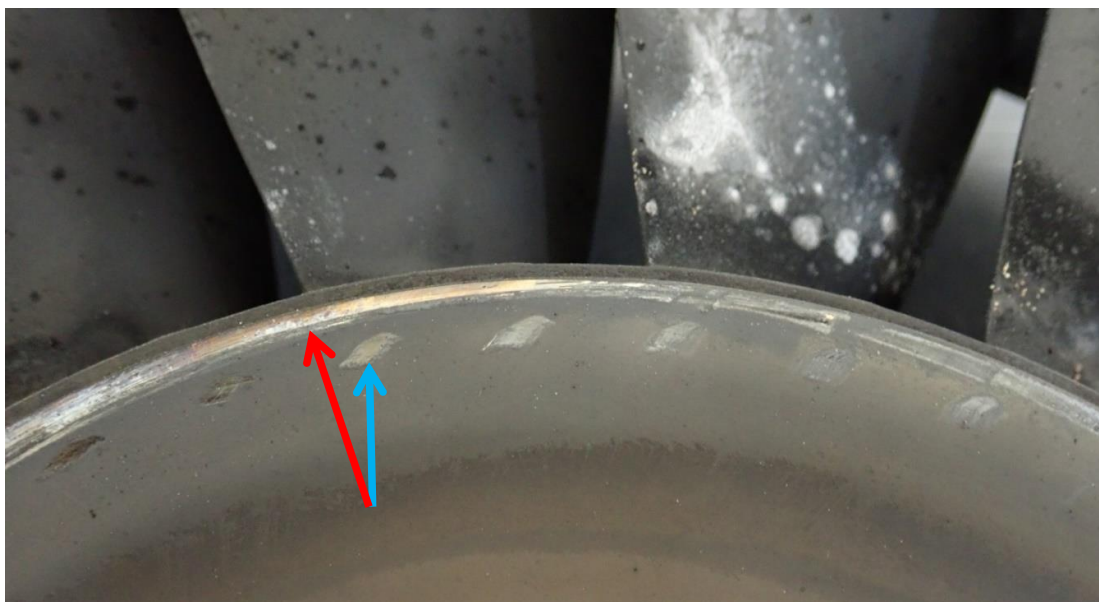
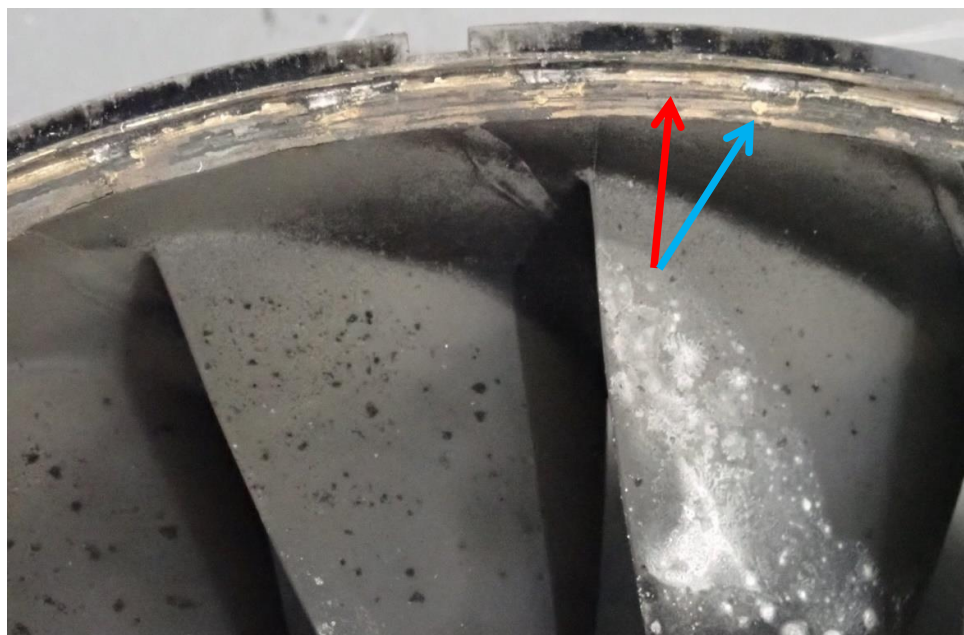
**Power Turbine Vane and Baffle:** The upstream side of the vane inner rim and baffle exhibited circumferential scoring from contact with the compressor turbine (Ref. Photos No. 109, red arrows & 110). The inner baffle on the upstream side exhibited circumferential scoring from contact with the compressor turbine disk (Ref. Photo No. 111, red arrow). The downstream side of the baffle exhibited light circumferential rubbing from contact with the power turbine (Ref. Photo No. 112 & 113, red arrow). The baffle also exhibited static imprints of the power turbine blade platforms (Ref. Photo No. 113, blue arrow). The upper portion of the outer rim exhibited localized rubbing from contact with the blade tips (Ref. Photo No. 114, red arrow). The outer rim also exhibited static imprint marks from contact with the power turbine blade tips (Ref. Photo No. 114, blue arrow). The downstream side of the inner baffle exhibited circumferential scoring on the lip (Ref. Photo No. 115).

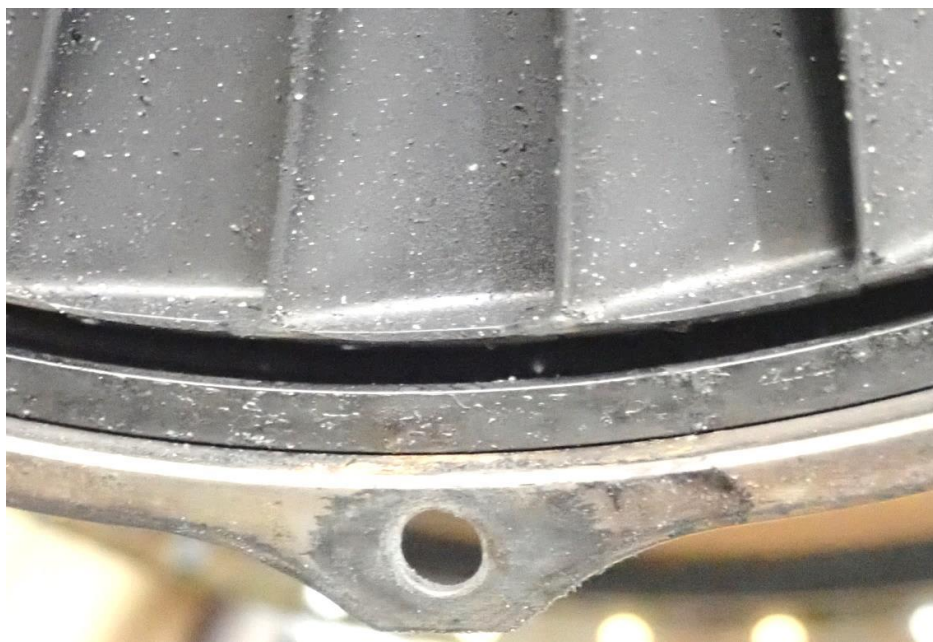
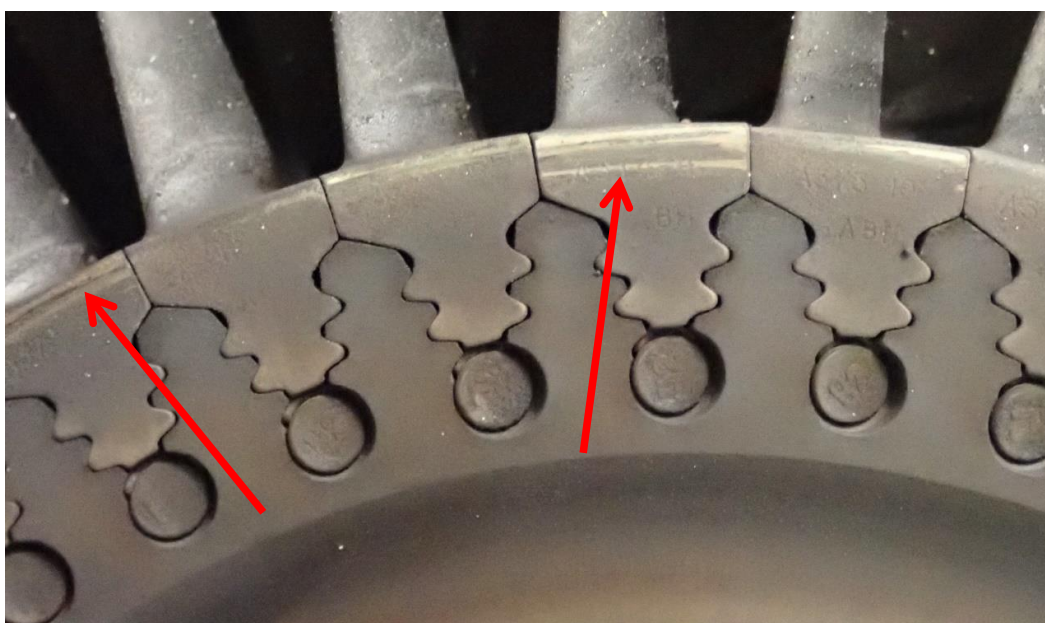
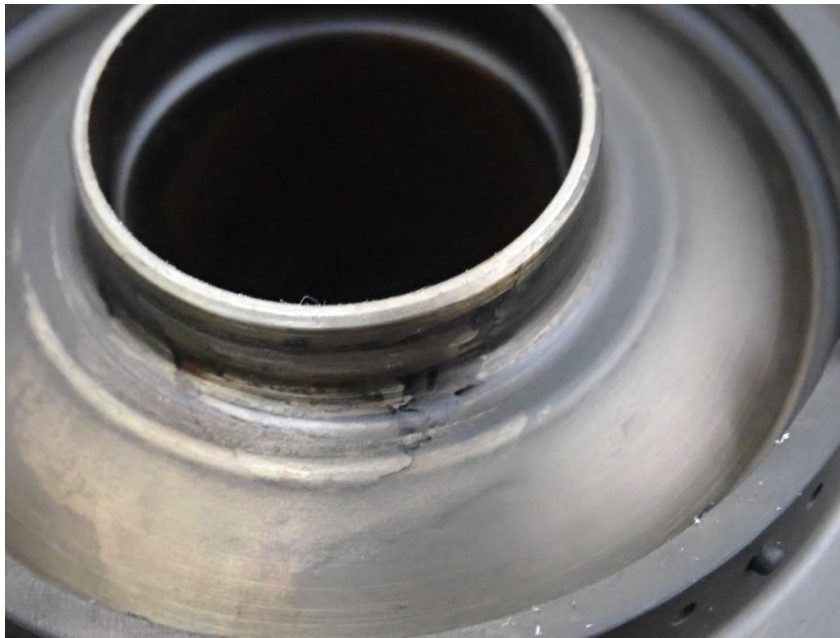
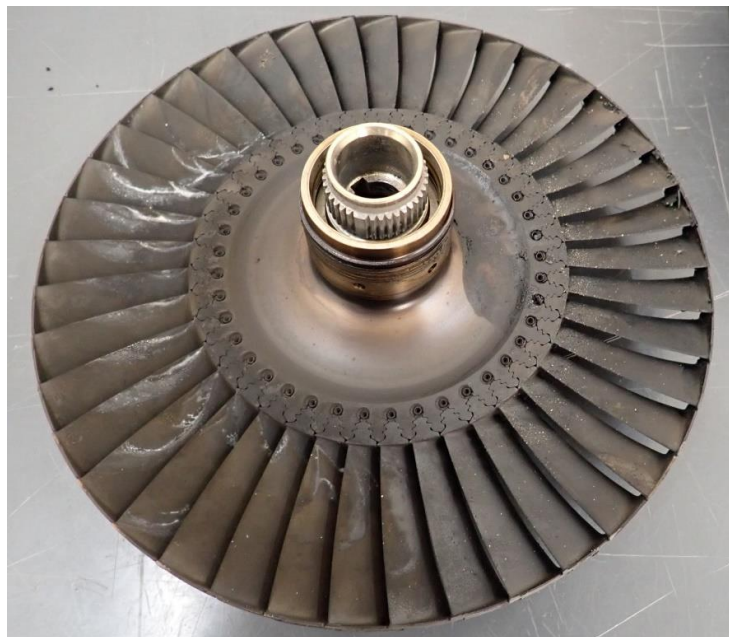
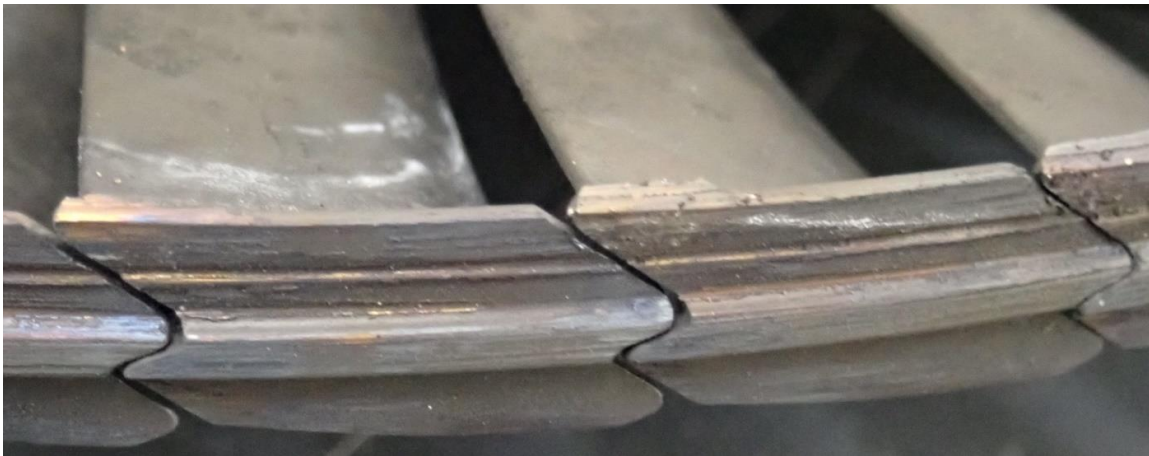
**Power Turbine:** The majority of the turbine blades exhibited some discolouration with soot/debris buildup adhered to their surfaces (Ref. Photo No. 116). The exhaust duct was distorted resulting in the turbine being loaded against the shroud at the 11 o'clock position (Ref. Photo No. 116). Photo No. 117 shows the gap between the blade tips and the shroud due to the exhaust duct distortion. The upstream side of several of the blade platforms exhibited circumferential rubs from rotational contact with the power turbine vane baffle (Ref. Photo No. 118, red arrows). The disc hub, adjacent to the retention bolt bore exhibited circumferential rubbing from contact with the lip of the inner baffle (Ref. Photo No. 119). The downstream side of the turbine was unremarkable except for discoloration (Ref. Photo No. 120). The blade tips exhibited rubs from contact with their respective shroud and the leading edge tips from contact with the power turbine vane (Ref. Photo No. 121).

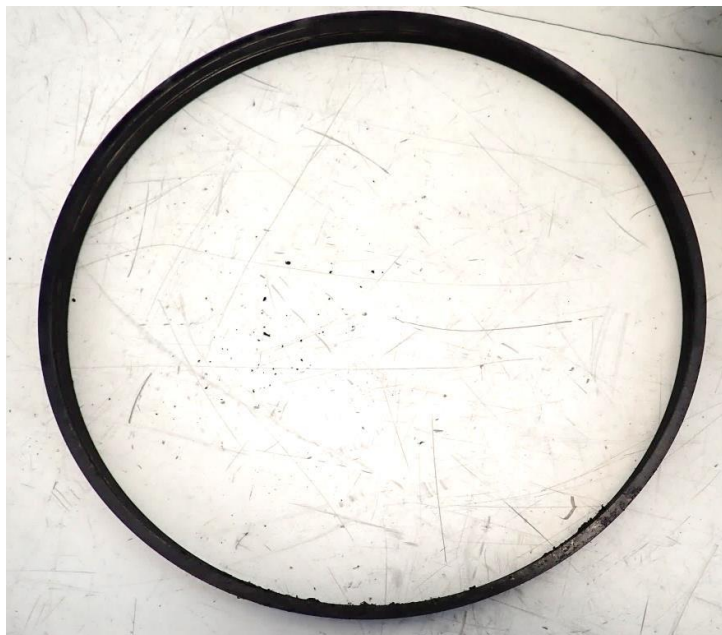
Photo No. 122

**Power Turbine Shroud:** The shroud exhibited rubs on the knife edges with the more pronounced rubbing from 6 to 10 o'clock (Ref. Photos No. 122 & 123).

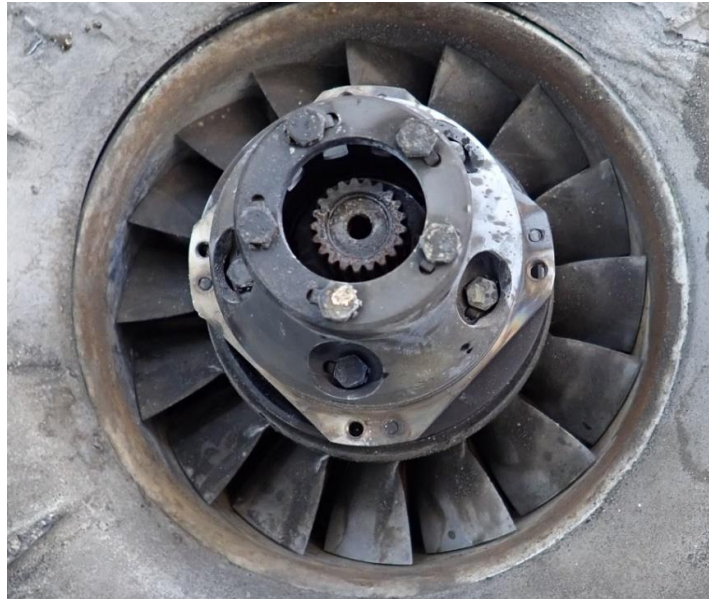
Photo No. 125

The compressor was not removed from the gas generator case or disassembled for the purpose of this investigation (Ref Photo No. 125). The 1<sup>st</sup> stage rotor blades were discoloured and the blade tips exhibited rolled over material from contact with their respective shroud (Ref. Photo No. 126 blue arrow). The rubbing is indicative of rotation at impact. The 1<sup>st</sup> stage stator was discoloured but appeared intact (Ref. Photos No. 127, red arrow). The remaining compressor components and the No. 2 bearing were not accessed.

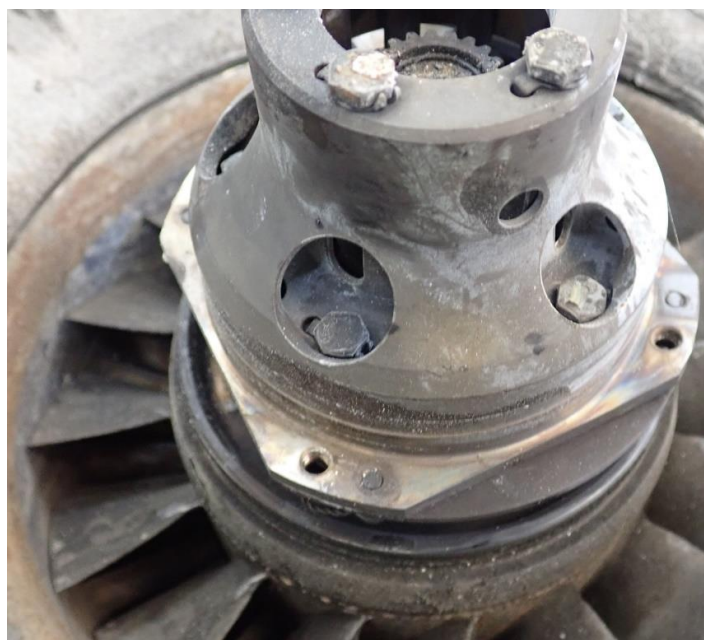
Photo No. 128

The No. 1 bearing was dry but rotated freely (Ref. Photo No. 128). The bearing was not removed for the purpose of this investigation.

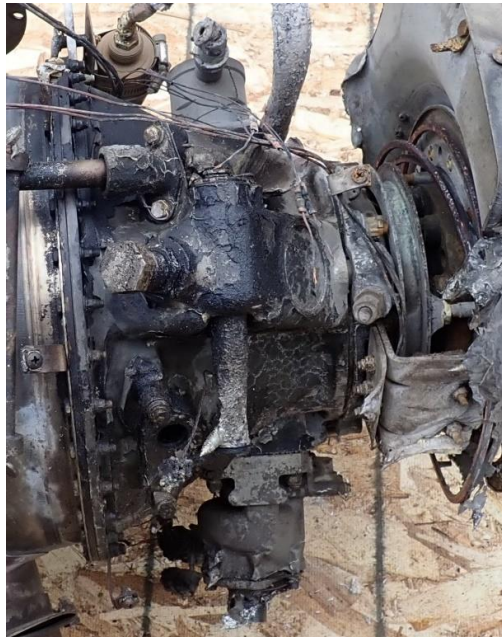
Photo No. 129

The exterior of the front gearbox housing was thermally distressed from exposure to the post impact fire (Ref. Photo No. 129). The gearbox was not disassembled for the purpose of this investigation.

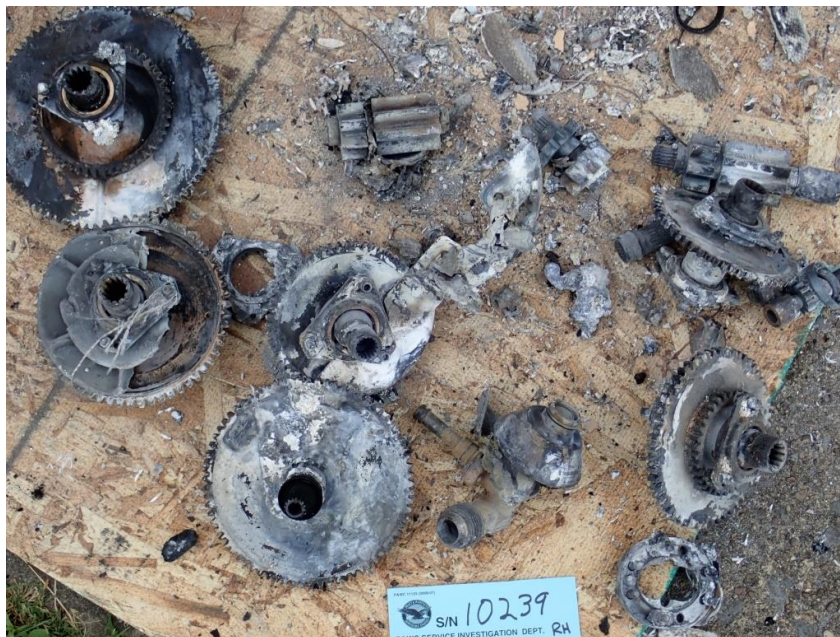
Photo No. 131

The gearbox housings were consumed by the post impact fire, exposing the spur gears, bearings and the scavenge oil pump gears (Ref. Photos No. 130 & 131). The inlet case struts were either fractured or burned away (Ref. Photos No. 132). The upper section and a portion of the lower wall of the oil tank were consumed in the fire (Ref. Photo No. 133, red arrows).

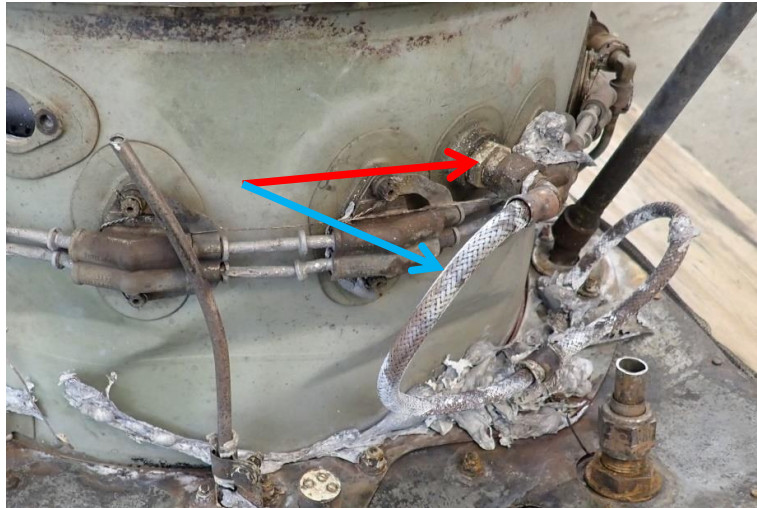
Photo No. 135

**Ignition Plugs:** Both plugs were in place but were not removed for the purpose of this investigation (Ref. Photos No. 134 & 135, red arrows).

**Ignition Leads:** The left hand lead was fractured and both leads were thermally and impact damaged (Ref. Photo No. 134 & 135, blue arrows).

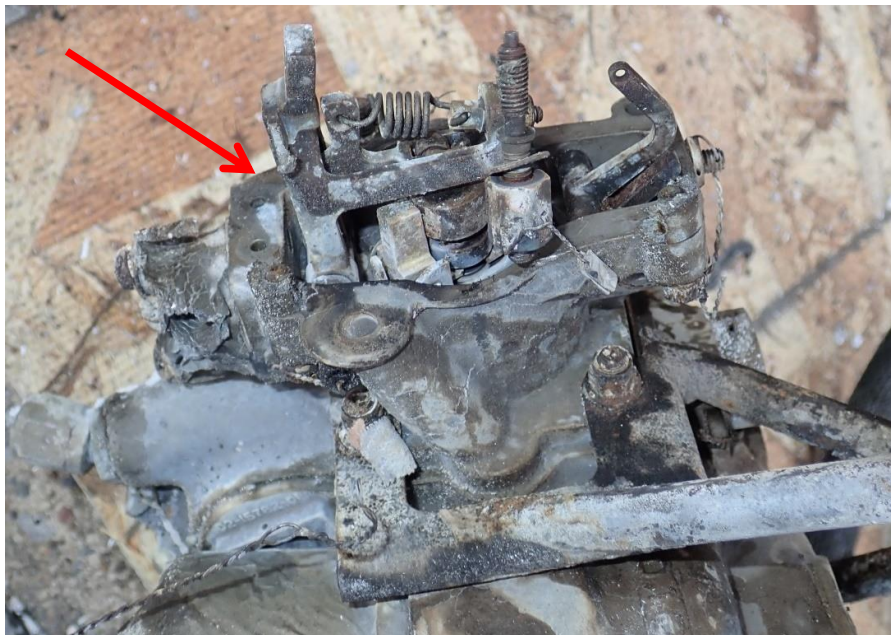
Photo No. 137

**Fuel Control Unit (FCU):** Most of the control unit housings were consumed in the post impact fire. Portions of front housing and some of the internal components were attached to the fuel pump (Ref. Photo No. 137, red arrow).

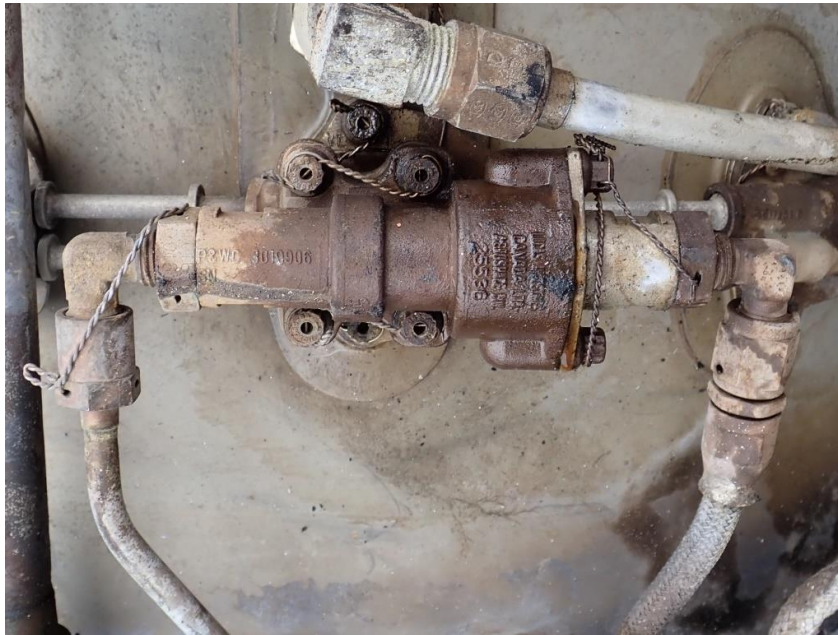
Photo No. 138

**Flow Divider Valve (FDV):** The valve was mounted to the inlet fuel nozzle but was discoloured (Ref. Photo No. 138).

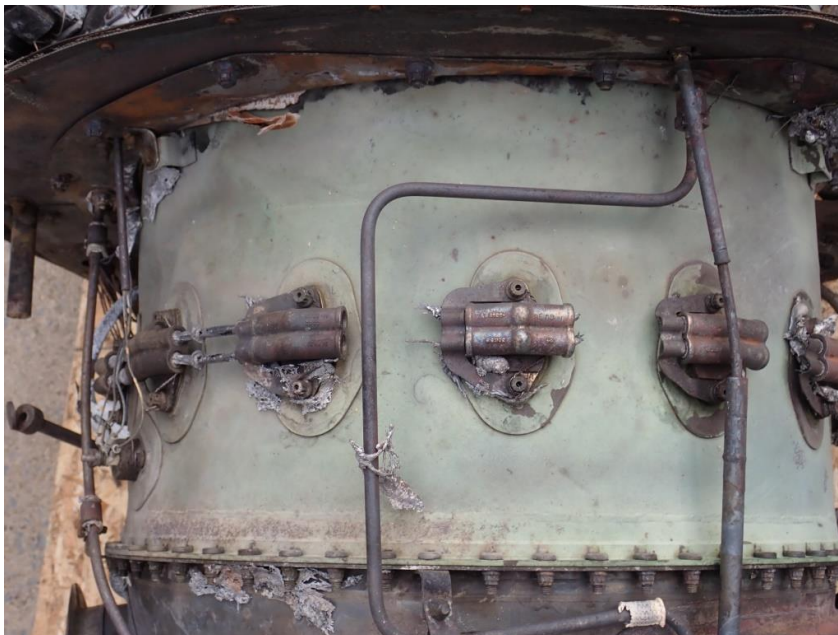
Photo No. 139

**Fuel Nozzles:** All of the nozzles were attached to their respective mounting pads on the gas generator case (Ref. Photo No. 139). The exterior of the nozzles were thermally damaged and the fuel transfer tubes were thermally damaged or consumed by the post impact fire.

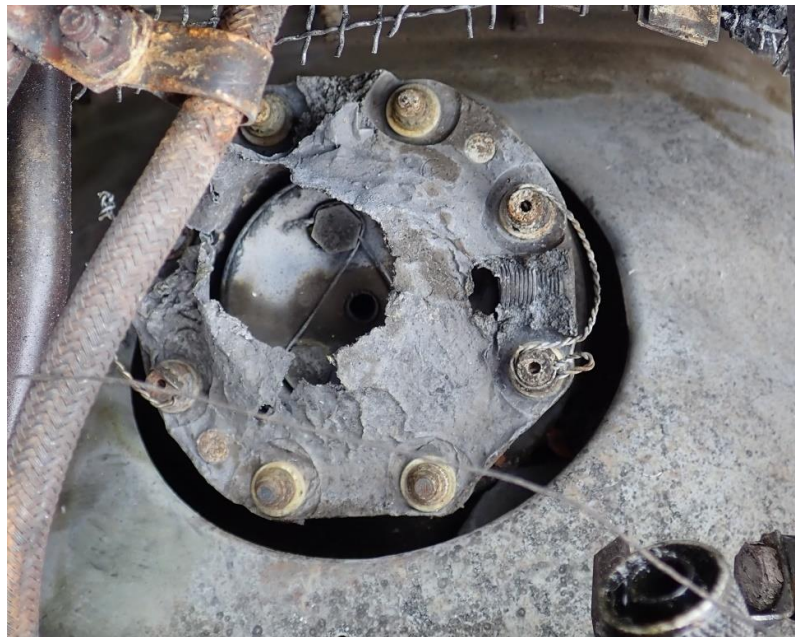
Photo No. 140

**Compressor Bleed Valve (BOV):** Portions of the valve housing was consumed in the post impact fire (Ref. Photo No. 140).

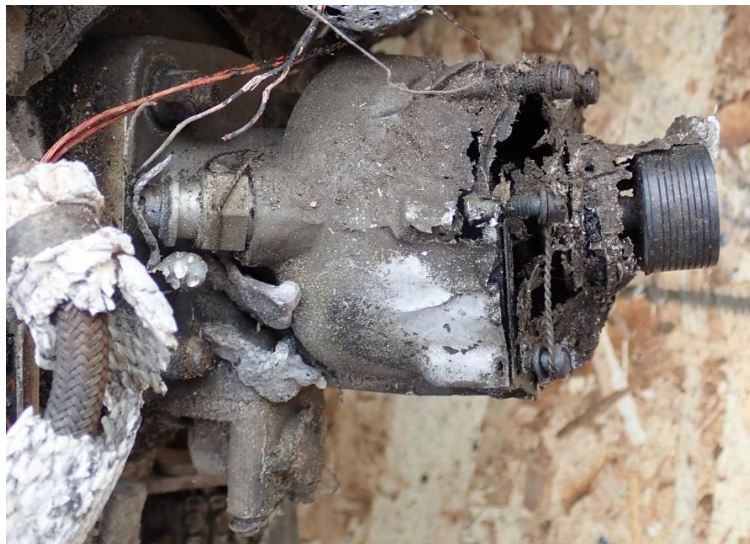
Photo No. 142

**Overspeed Governor (OSG):** The governor was mounted on its respective pad on the reduction gearbox and was thermally damaged (Ref. Photo No. 142).
