## **NATIONAL TRANSPORTATION SAFETY BOARD**

# **AIRFRAME AND ENGINE EXAMINATION**

**WPR20LA152**

Location: Santa Maria, CA  
Date: May 20, 2020  
Aircraft: Cirrus SR20, Registration N883PJ, Serial #1217  
NTSB IIC: Samantha Link

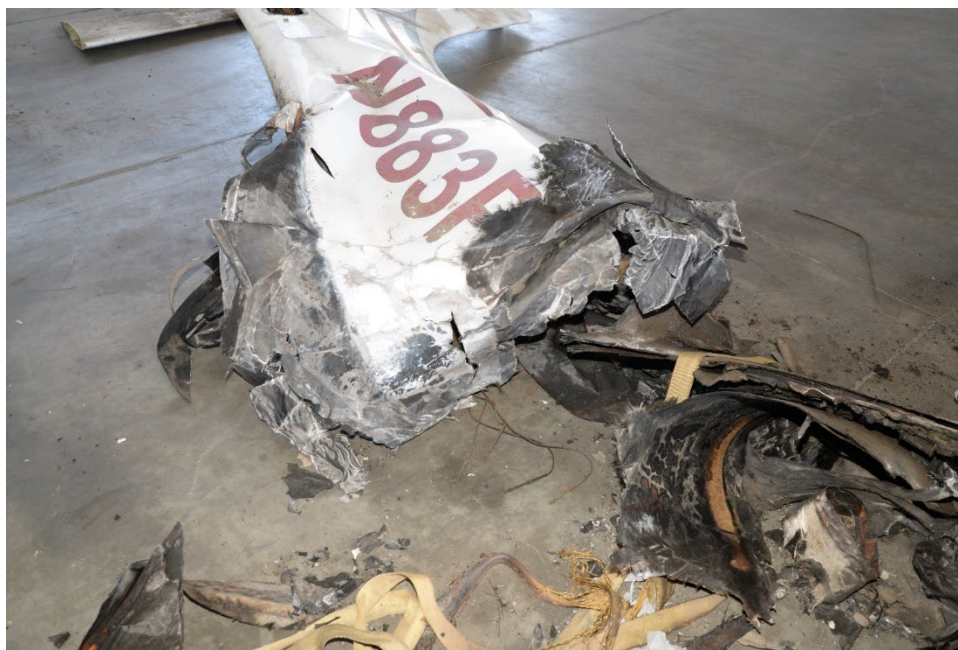
Figure 4: Aft Fuselage Immediately Infront of the Empennage

- The vertical stabilizer remained attached to empennage and sustained thermal damage.
    - The rudder remained attached by the lowest attachment point.

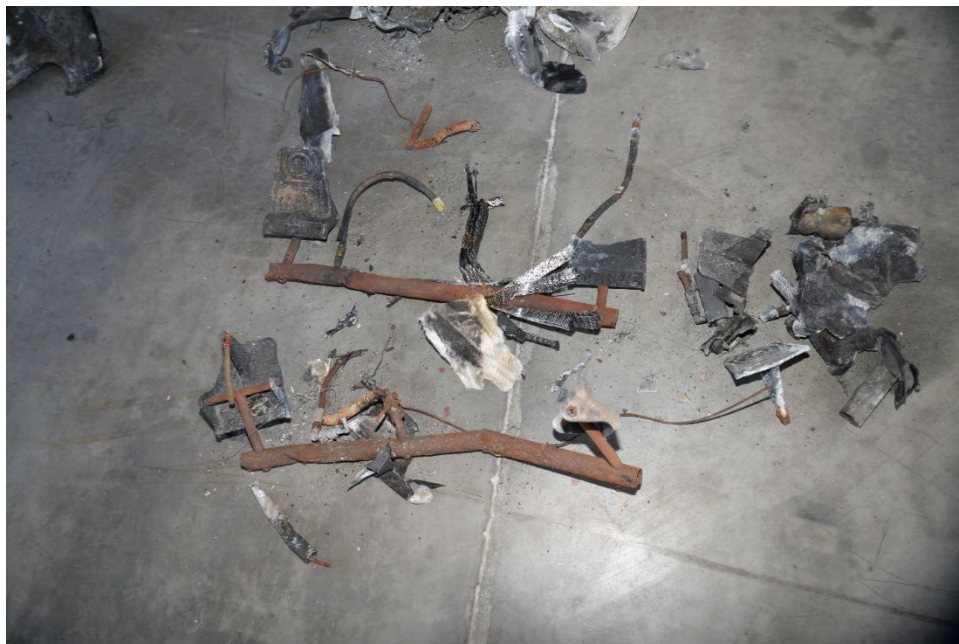
Figure 6: Rudder Pedal Assemblies

- Fragments from the cockpit controls were noted loose within the wreckage.
    - The aileron control cables were fragmented; however, they were present from the wings to the cabin area.

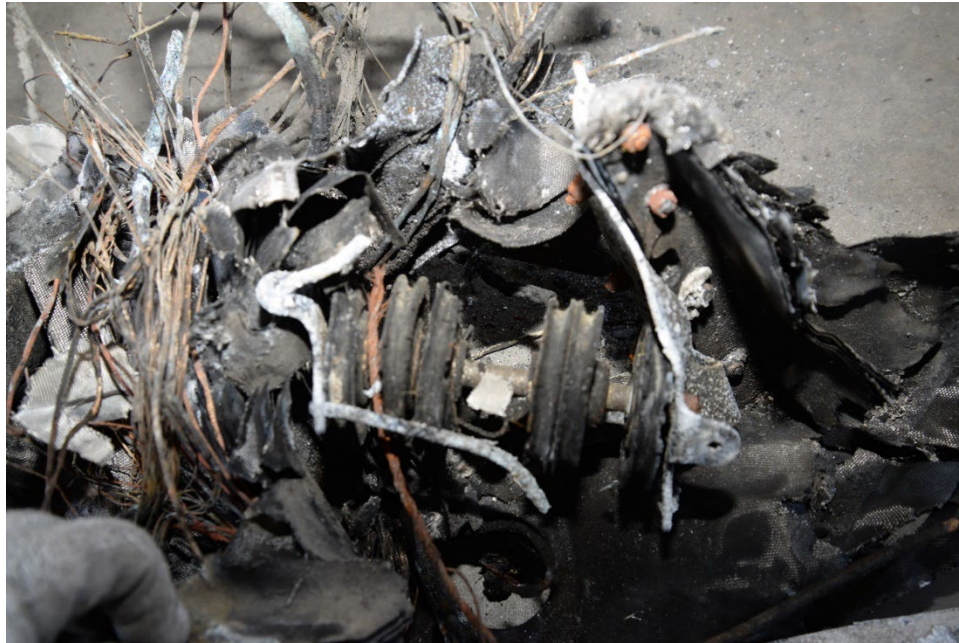
Figure 7: Forward Pulley Gang

- A fragment of control cable was present at the actuation pulley.
  - Flight control continuity was mostly established throughout. The flight control system was thermally damaged throughout and the center cabin area controls were not present likely due to the post-crash fire.

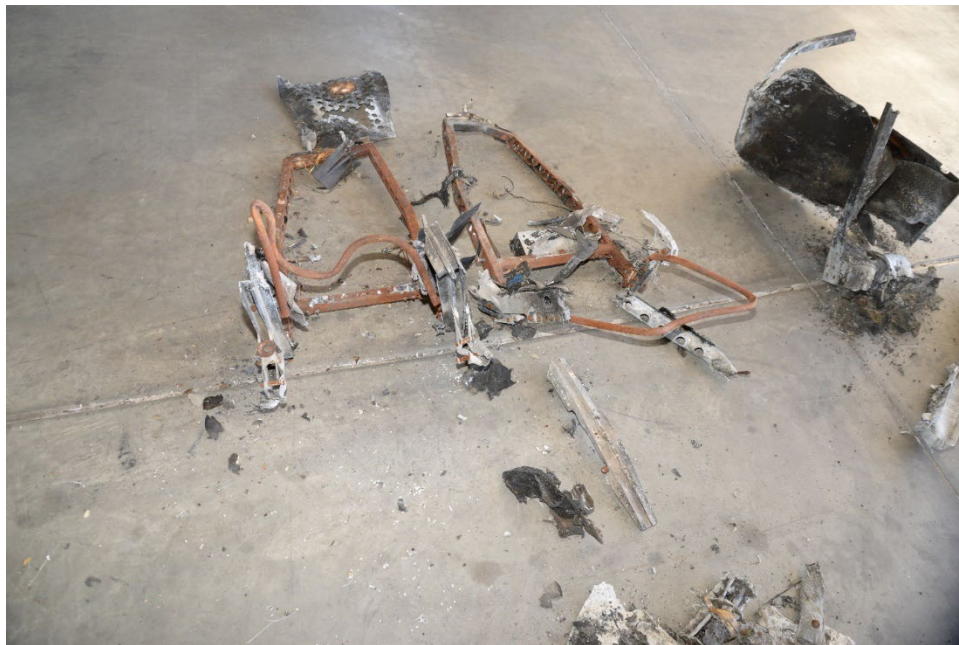
Figure 8: Front Seat Frames

- The airplane was mostly consumed by fire.
- The cabin area sustained extensive thermal damage and was mostly not present.
  - The instrument panel was destroyed. Instruments, radios, and other panel items were found loose within the wreckage.
    - All components sustained extensive thermal damage.
  - The front two seats were mostly consumed by fire.
    - Only the seat frames remained.
  - The rear seats were mostly consumed by fire.
  - The CAPS activation handle was found out of the holder.
    - About 4 feet of cable remained secured to the activation handle.
    - The rocket launch tube and parachute were present and examined with no anomalies noted.
- The aft fuselage and empennage were present and sustained some thermal damage.
- The wing spar sustained extensive thermal damage. (Single spar airplane)

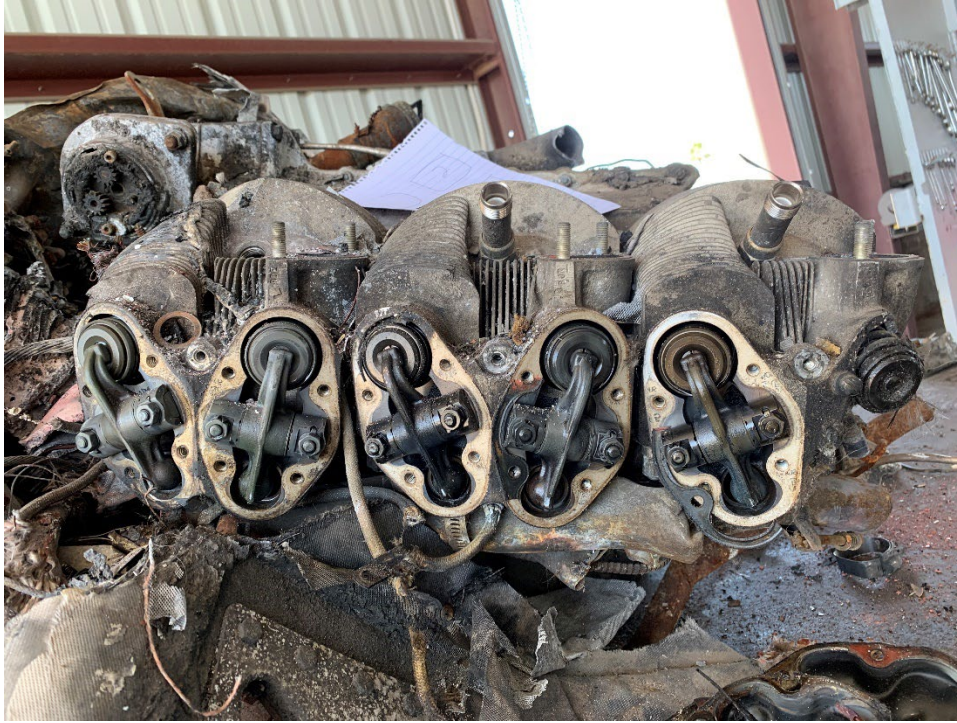
Figure 11: Right Side of Engine (Cylinders #1, 3, 5)

- The engine sustained extensive impact and thermal damage.
- The firewall was crushed forward around the aft portion of the engine.
  - The cooling fins on the aft side of cylinder #1 were fractured and crushed.
  - All upper engine components were shifted forward and compressed.
- The propeller assembly was completely fracture separated from the crankshaft.

- The piston was seized within the cylinder.
      - The push rods were fracture separated.
- The push rod and rocker arm for the intake valve on the #5 cylinder were fracture separated from the cylinder.

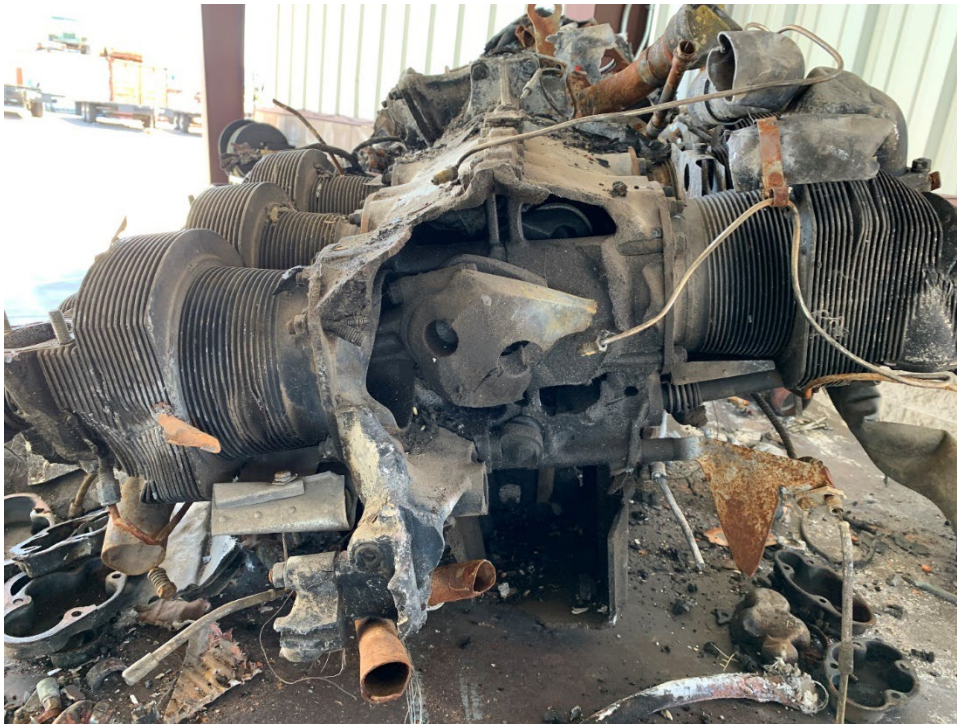
Figure 12: Front of Engine

- The front of the engine case, camshaft, crankshaft, and the #6 cylinder assembly were fracture separated, exposing the core of the engine.
  - All fracture surfaces were consistent with overload.
