# NATIONAL TRANSPORTATION SAFETY BOARD

## MATERIALS LABORATORY FACTUAL REPORT

Report No. 20-045

Place : Glendale, Arizona  
Date : June 2, 2020  
Vehicle : OMF Aircraft OMF-100-160, N225CK  
NTSB No. : WPR20LA165  
Investigator : Stephen Stein, AS-WPR

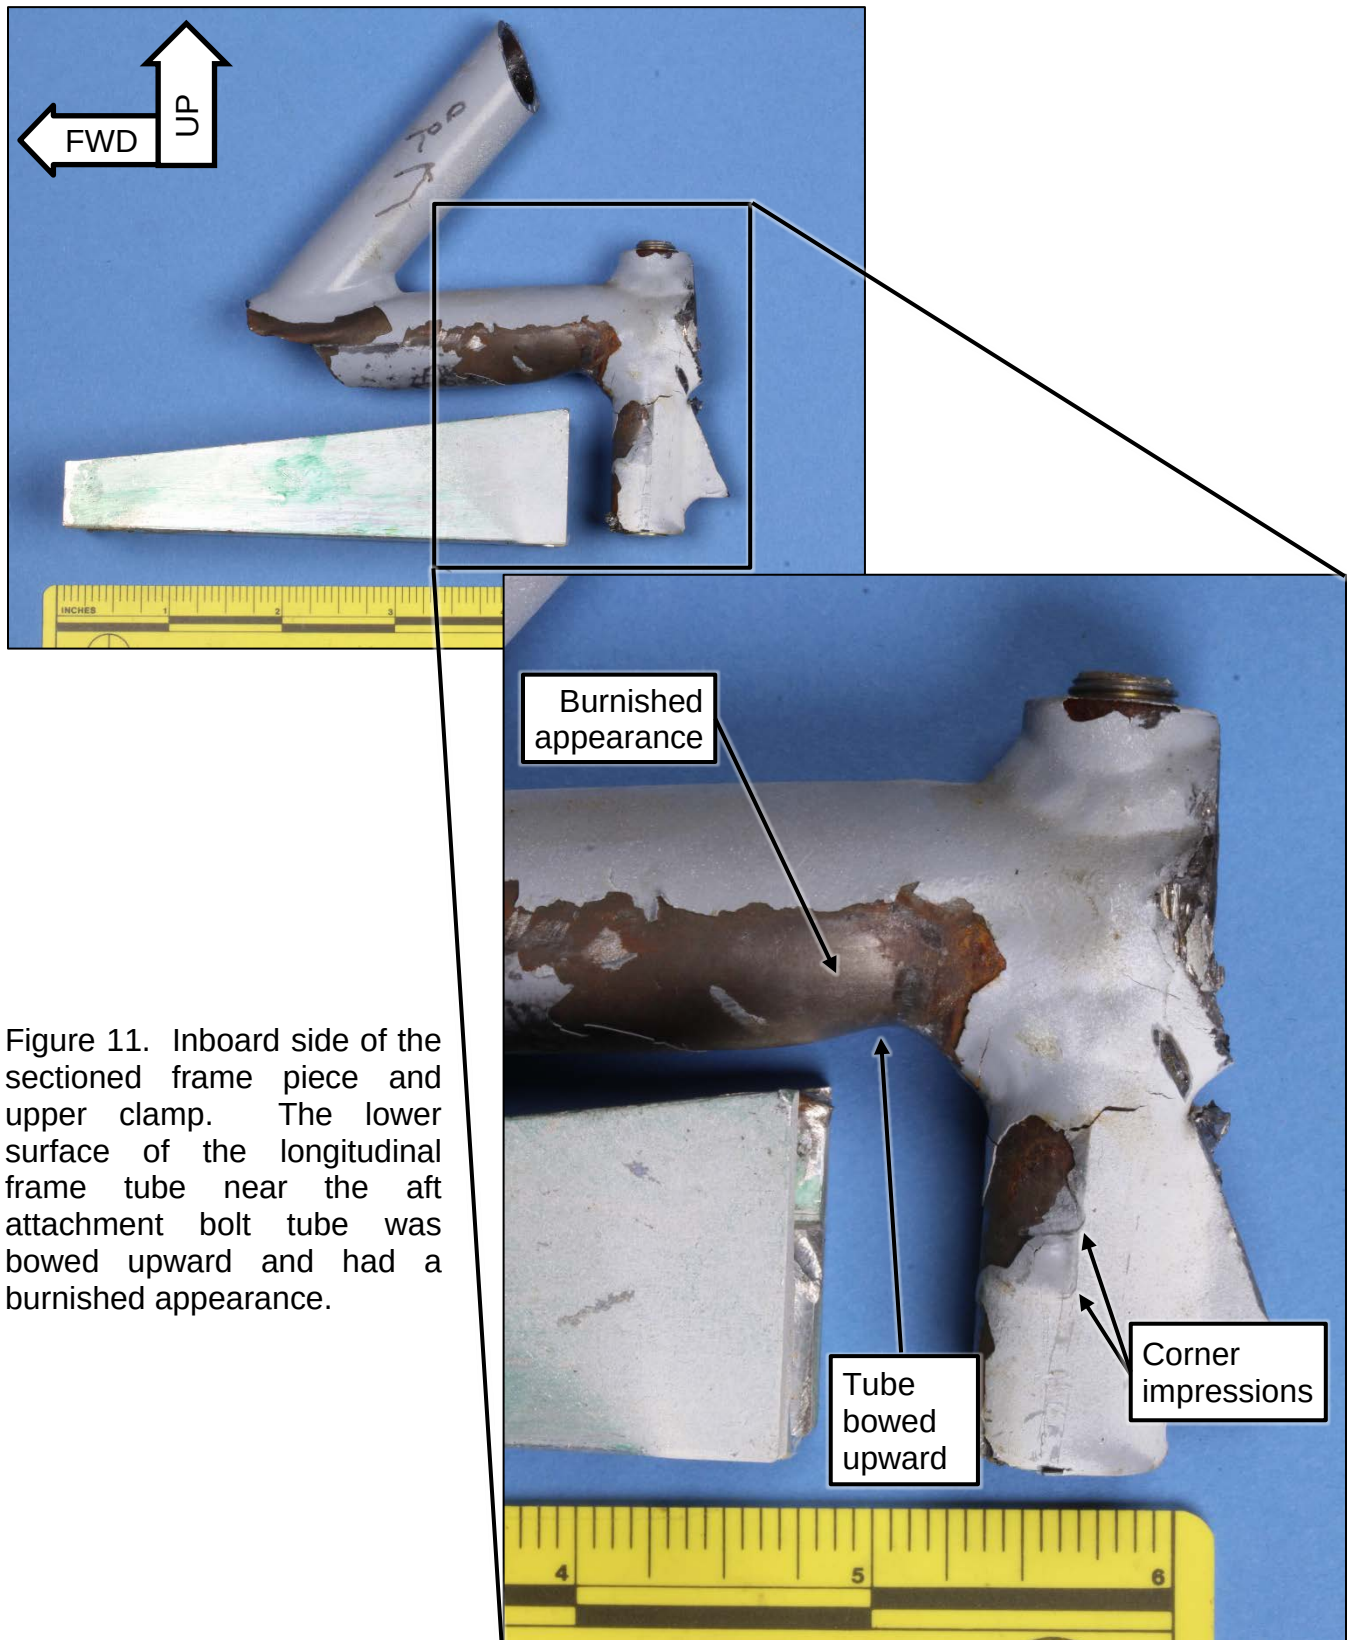
However, evidence of deformation to the longitudinal tube associated with contact with the upper clamp before the tube fractured was observed. As noted in figure 10, the upper tube was wrinkled and creased on both sides of the aft fracture through the longitudinal tube, and the location of the wrinkles and crease corresponded to contact with the upper side of the upper clamp. At the aft attachment tube, the lower surface of the longitudinal tube was bowed upward as shown in figure 11. The lower portion of the longitudinal tube had a more reflective appearance, appearing burnished relative to the surrounding surfaces. On the aft post, two impressions of the lower aft corner of the upper clamp were observed on the inboard side of the post. One impression was surrounded by white paint consistent with the as-assembled position, and another impression was observed above the original impression consistent with the lower aft corner of the upper clamp displaced upward and rotated counterclockwise (as viewed looking outboard) relative to the as-assembled position against the aft post.

Figure 10. View of the RMLG outboard attachment area with fractures in the longitudinal frame tube placed in close proximity after cutting the aft attachment bolt.
