# **Landing Gear Failure**

**Cessna 310B, N6602B**

**Accident Number:WPR20LA187**

**Gear Examination Report**

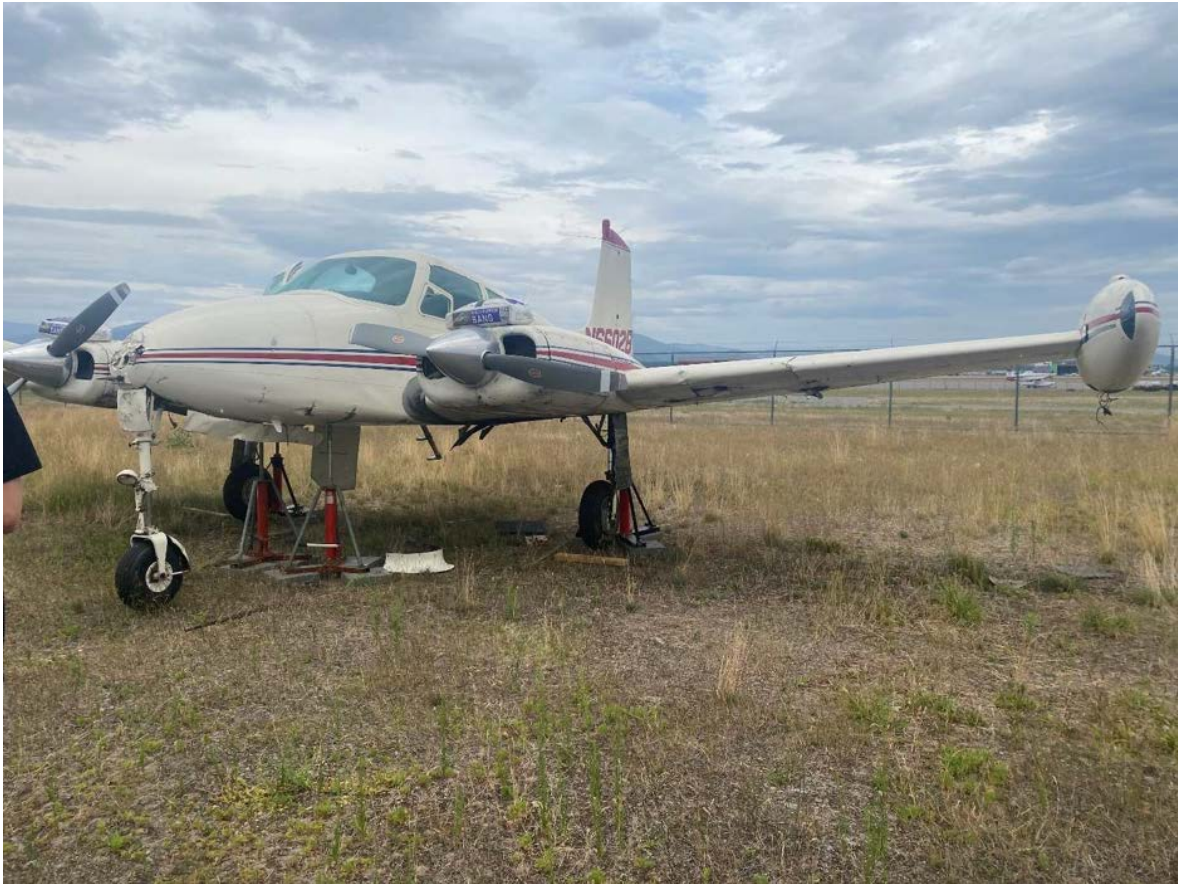
*Subject Aircraft on jacks*

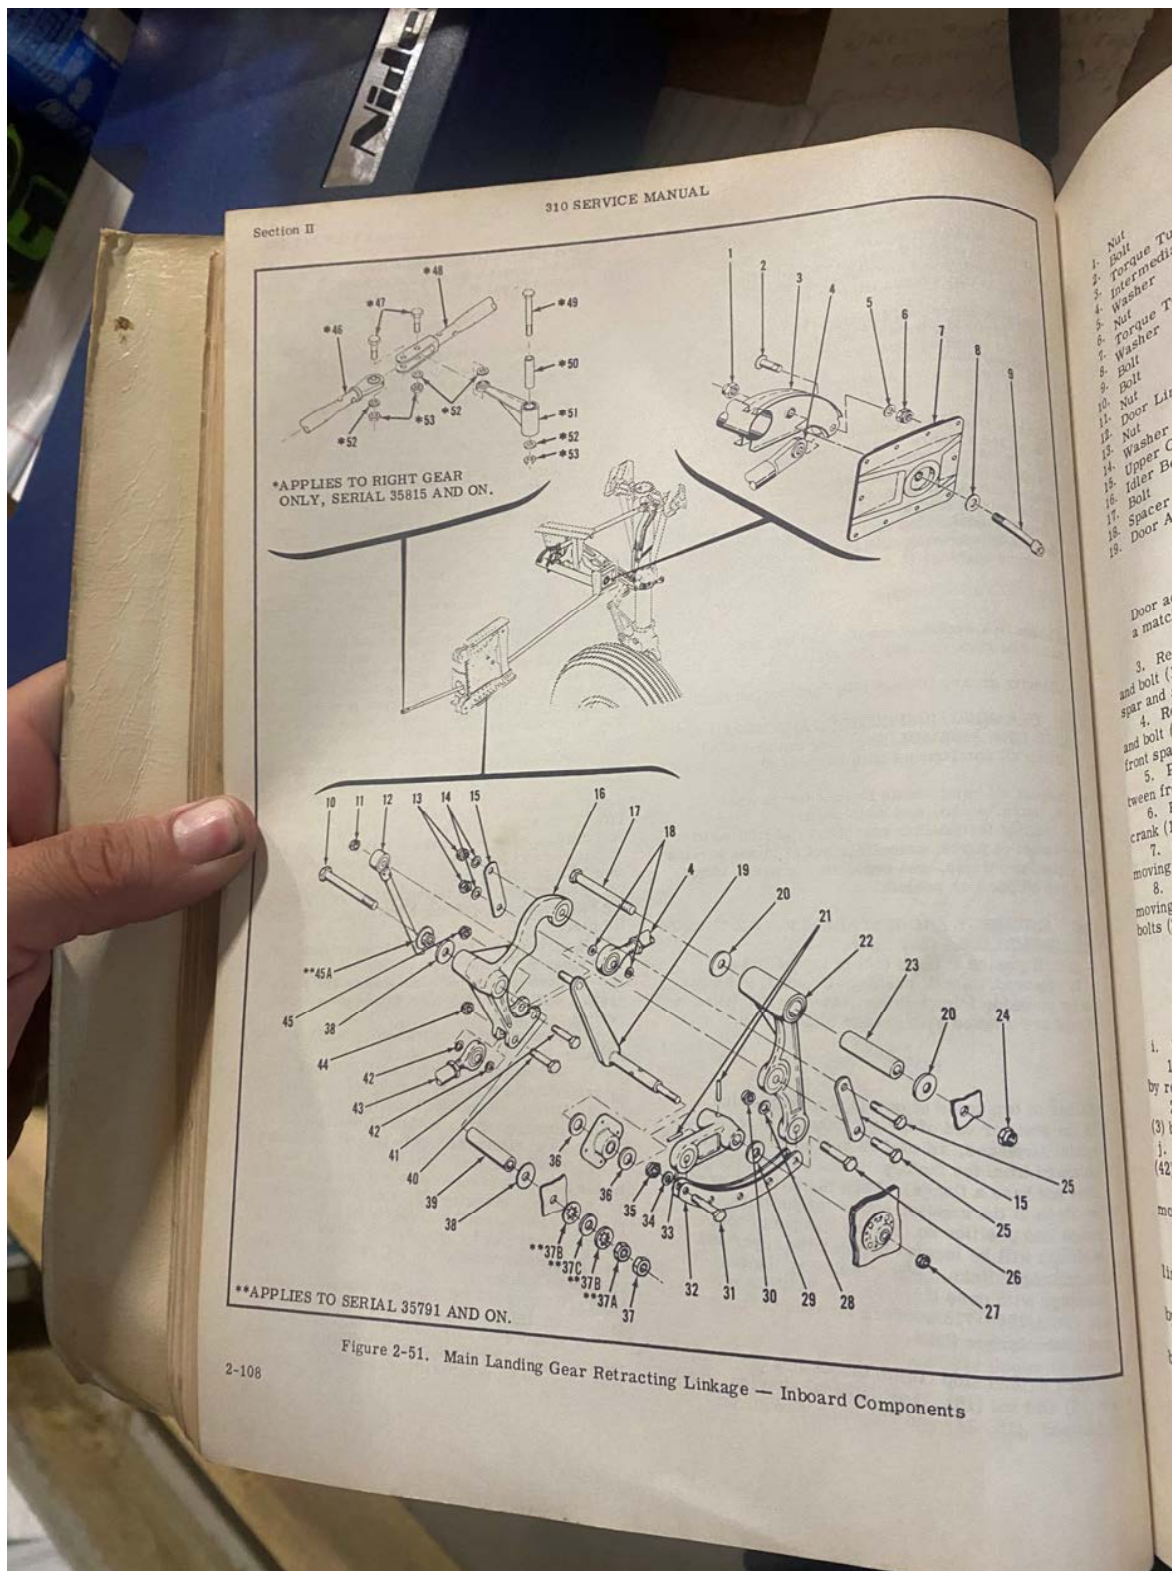
Figure 2-51

- L/H Door Actuator Arm (Item 19 Fig. 2-51) appears to be recently replaced due to cleanliness of part along with clean swarf located in L/H gear well. No notation of part replacement in Airframe log books from 1990 to present. Asked Latitude Aviation's chief mechanic Dustin Wise about recent arm replacement he stated that it was not replaced that he knew of, but that roll pins (Item 21 Fig. 2-51) were recently found sheared and replaced prior to the accident. However no record of replacement was noted in maintenance logs.
