## Main Rotor Transmission Tear-down Inspection

Enstrom Model 280FX S/N 2099 N280MM, NTSB Investigation: WPR20LA191

Accident Date: 23 June 2020

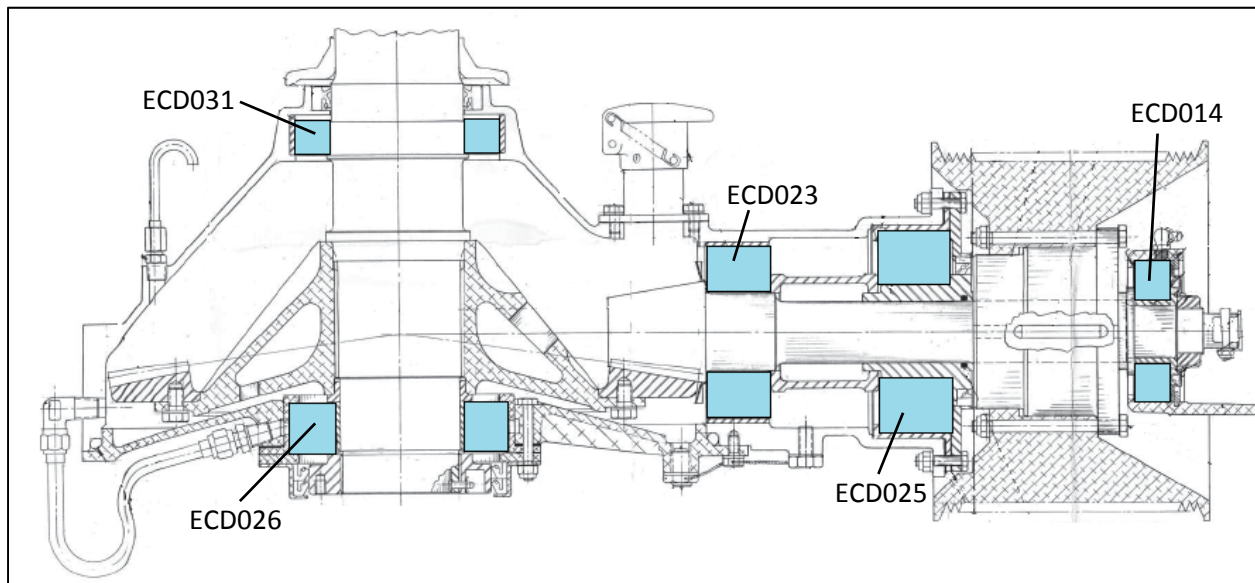
Figure 5. Transmission Bearing Locations

A schematic of the transmission is shown in Figure 5 with the bearings labeled. All the bearings had a similar condition. Each bearing is discussed separately below.
