**Honeywell Aircraft Accident Field Notes Prepared for the NTSB**  
**Accident Number: WPR20LA211, Payson, AZ, July 07, 2020**  
**Bell UH-1H, Registration: N623PB, S/N: 64-13689**

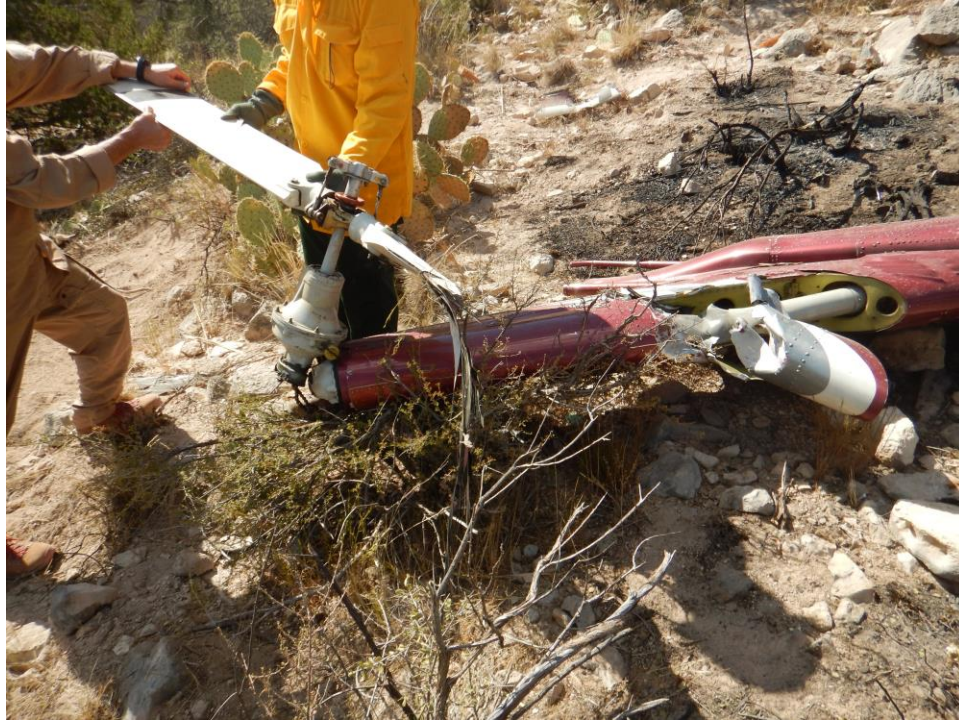
The tail boom was impact damaged and fragmented (Figure 34). There was partial fire damage – not as much as the rest of the wreckage. It was separated from the rest of the helicopter just forward of the horizontal stabilizer mount (Figure 35 and Figure 36). The horizontal stabilizer was displaced from the tail boom. The left-hand stabilizer was torn from its structural arm attachment and exhibited compression/crushing damage (Figure 37). The tail rotor drive shaft was fractured and fragmented along its length, there was thermal damage in some places (it was completely melted between the forward and aft firewalls, shown in Figure 38). The tail rotor drive shaft input into the 45° gearbox could be minimally rotated. The control cable inputs were present but continuity was not verified (Figure 39). One of the tail rotor blades was fractured, partially separated, and a portion of the leading edge remained within the vertical fin (Figure 40) where it appears as if it was driven into the tail rotor drive shaft between the 45° gearbox and the 90° gearbox (Figure 41). The other tail rotor blade was intact but exhibited impact damage (Figure 42 and Figure 43). The 90° gearbox was separated from its mount and fractured, it was oriented on the opposite side of the tail boom from its normal position (Figure 44). The vertical fin exhibited crushing/buckling along the structural section.

**Figure 44. 90° Gearbox Separation**
