# Party Submission

## Technical Analysis of ASG-29 Accident near Ely, Nevada on July 11, 2020

**September 18, 2022**

Andy Kanigowski

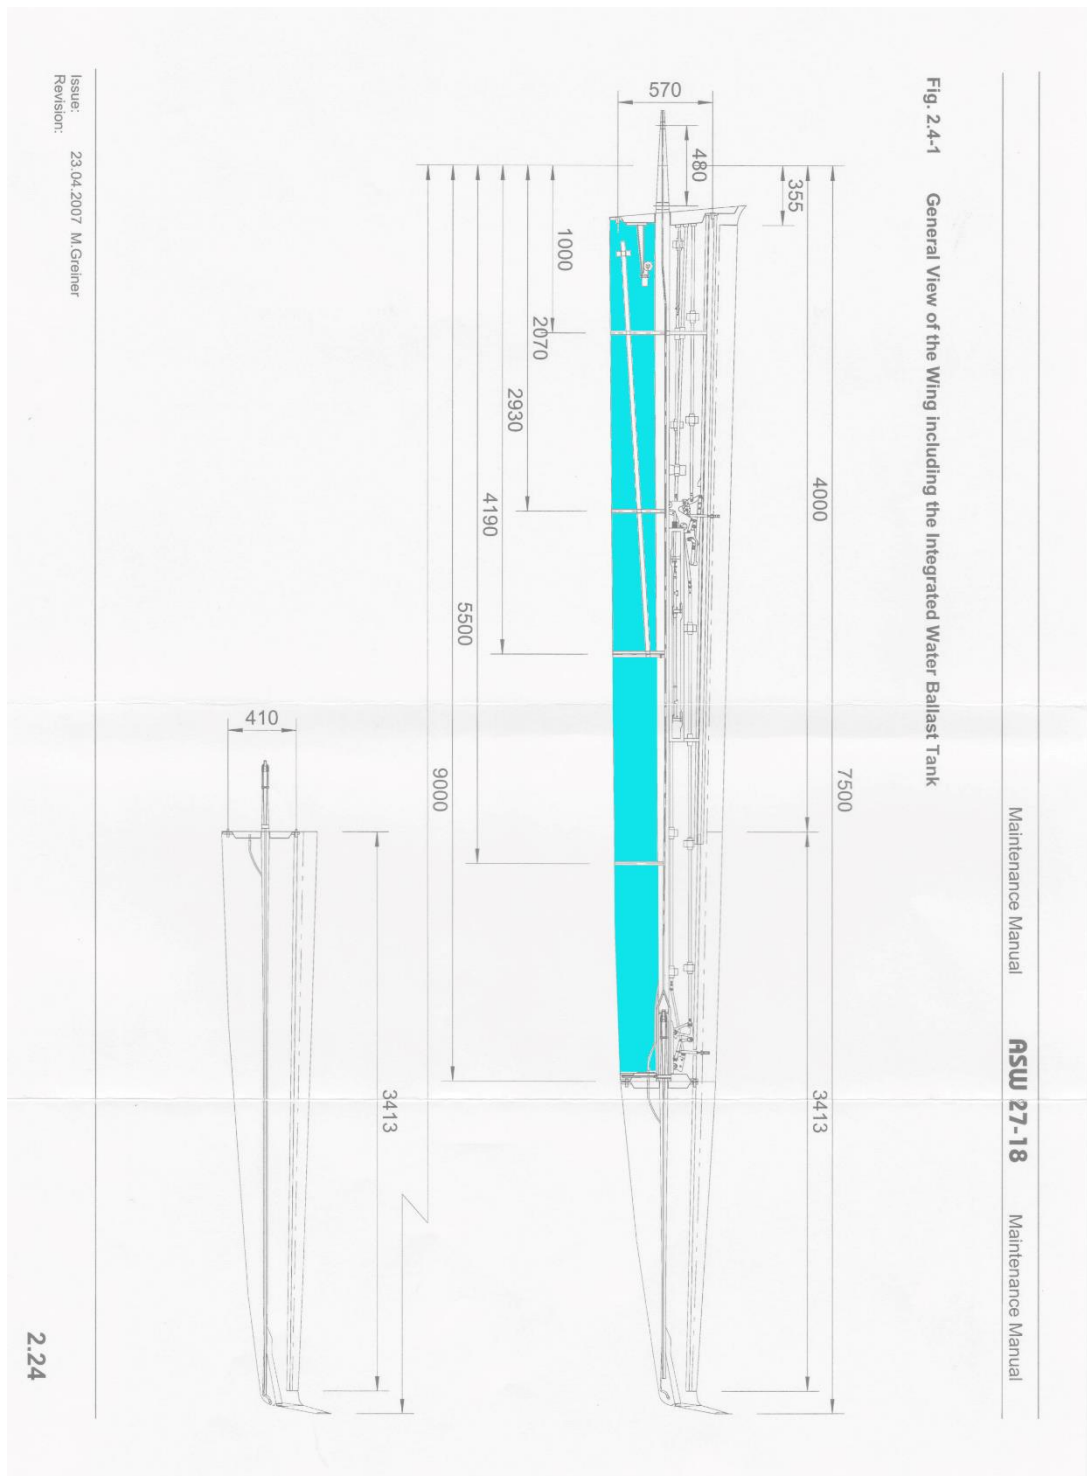
Figure 2.4-1: General View of the Wing including the integrated Water Ballast Tank.

This inner wing section houses the internal water tanks along its entire 5m span, in the forward first half of the wing chord (see appendix Figure 2.4-1). Observations show this section of the wing was broken into fragments along the entire 5m span, precisely along the forward half of the wing chord where the water tanks are located.

The leading edge section of the wing is directly used as water ballast tank (integrated tanks) that extend over the entire span of the inner wing (excluding the wing extensions).

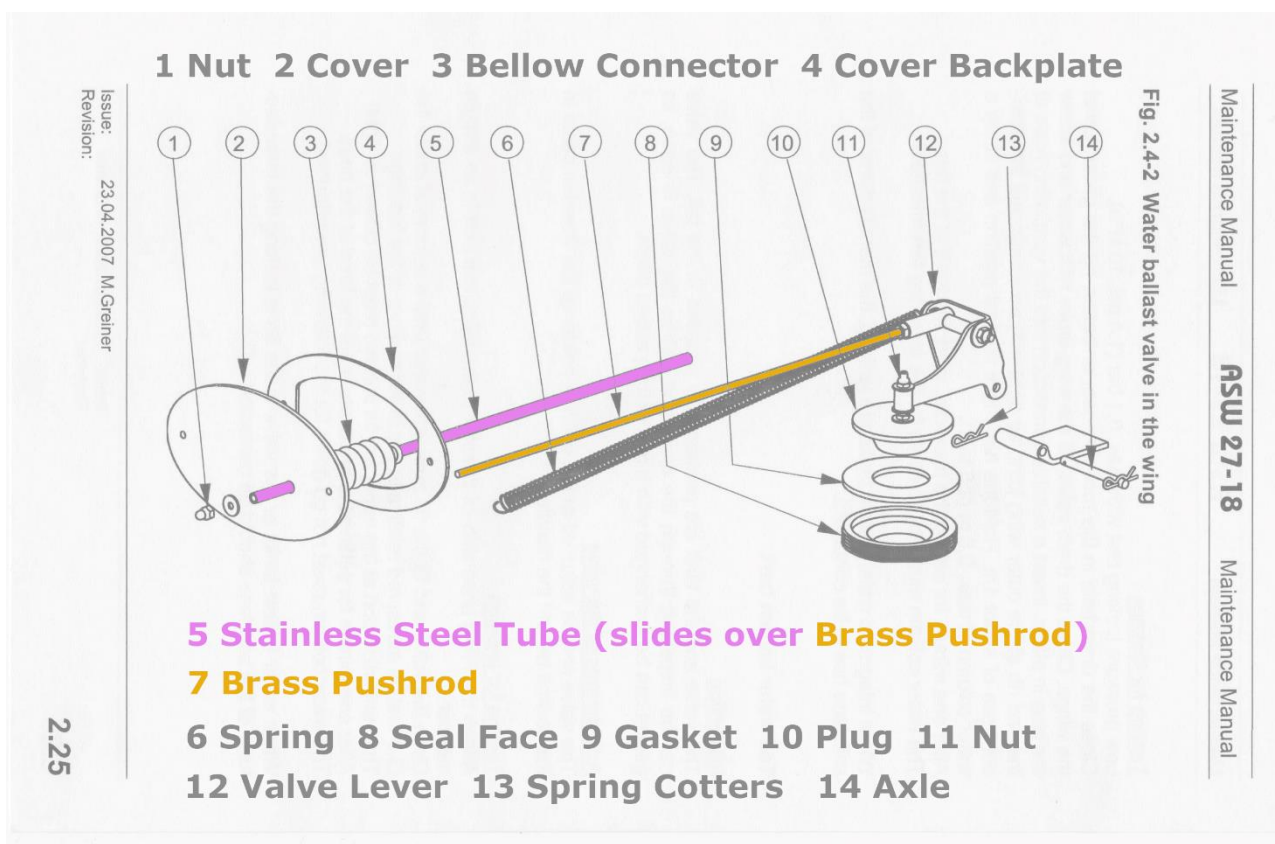
Figure 2.4-2: Water ballast valve release mechanism inside the wing

Figure 2.4-2 shows detail of the water release mechanisms inside each wing, located in the chamber closest to the wing root. The water release valve is spring loaded and kept closed by the force of the spring. A pushrod works against the force of the spring to open the valve. The pushrod is actuated by a rocker located inside the fuselage.

The rocker is actuated by a Bowden cable terminated inside a female brass tube mounted in the rocker housing inside the fuselage at the root rib of each wing. The release cable is controlled from a pilot lever on the right side of the cockpit (see Figure 2.4-6 on the next page).

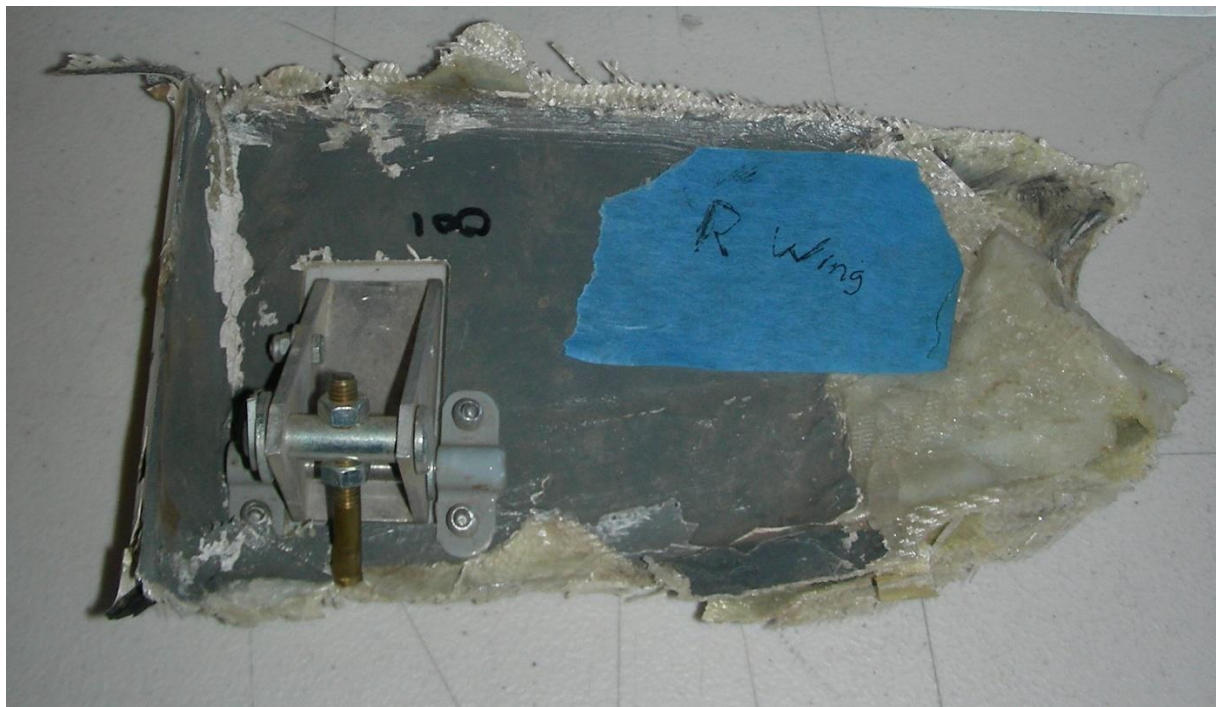
001: Right Rocker and Housing Assembly (inside view)

Observations show that cable to the right wing is broken in a manner which shows signs of tensile stress. The ends of the cable are frayed due to tensile force pulling on the cable during impact. This indicates that the cable termination was secure during flight and broke

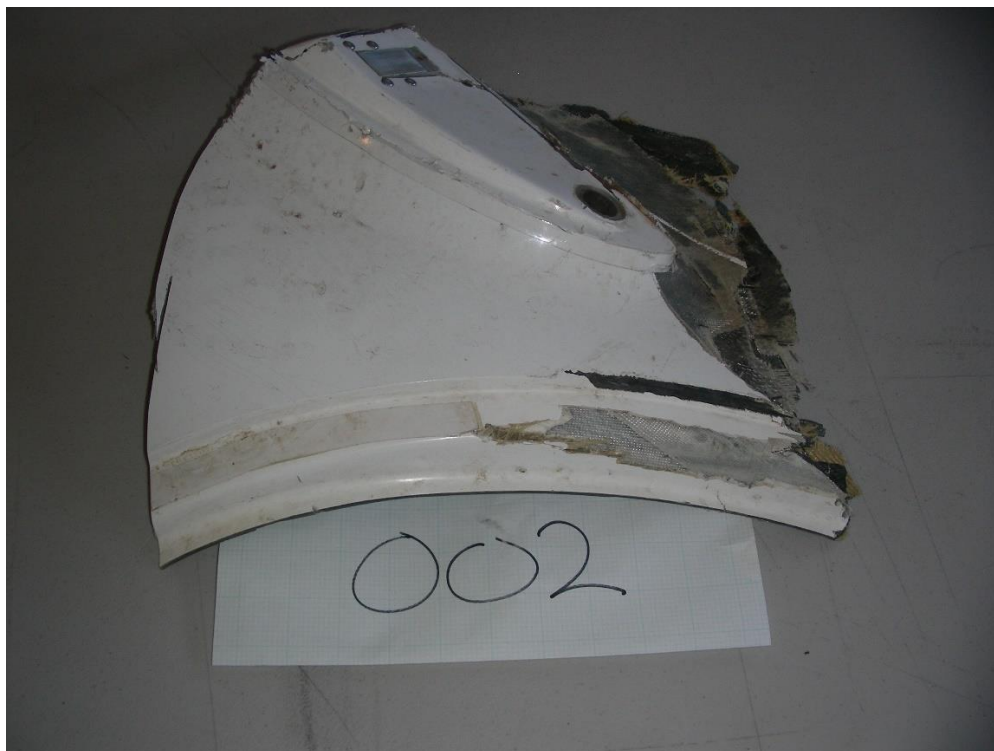
002: Left Wing Rocker and Housing Assembly (outside view)

Observations show that the cable to the left wing does NOT show signs of stress or breaking under tensile force. The evidence suggests that the cable termination failed prematurely (during flight).

Check for LACK of evidence of cable break from impact forces (unlike the right side)
