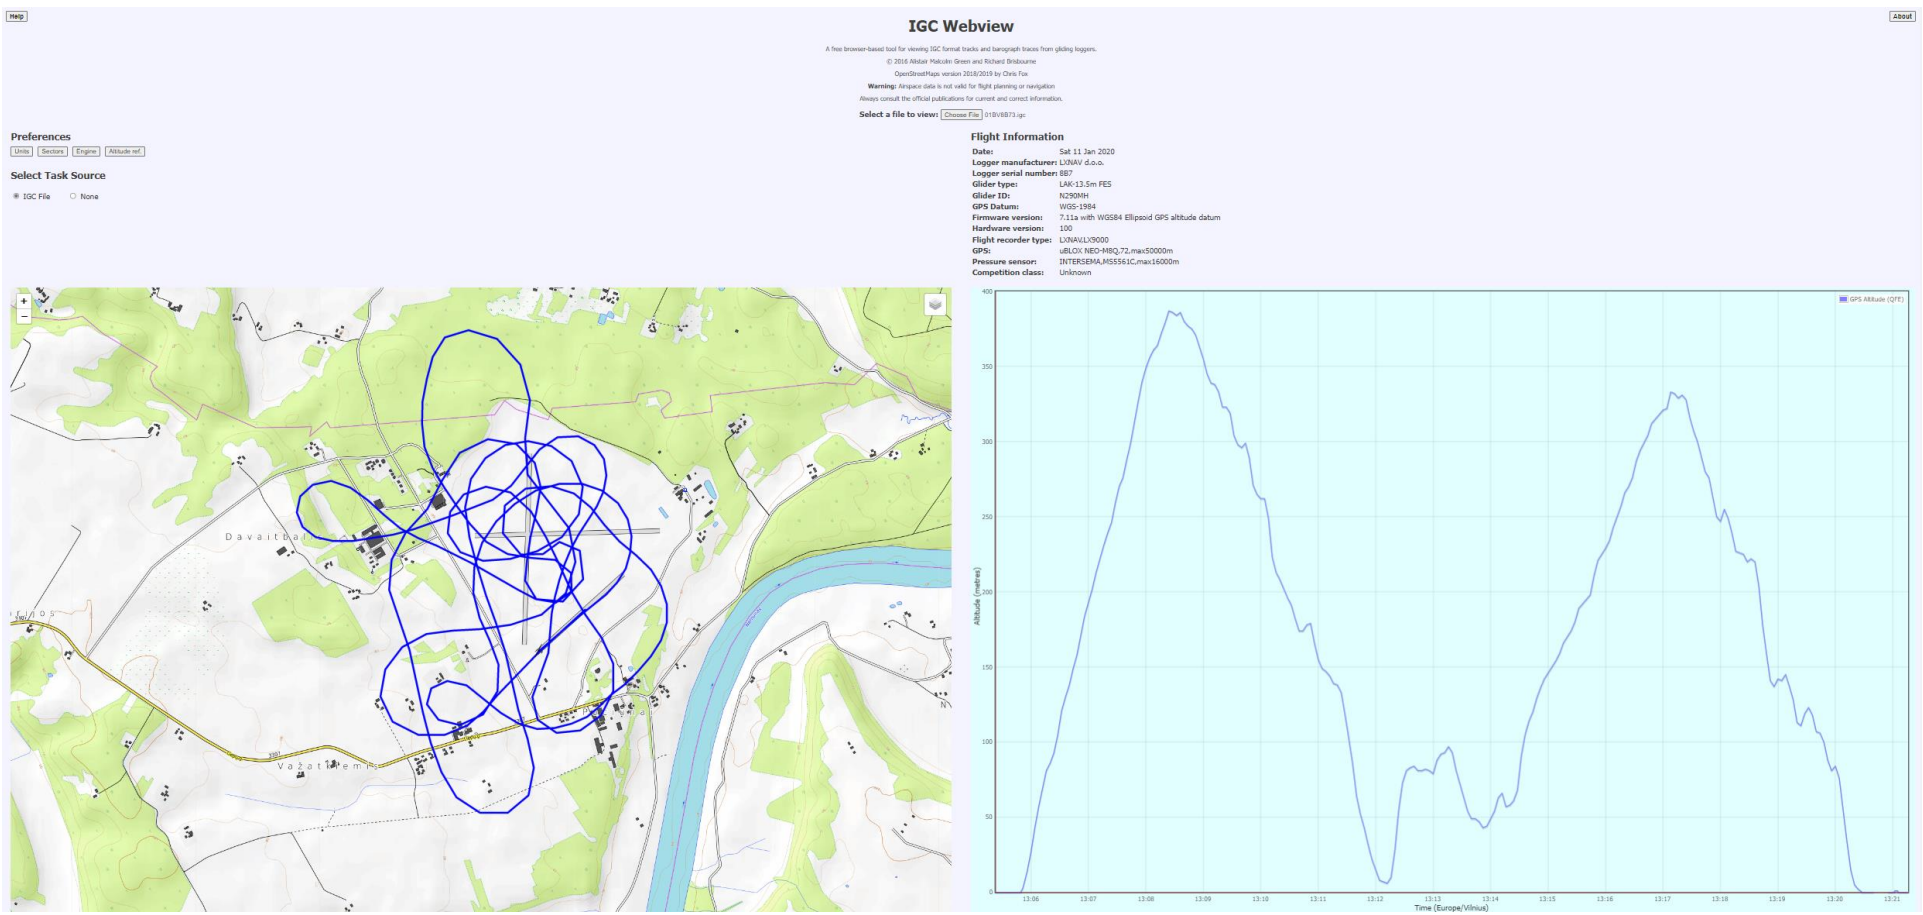
~15 min flight at the manufacturer.

Data from the LX9000

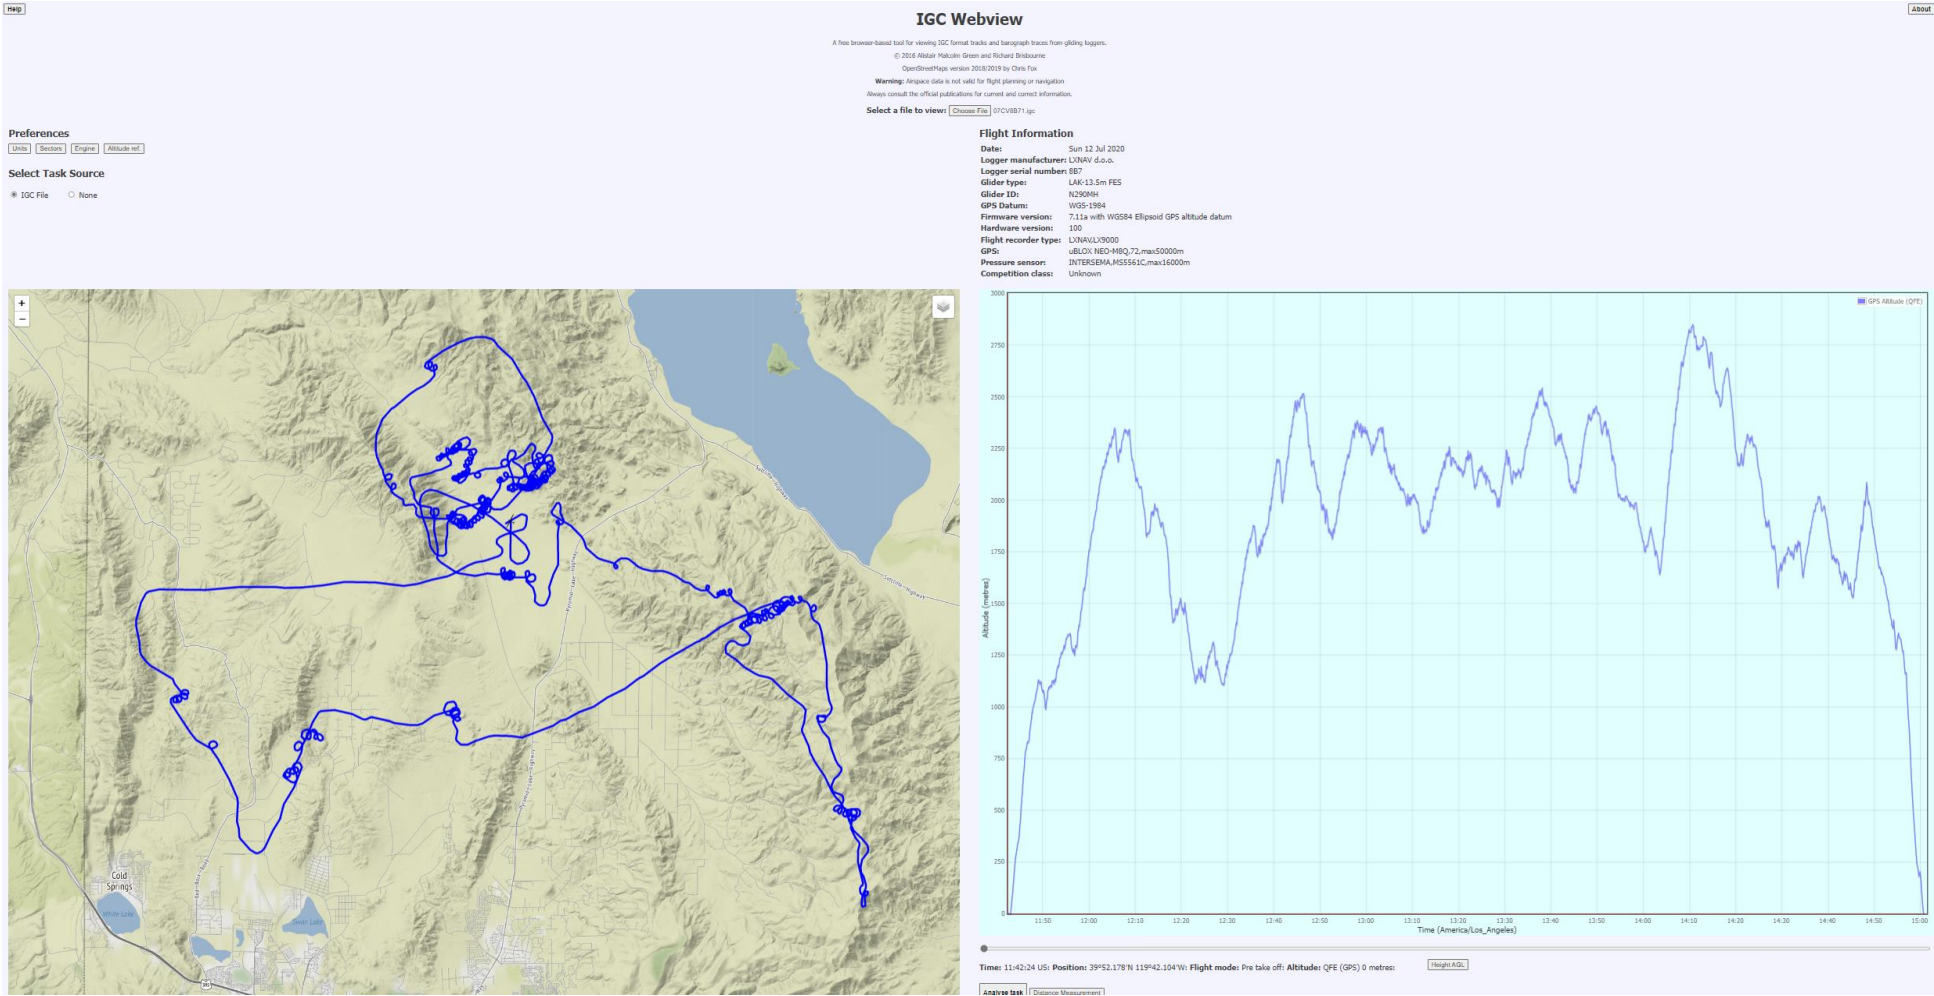
Figure 3-Flight track.

~4 hr 15 min flight at Air Sailing Gliderport, Sparks, Nevada.

(ADS-B data for this flight was intermittent.)

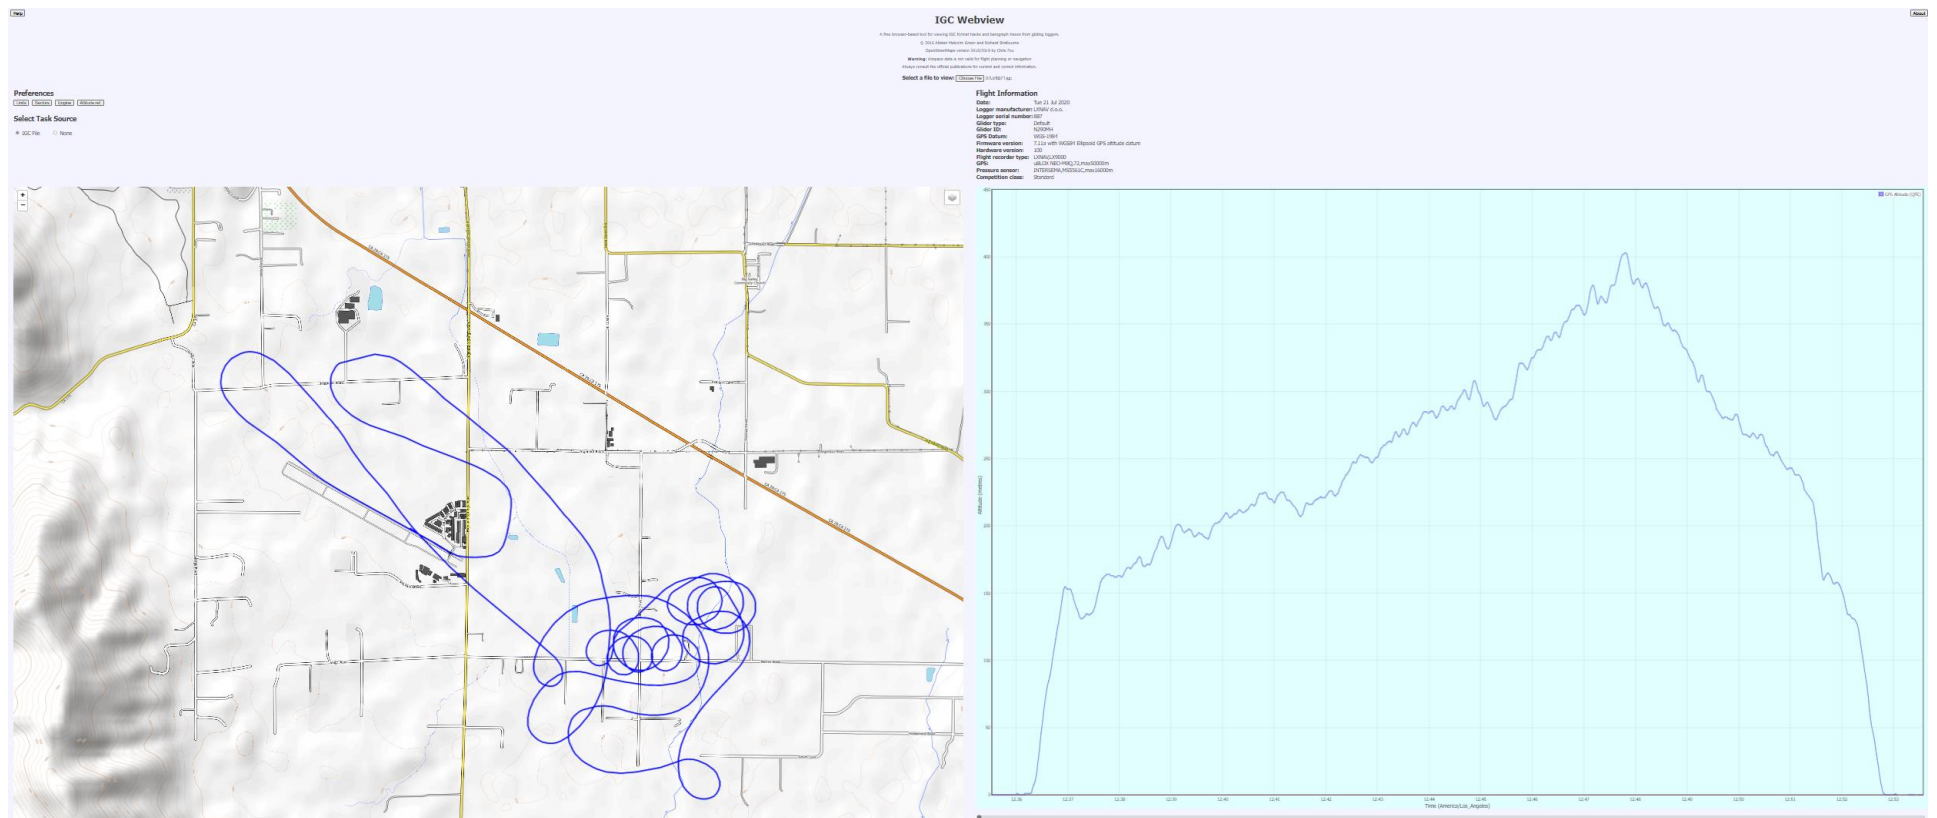
Figure 4-Flight track.

~17 min flight at Lampson Field Airport, Lakeport, California.

(ADS-B data for this flight was not found)
