## INVESTIGATIVE MATERIAL SUPPLEMENT

On February 19, 2021, about 1158, a Piper PA-32-260 Cherokee Six airplane, N57014, was substantially damaged when it was involved in an accident in Los Angeles, California. The pilot was fatally injured and a person on the ground sustained minor injuries. The airplane was operated as a Title 14 *Code of Federal Regulations* (CFR) Part 91 personal flight.

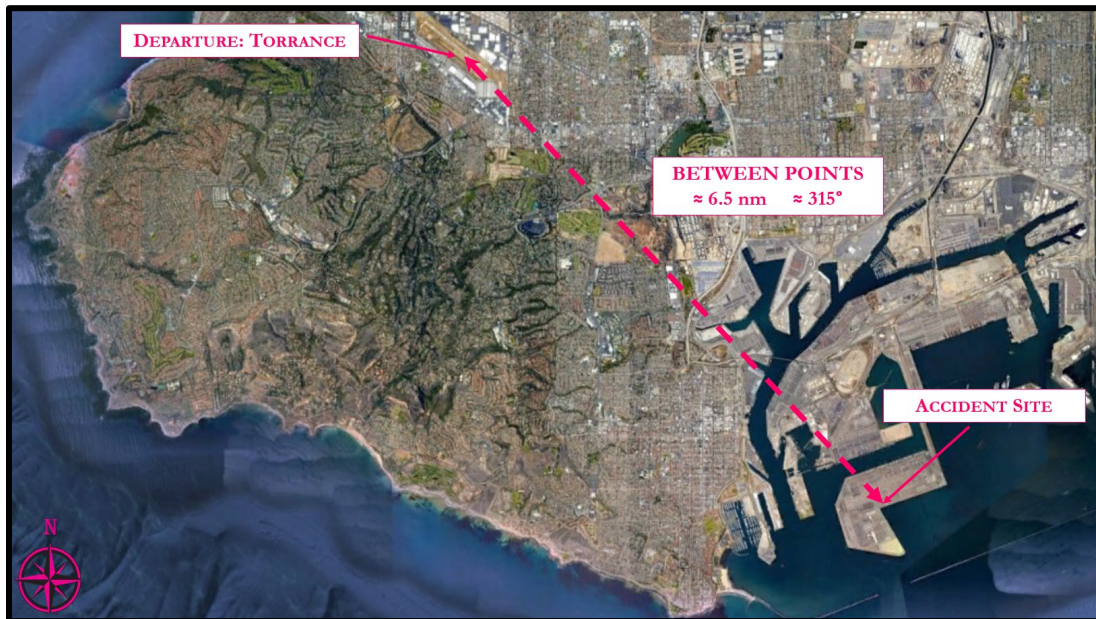
Figure 6: Accident Site in Reference to Departure

The accident site was located in a container shipping yards about 6.5 nautical miles (nm) southeast of Torrance at the following coordinates: 33.723995, -118.251341. The wreckage was found distributed over about 200-feet on a median magnetic bearing of about 79°.

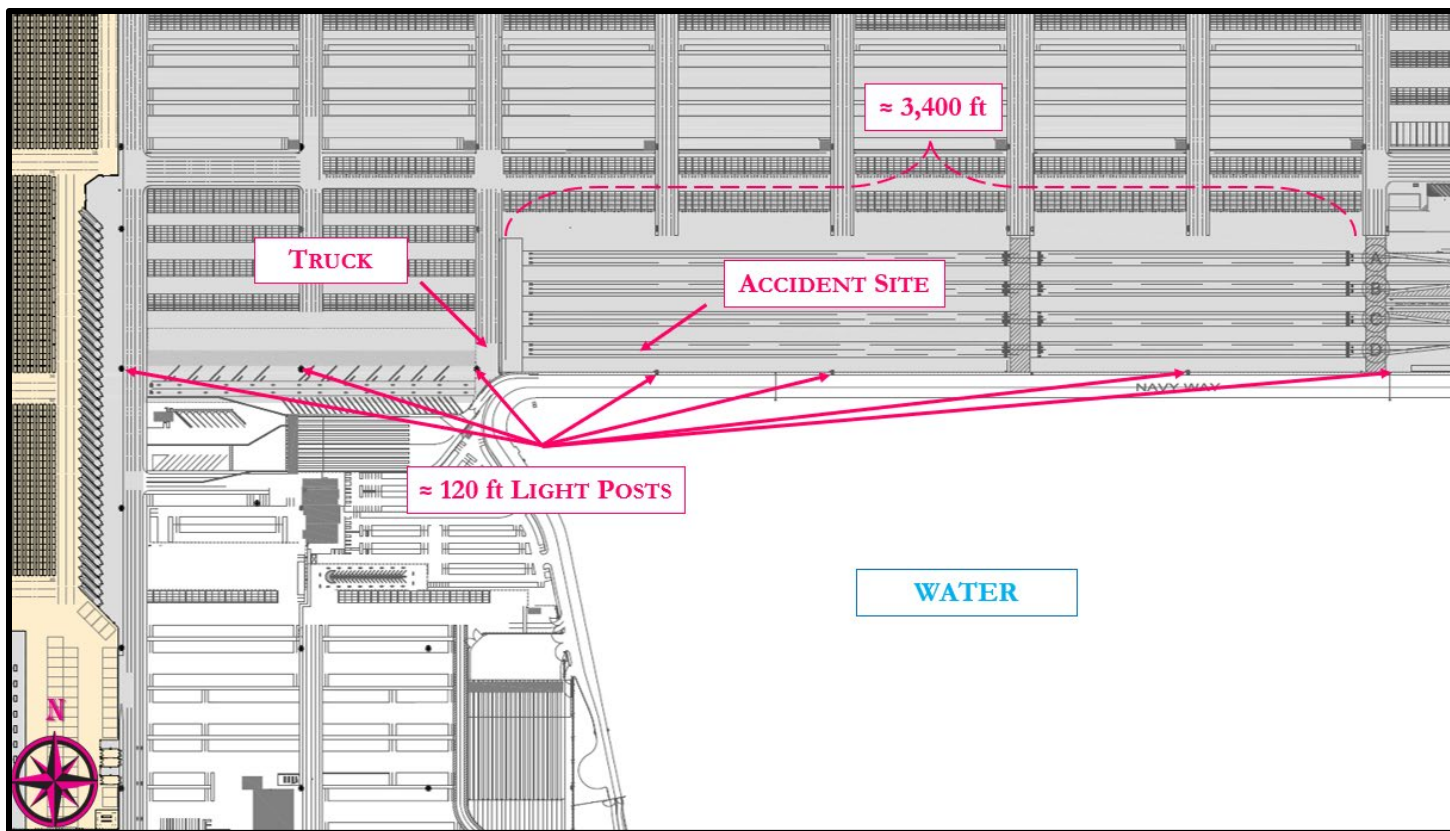
Figure 8: Diagram of Accident Site (showing light posts)

The first identified piece of debris was the outboard left wing that had come to rest in the truck cab. The hood of the truck, about 6 feet above ground level (agl), had paint transfers, consistent with the tip of the left wing contacting cab in a left-wing low attitude. Adjacent to the truck was a 120 feet tall light post, which is where security cameras were located.

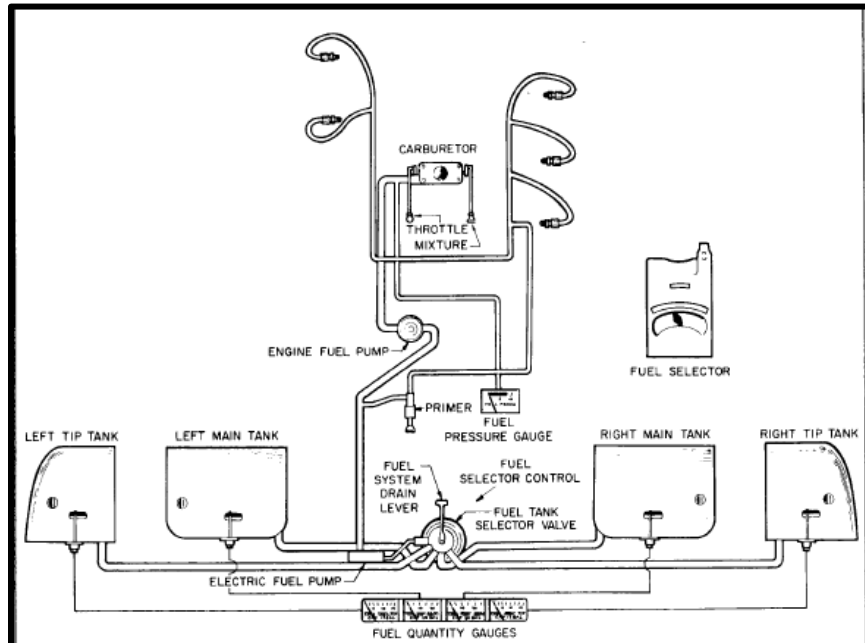
Figure 12: Fuel System

The fuel system consisted of two aluminum tanks contained in the inboard leading edge section of the wings in addition to two fiberglass tanks located in each wing tip. The main tanks have a maximum capacity of 25 gallons each while the tip tanks hold a maximum capacity of 17 gallons each. The system was designed for fuel to be taken from each tank through a screen located in the tank outlet fitting and onto a combination fuel selector valve and strainer located under the floor panel under the middle seats. The fuel selector valve is controlled remotely by a selector lever located on the sloping face of the control tunnel. The strainer portion of the valve is operated by a lever located on the right front side of the spar cover under the forward end of the right middle seat. From the selector valve, fuel is drawn through the electric fuel pump located in the area under the middle seats, through the engine driven pump and onto the carburetor.

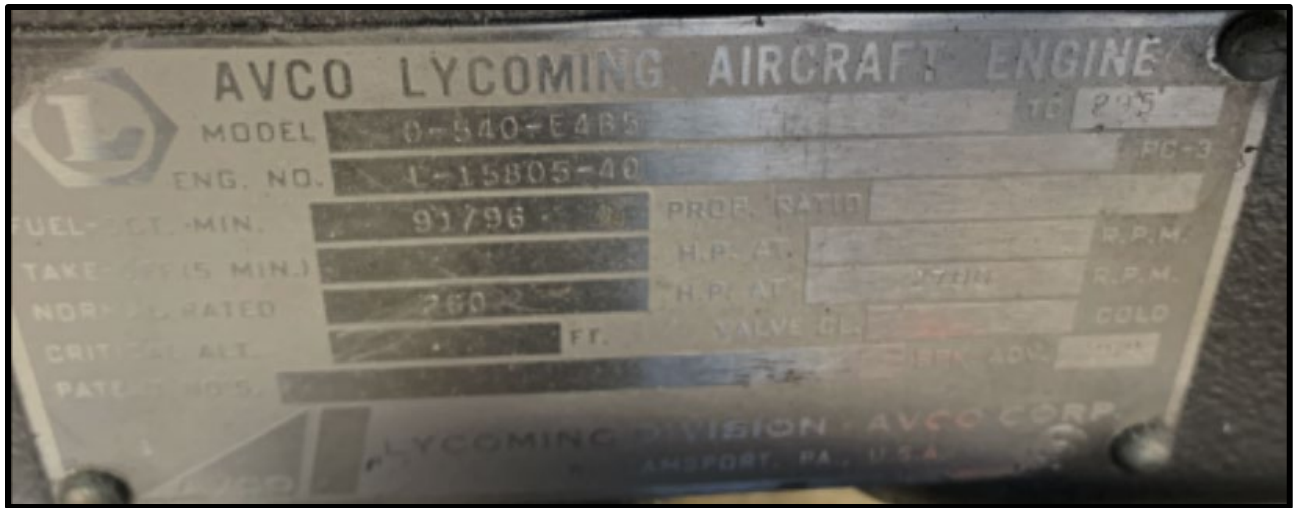
Figure 14: Engine Data plate

The Lycoming O-540-E4B5, serial number L-15805-40, was the original engine installed on the airplane at manufacture.
