# National Transportation Safety Board

WPR21FA223

## INVESTIGATION MATERIALS SUPPLEMENT

Location: Porterville, California  
Date: 06/07/2021  
Time: 1420 Pacific standard time  
Airplane: Vans RV-6A

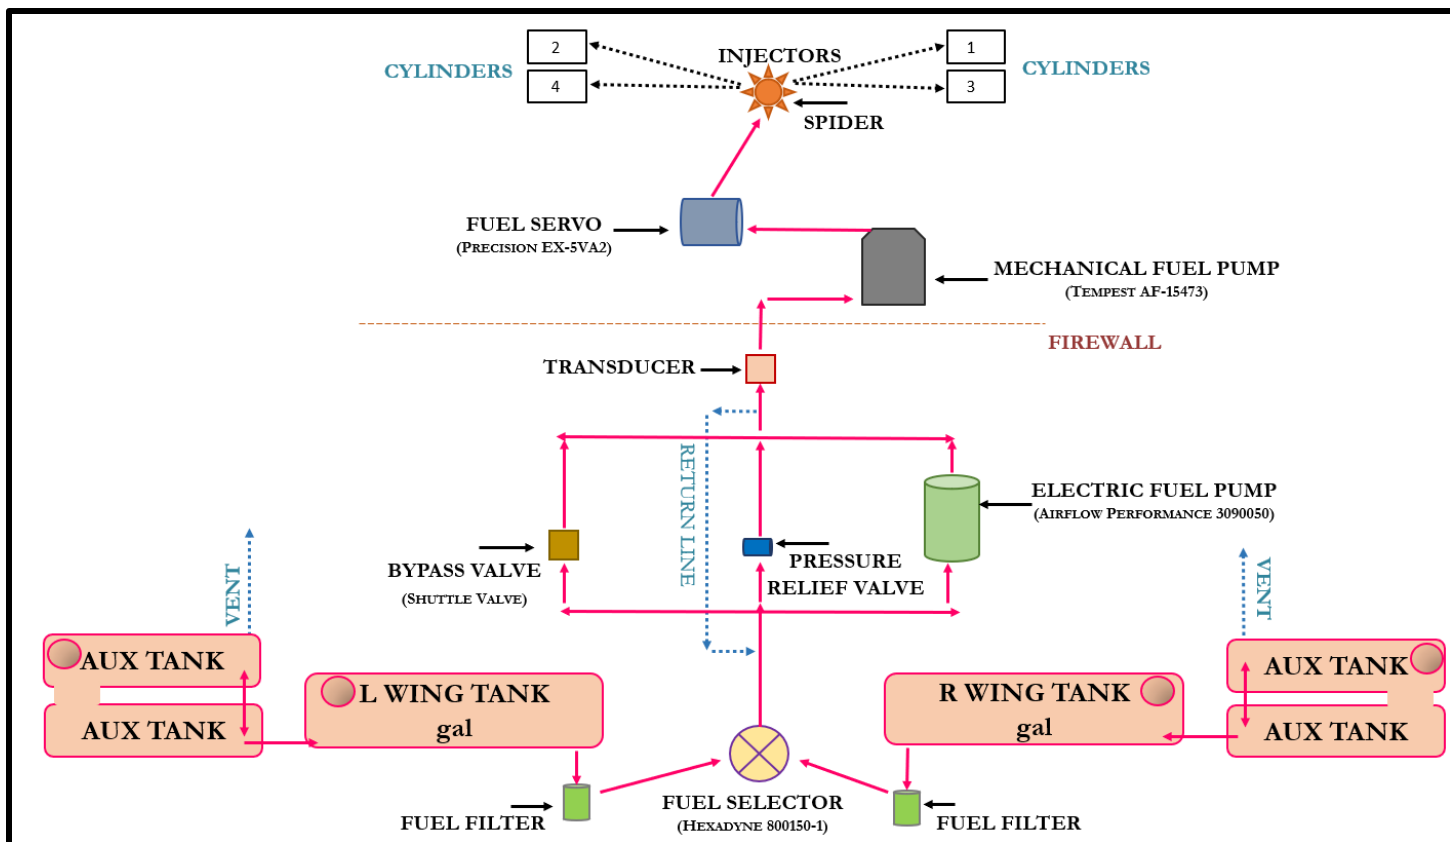
Figure 4: Graphic Depiction of the Fuel System

From the selector valve, fuel was routed to an Airflow Performance (p/n 3090050) electric fuel pump. On the electric pump there were two valves, one was the pressure relief valve (blue valve) and the other was a bypass-check valve (gold color). When the electric pump is off the check valve allows free flow to the engine pump. When the electric pump is energized the check valve closes which keeps electric pump flow from short circuiting. With the electric pump on, the pressure is built up until the opening pressure of the relief valve is met (25-35 PSI) which supplies the fuel injection system with the required fuel pressure to operate. The excess flow that the electric pump generates is returned back to the inlet of the electric pump.

Fuel was then fed to a transducer and then through the firewall. From the firewall, the fuel was routed to a Tempest mechanical fuel pump, AF-15473 (s/n F003164) and continued to the Precision EX-5VA2 fuel servo. From the servo the fuel was routed to the spider located on top of the engine, which divided the fuel into the four cylinders.

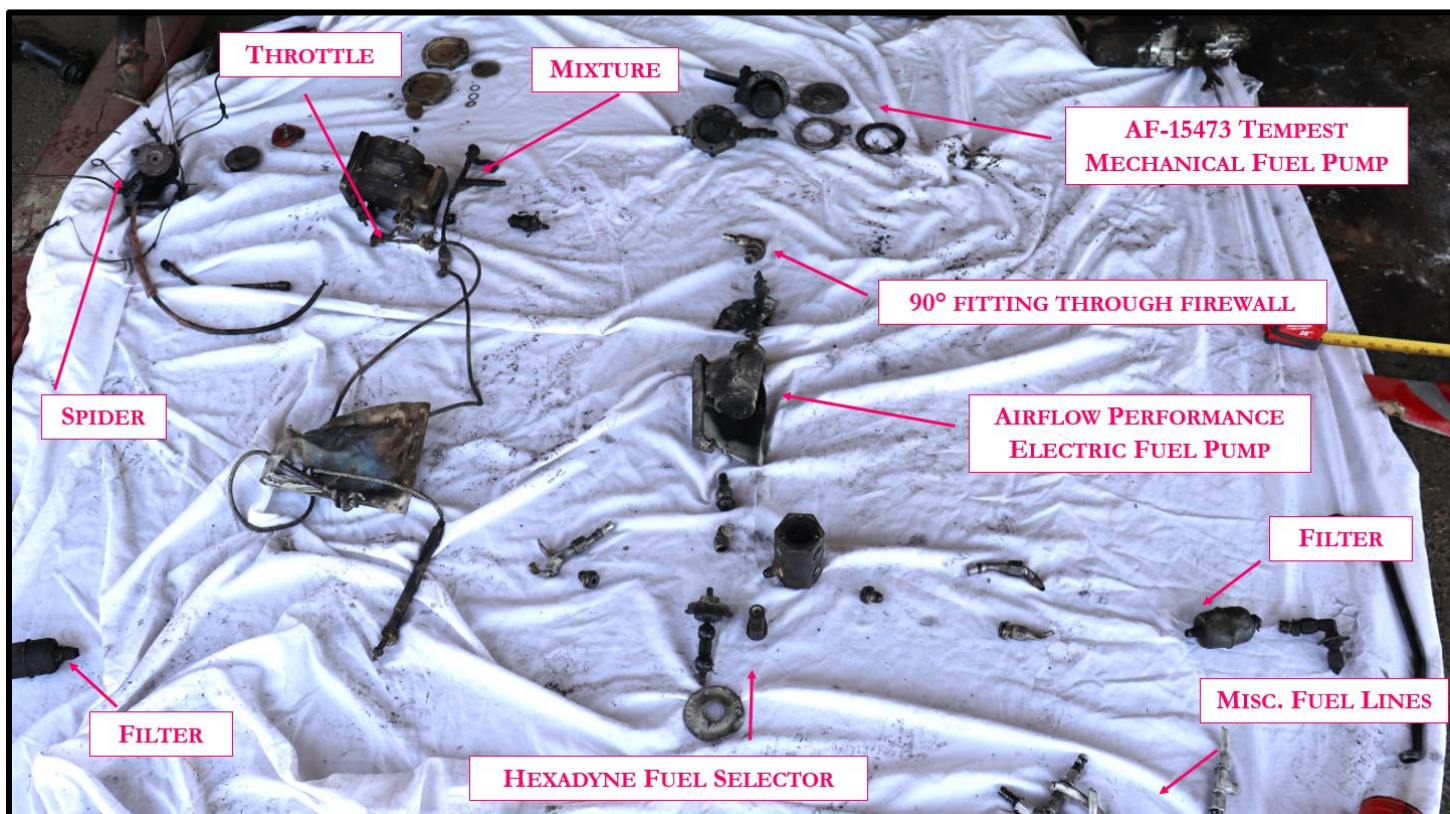
Figure 5: Fuel System

Several pictures taken prior to the accident revealed that there was rubber lined fuel hoses. Additives in the fuel will deteriorate and erode the rubber liner, creating either a cavitation void for an air leak or a fuel leak; either could cause a starvation or a momentary fuel starvation.

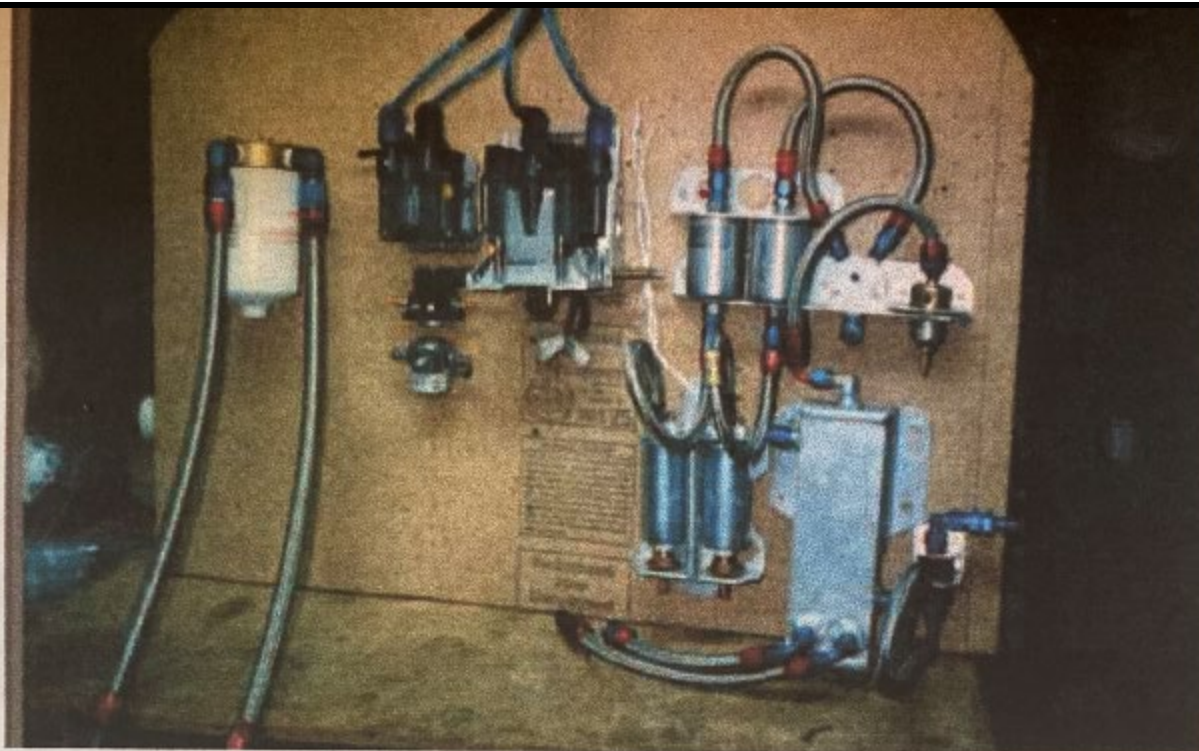
Figure 6: Excerpt from Builder's Manual

The following information was in the original paperwork for the airplane build, but it is unknown what the pilot had done or if he modified the fuel system further.

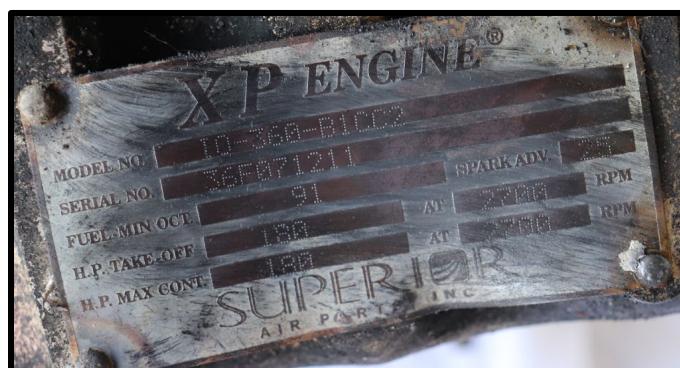
Figure 11: Data Plate on Engine

The Superior XP-IO360-B1CC2, serial number 36F071211, was installed on the airplane in 2013 by the original builder.<sup>1</sup> The ignition system consisted of one Slick magneto and one Light Plasma III ignition. The engine was outfitted with Vetterman exhaust.

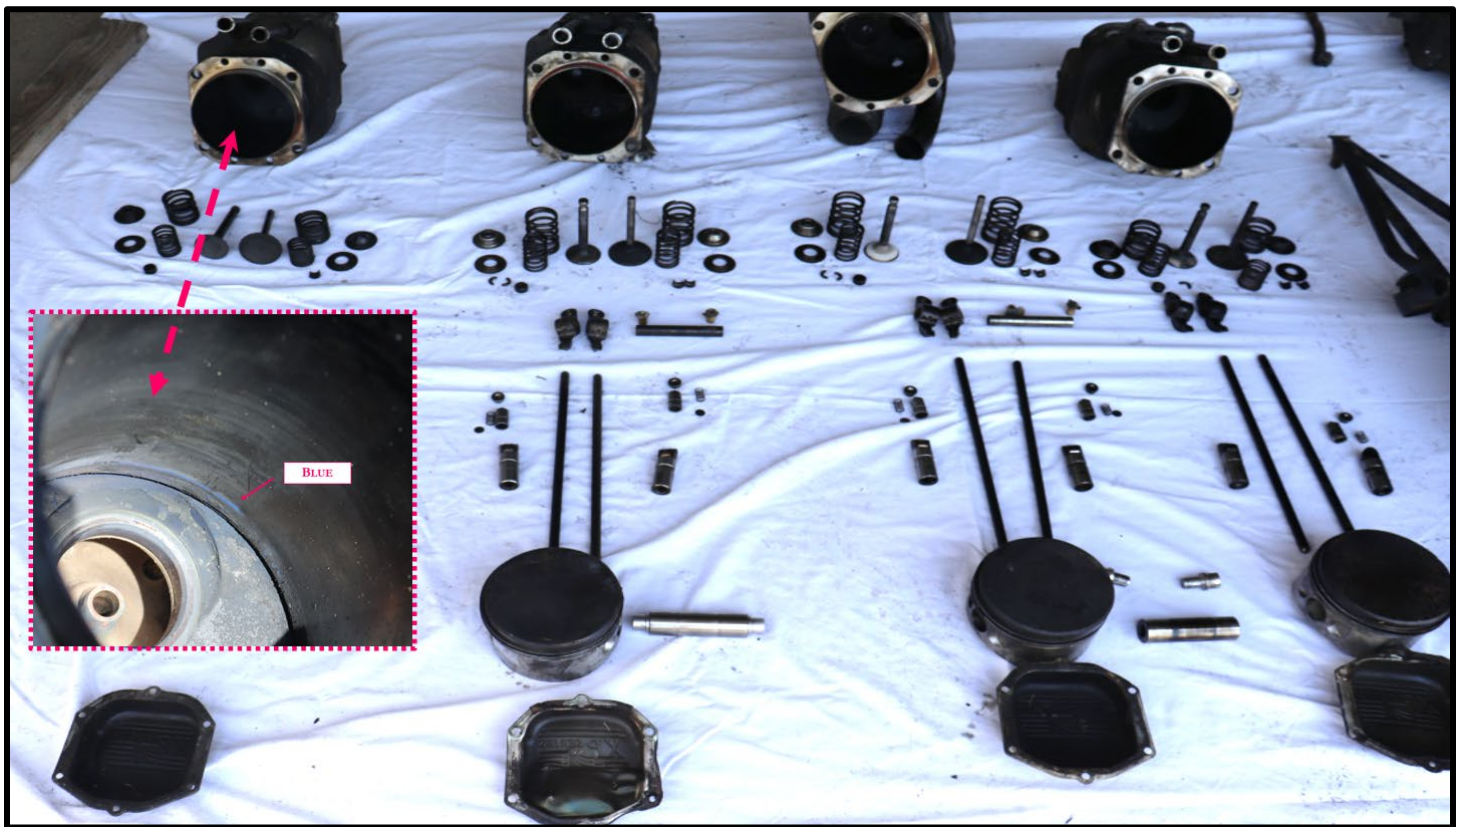
Figure 13: Engine Internal Components

The crankshaft, idler gear, and camshaft gears were all aligned with their respective marks aligning. The oil pump was disassembled revealing intact gears; the pump rotated freely.

The thermal exposure appeared to be more extensive on the Nos. 1 and 3 cylinders. The bearings were free of wear and no fretting was observed. The crankshaft was intact and the connecting rods remained secured with a dark coloration consistent with thermal damage.

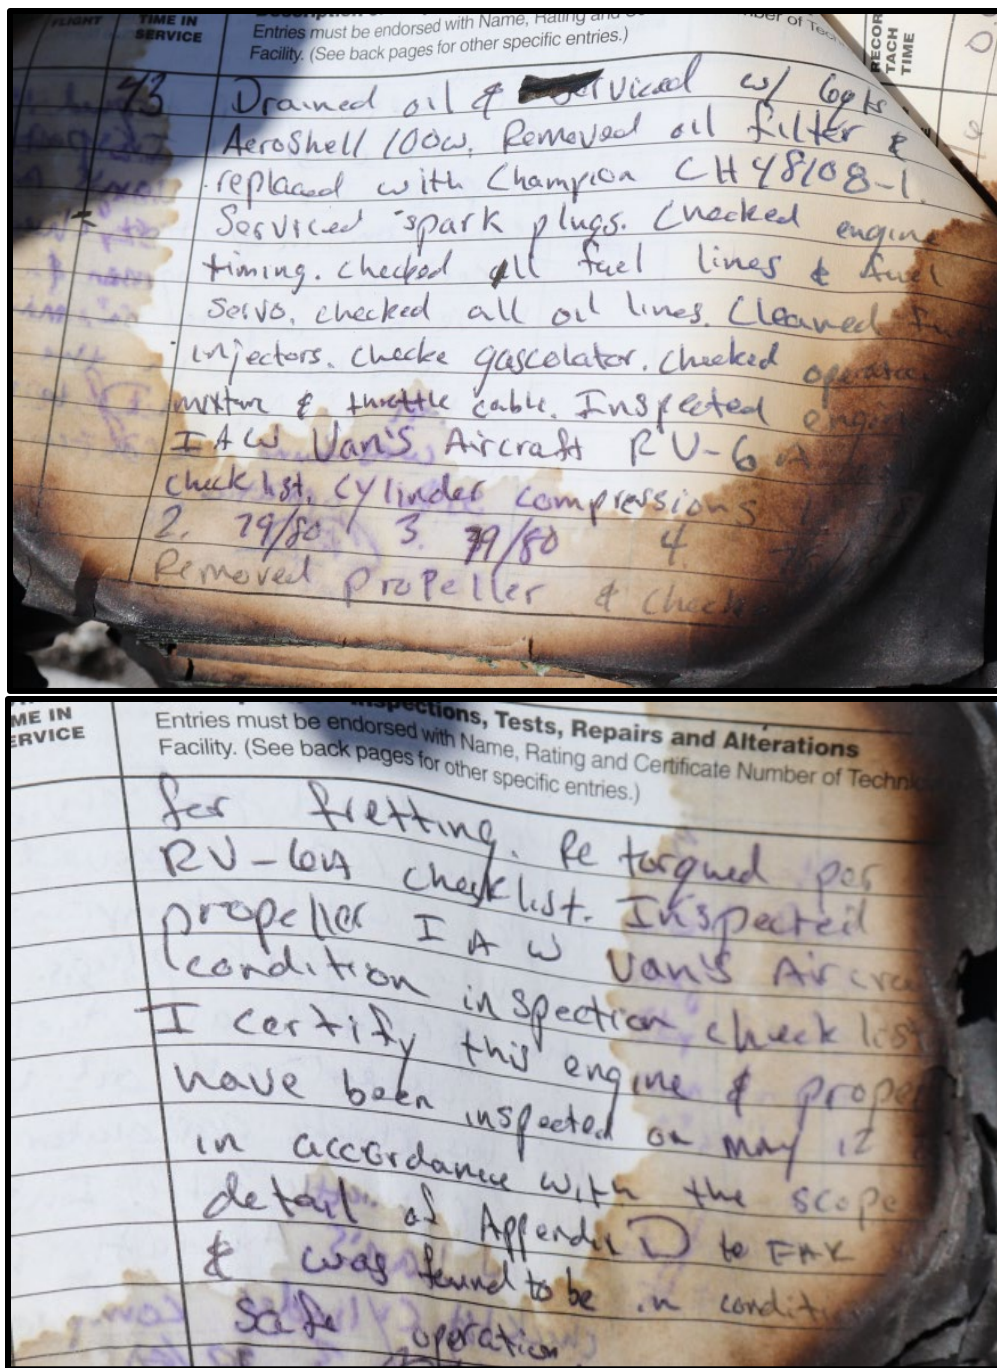
Figure 17: Excerpts of Logbooks

Partially burned maintenance logbooks were found. The first entry in the engine logbook indicated that engine was installed with an Airflow Performance injection, 1 Slick Magneto, 1 Light Plasma III ignition, a Sky-Tec starter, a Vetterman exhaust and a Catto propeller. The next entry indicated that at an engine time of 43 hours, the following work was done:
