## **NATIONAL TRANSPORTATION SAFETY BOARD**

# **AIRFRAME AND ENGINE EXAMINATION**

**WPR21FA243**

Aircraft: N62EF / Progressive Aerodyne, SeaRey LSX, S/N: 1MK480C

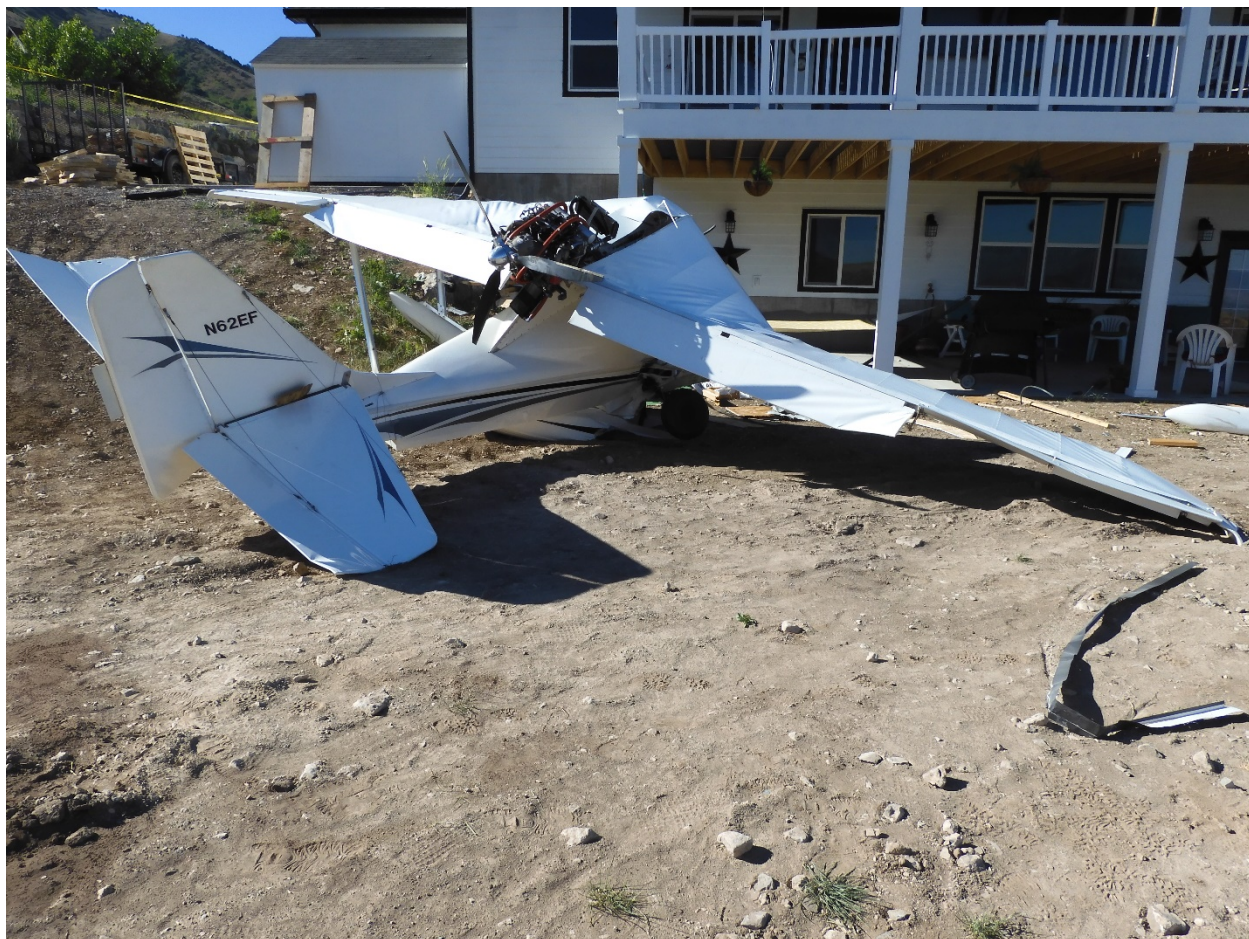
Fuselage. The boat hull fuselage was constructed of composite material and fractured at a point near the bulkhead just aft of the pilot's seats. The forward portion, including the cockpit area was underneath the aft portion of the fuselage and required removal of the right wing to reposition the forward section of the fuselage for examination. There were multiple dents, tears, scratches and deformations near the forward section of the fuselage. The battery remained attached in the forward section of the fuselage and was removed. The aft section of the fuselage, from the break at the bulkhead, to aft, displayed multiple dents and gouges.

**Figure 4. Right-rear view of N62EF**

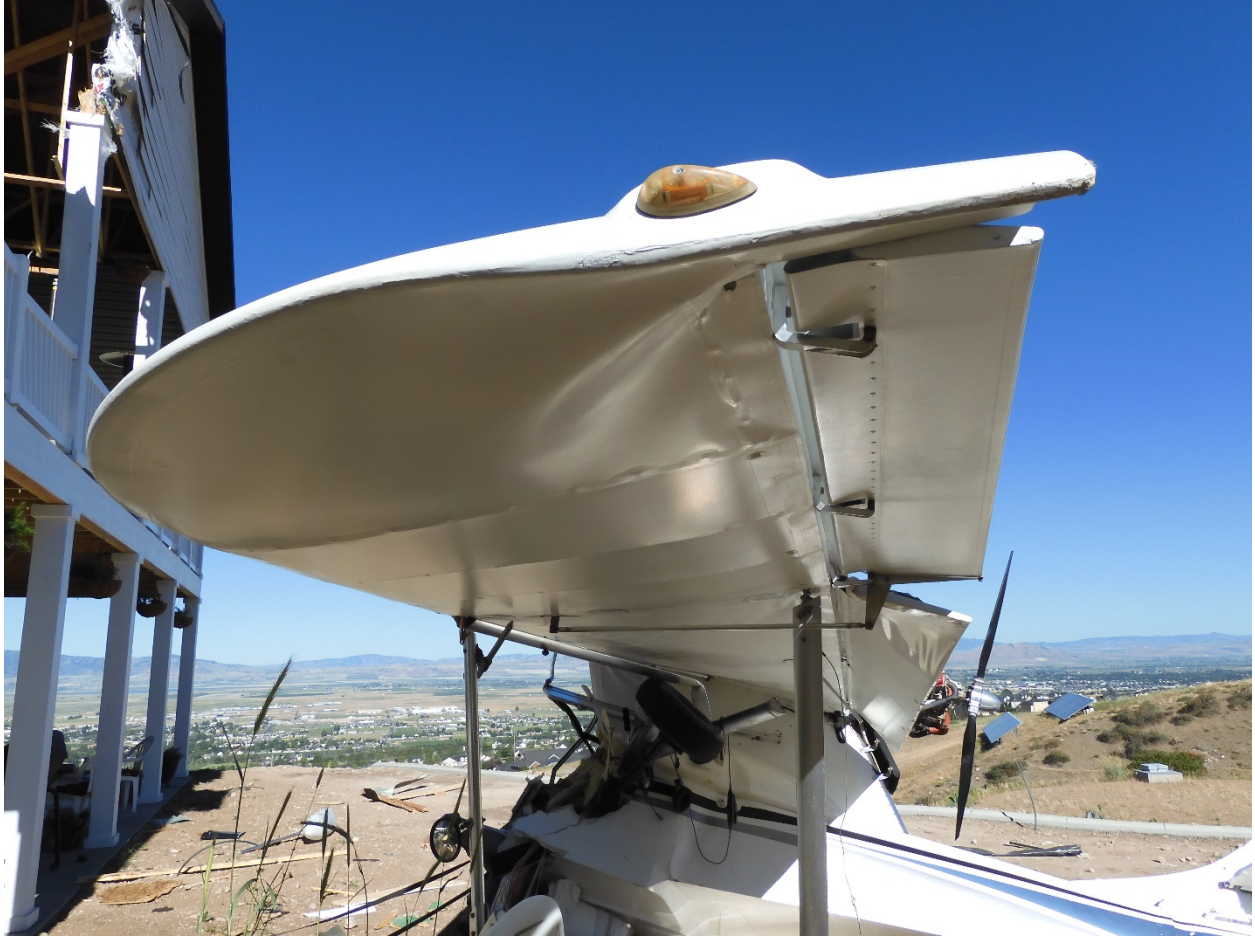
Left Wing. The left wing and all components of the wing remained attached to the fuselage. The upper and lower fabric had wrinkles, tears and small rips throughout. The leading edge displayed multiple dents and deformations. Both wing struts remained attached at the wing but had separated from the fuselage. The left-wing float remained attached to the wing. The left aileron remained attached to the wing and displayed minor damage. The aileron would not articulate up or down. The left flap remained attached to the wing at the hinges and appeared to be about 45° flap extended. The flap had slight bending and surface skin wrinkling.

**Figure 5. Left-side view, under the wing**

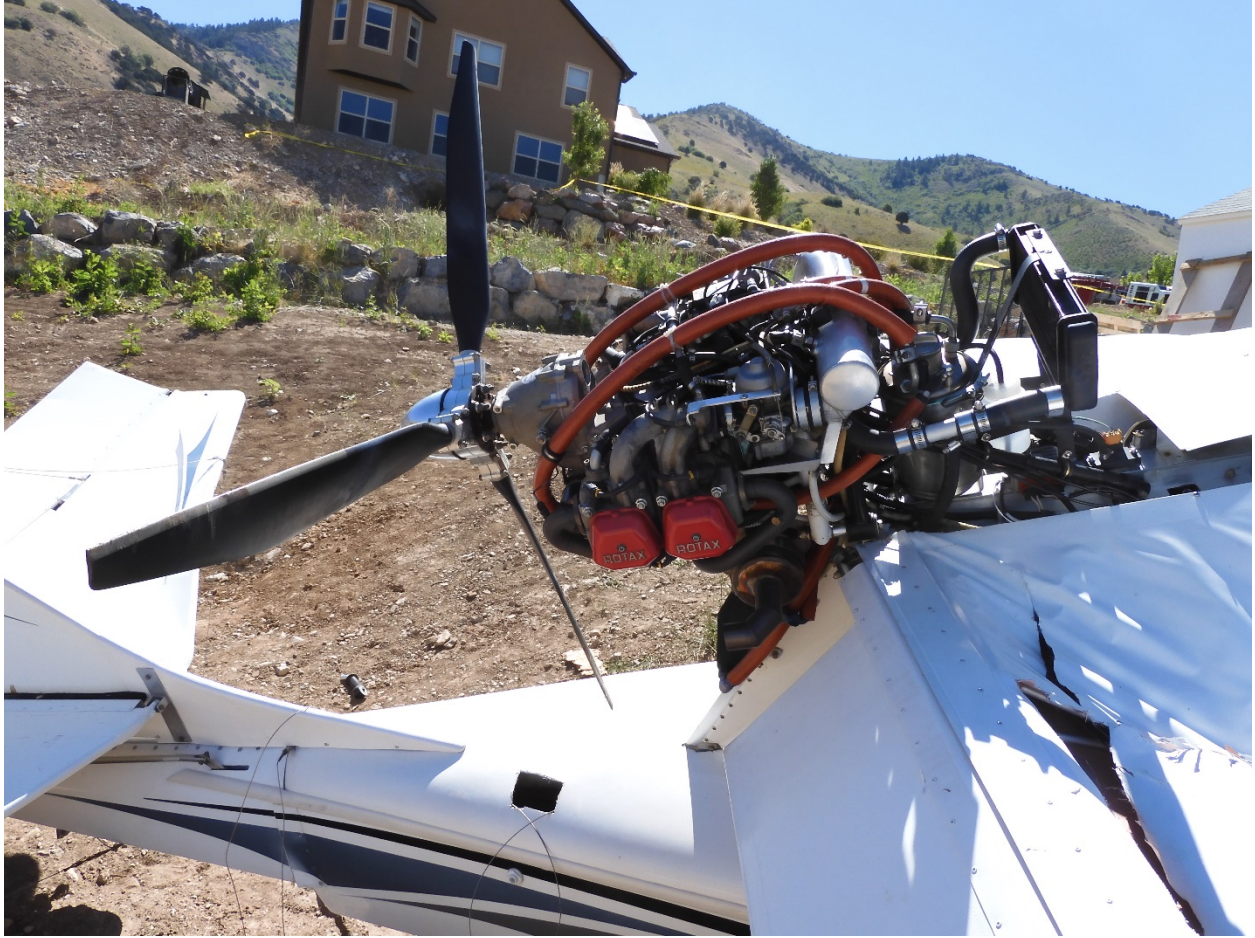
The engine remained attached to the fuselage at the engine mount. A visual examination revealed all components of the engine remained attached and appeared normal with no mechanical anomalies noted. Compression of all four cylinders was established. Oil remained in the oil reservoir.

**Figure 9. Right-side view of the engine.**

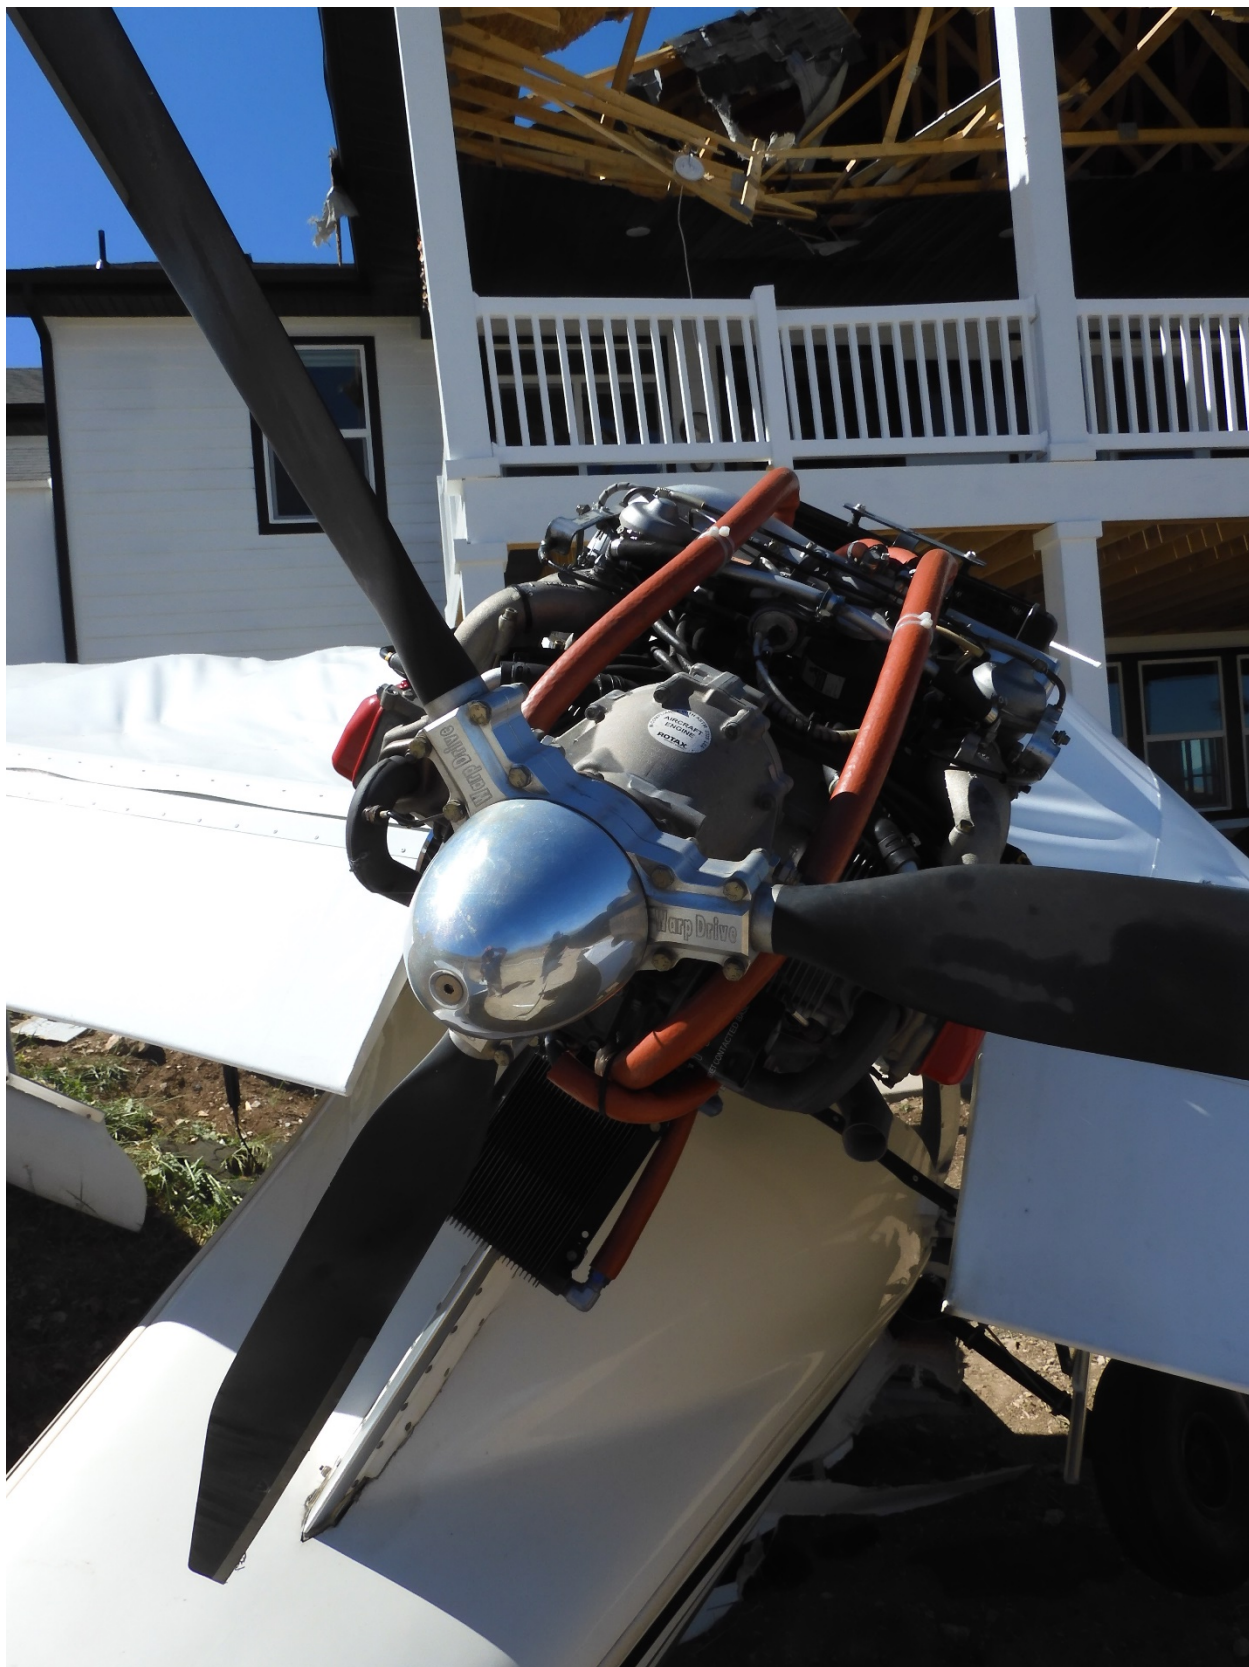
**Figure 10.**Rear view of the engine.

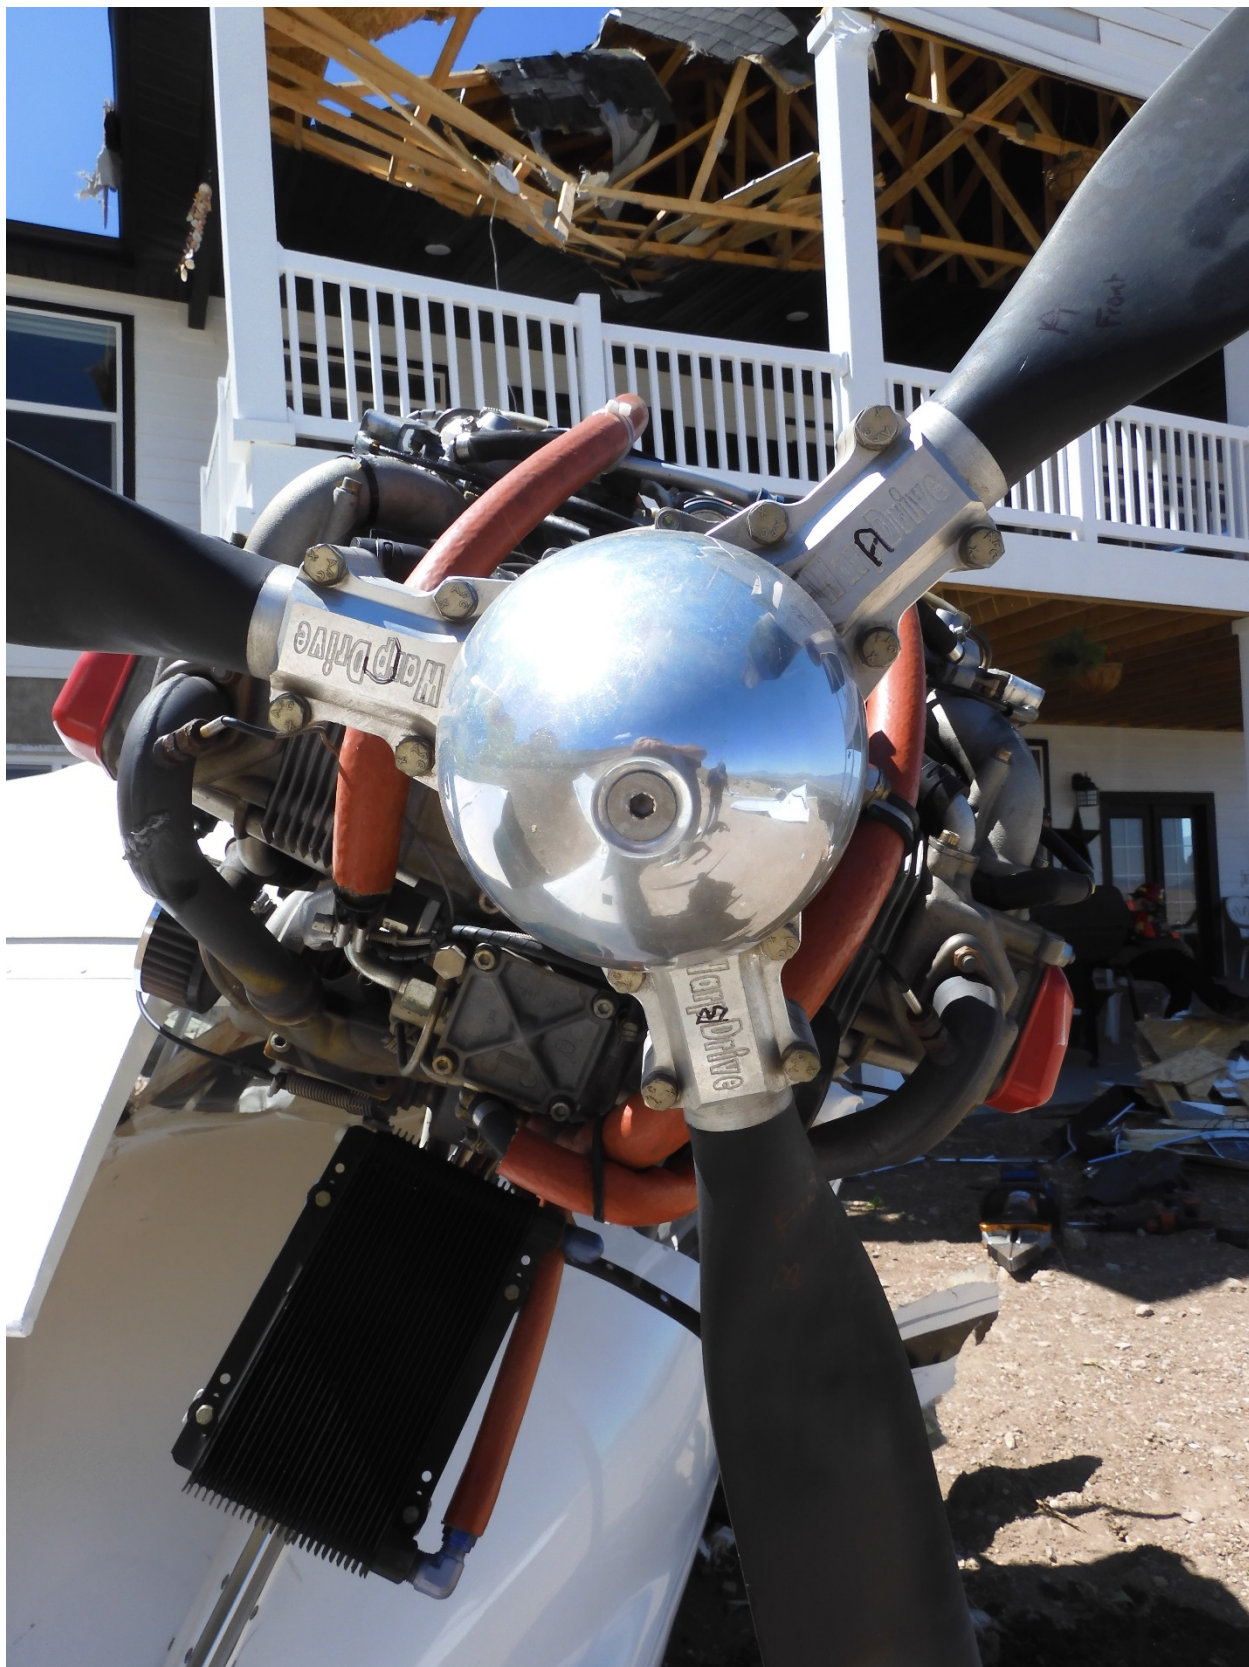
Propeller. The propeller remained attached to the propeller hub and displayed minor contact damage at the tips of the three blades. There was no other blade damage noted.

**Figure 11. Propeller hub.**
