**National Transportation Safety Board**  
Office of Research and Engineering  
Washington, D.C. 20594

## Airplane Performance Study

**Location:** Billings, Montana  
**Date:** October 30, 2020  
**Time:** 0105 GMT (1905 MDT)  
**Airplane:** Cessna 172M Skyhawk, N124TW  
**NTSB Number:** WPR21LA032

### **WPR21LA032, N124TW, Cessna 172M Skyhawk, October 30, 2020**

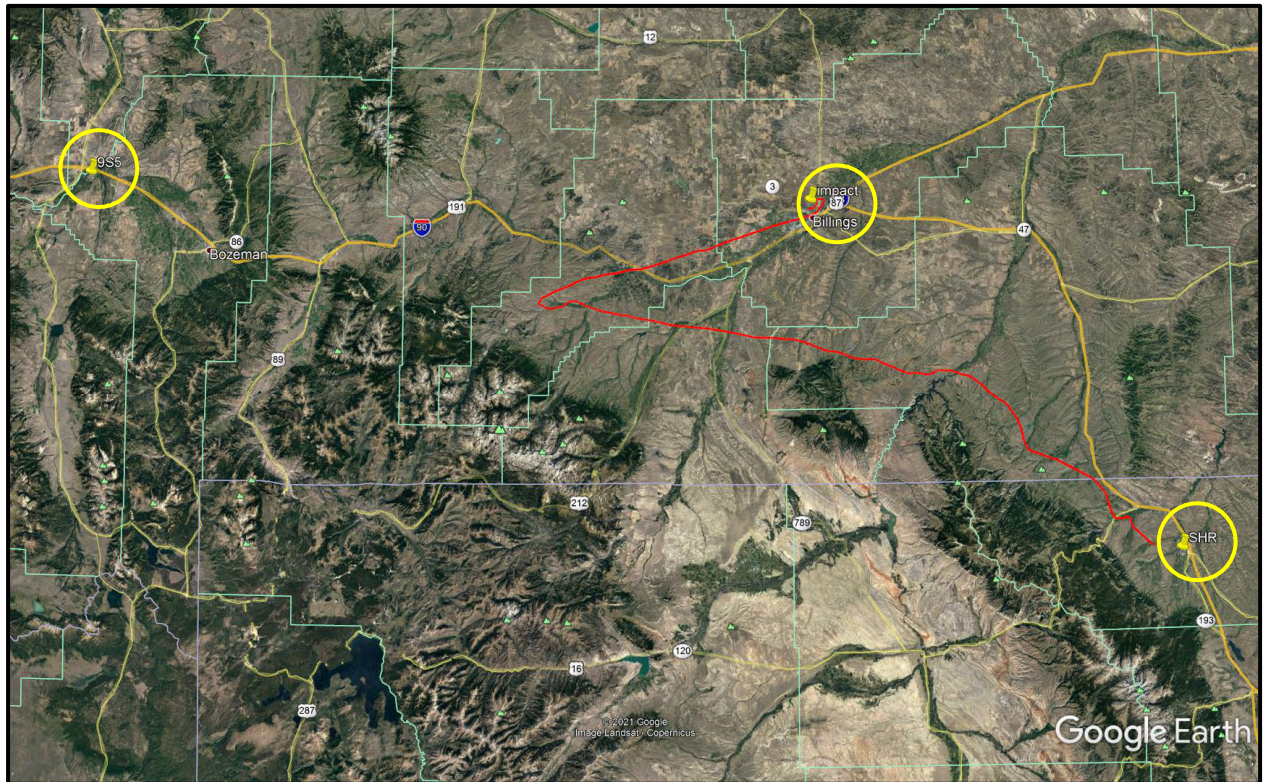
**Figure 1: Accident-leg Intended from Sheridan County airport (SHR), Sheridan, WY, to Three Forks airport (9S5), Three Forks, MT, but Diverted to Billings, MT**

The flight originated in Dallas, Texas, with multiple intermediate stops along the way. The accident-leg initiated from Sheridan County airport (SHR) in Sheridan, Wyoming, which has an airport elevation of 4,021 feet (ft) msl, and the pilot's planned destination was Three Forks airport (9S5) in Three Forks, Montana. (See Figure 1.)

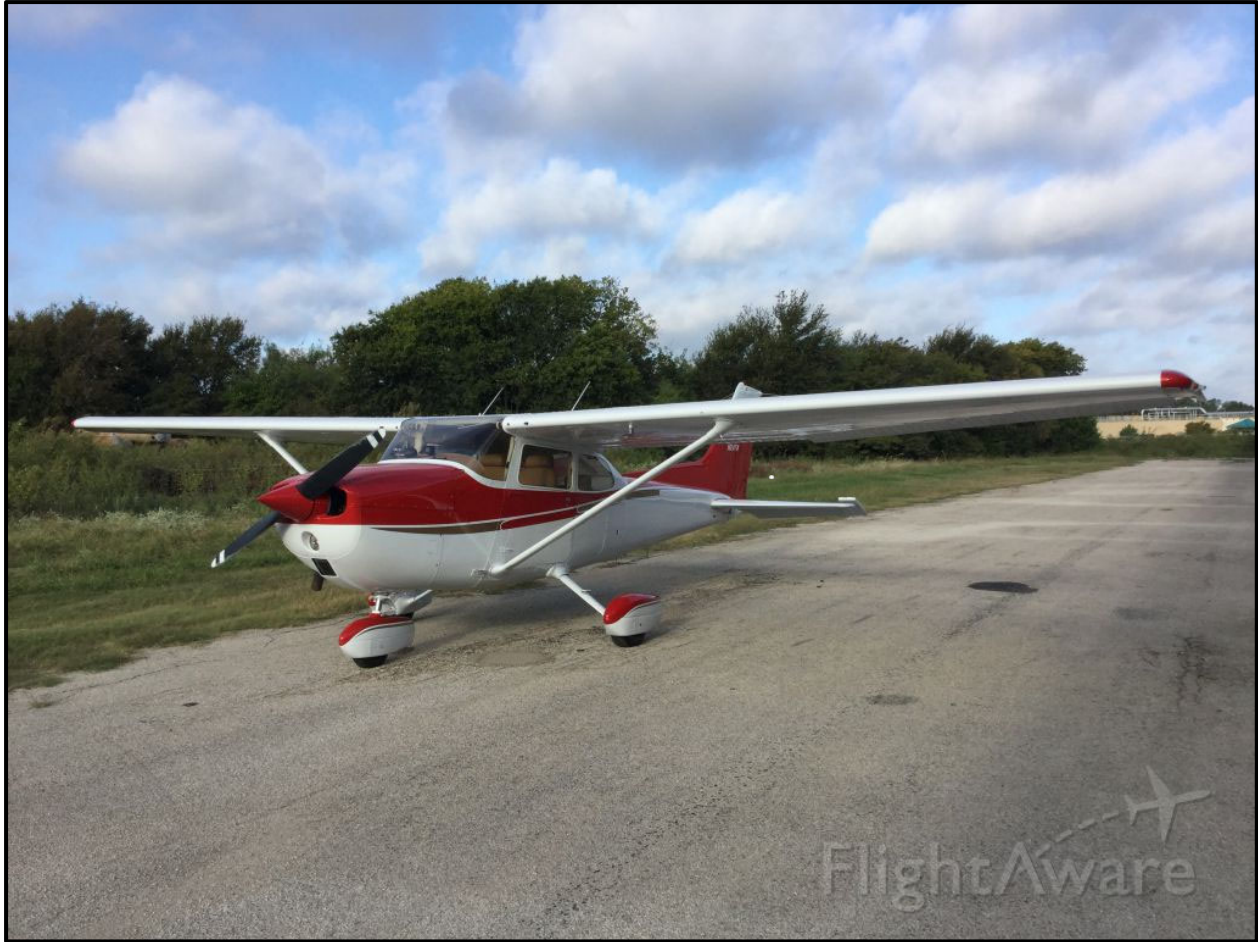
**Figure 2: Accident Airplane, N124TW, a Cessna 172M Skyhawk**

A picture of the accident airplane, a Cessna 172M Skyhawk, is shown in Figure 2. The airplane was manufactured by Cessna in 1975 and registered to the accident pilot.

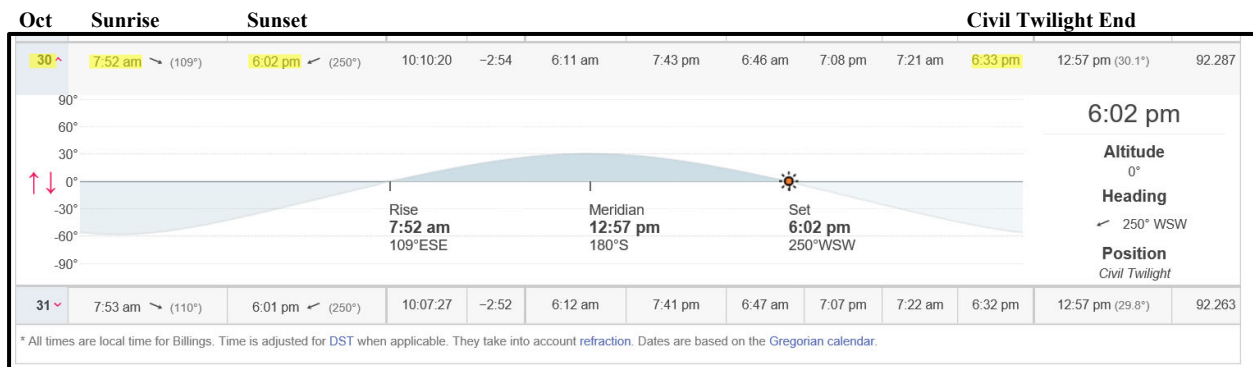
**Figure 10: Sunrise and Sunset Times in Billings, MT, on the Day of the Accident**

<sup>4</sup> Title 14 CFR Section 1 defines night as the time between the end of evening civil twilight and the beginning of morning civil twilight. The end of evening civil twilight in Billings, Montana, was at 6:33 pm MDT on the day of the accident. See Figure 10.
