## **A109S N109EX – Wreckage Survey Follow-up** **Los Angeles (CA, USA)**

*December 23, 2020*

# A109S N109EX – Wreckage Survey Findings

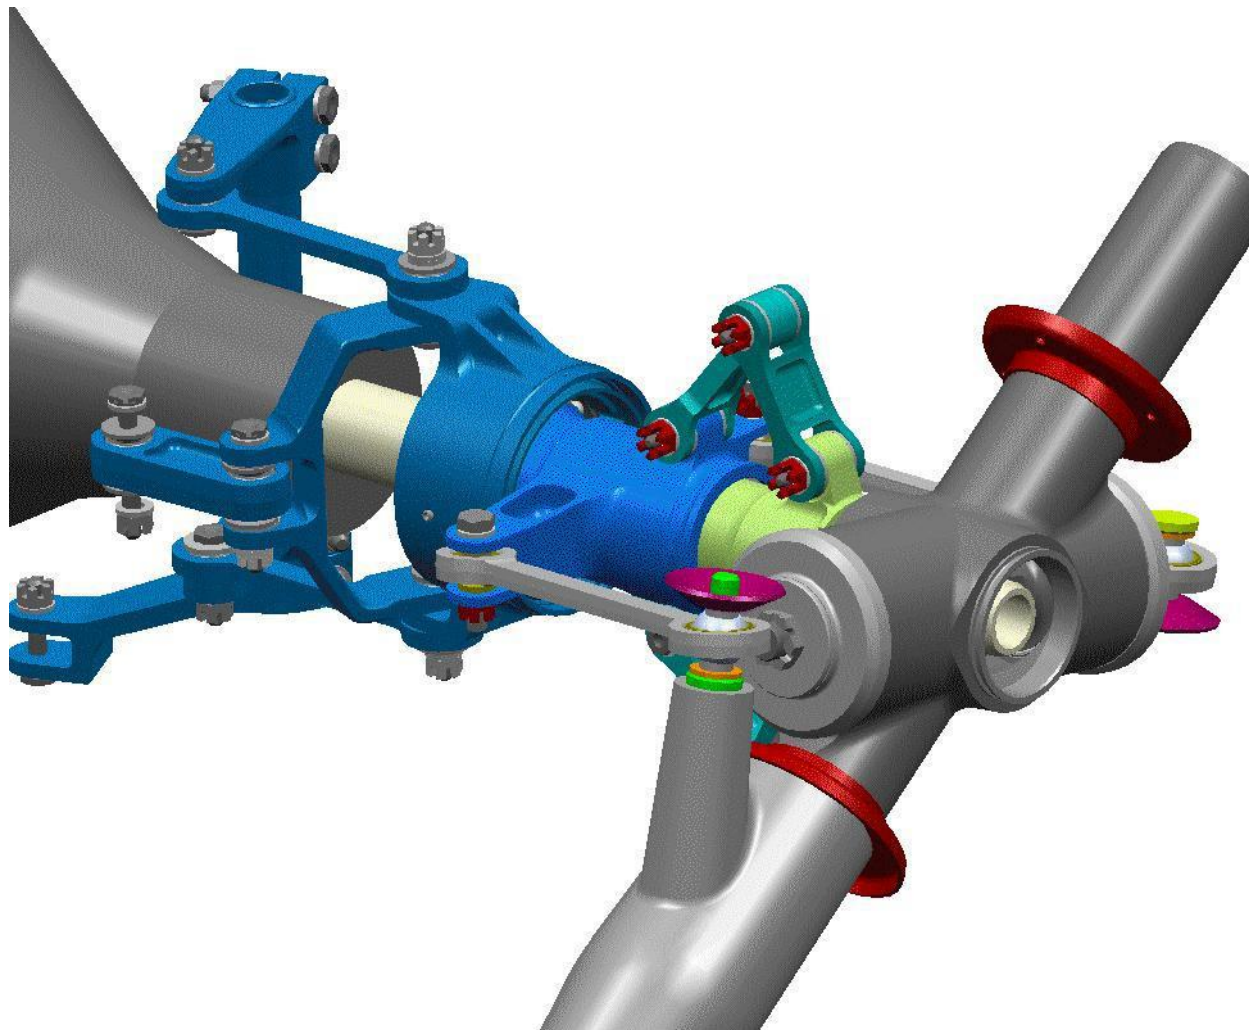
# TAIL ROTOR ROTATING CONTROLS INSTALLATION

- The DAU was removed and prepared for shipping for data download.
  - Tail rotor assembly, rotating controls, and 90° gearbox were visually examined. The examination of the rotating controls revealed a ring nut (possibly part 109-0130-97-103) separated from the sleeve (possibly 109-0130-94-111). See enclosed photo. The 90° gearbox, tail rotor assembly, minus the paddles, and rotating controls were prepared for shipping to the NTSB Materials Lab for further examination.
