## **NATIONAL TRANSPORTATION SAFETY BOARD**

# **AIRFRAME AND ENGINE EXAMINATION**

**WPR21LA039**

Location: Los Angeles, California  
Date: November 6, 2020  
Aircraft: Agusta 109S / N109EX  
NTSB IIC: Fabian Salazar

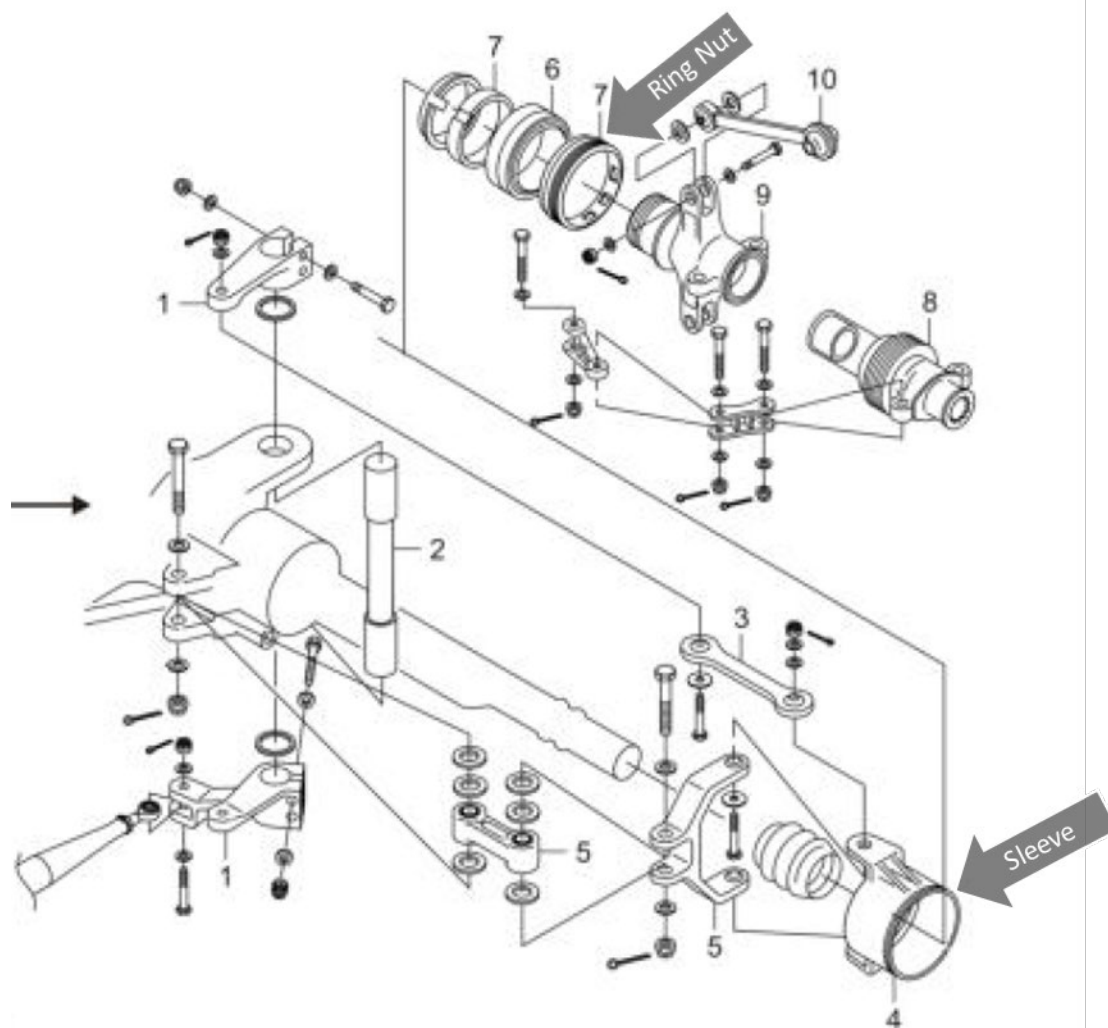
Figure13. Illustration of the rotating controls. The arrows point to the ring nut and thrust sleeve. Illustration courtesy of the airframe manufacturer.
