## INVESTIGATION SUPPLEMENTAL MATERIAL

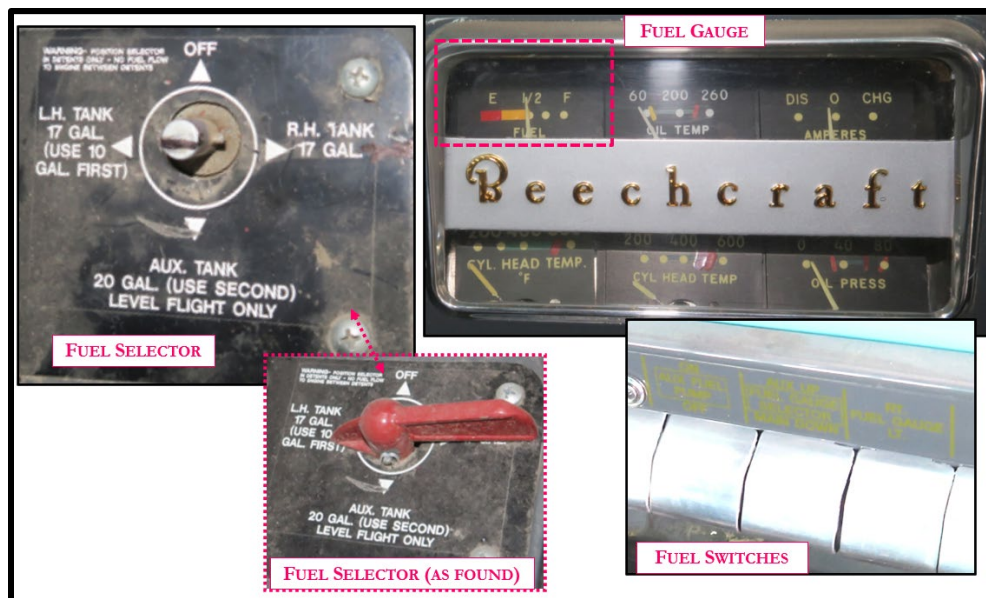
Figure 2: Fuel Selector and Fuel Gauge Switches

Individual electric sending-units were installed in all tanks, transmitting fuel quantity information to the sole cockpit gauge. The fuel level of either cell was designed to be reflected on the fuel gauge in the cockpit by the pilot switching the auxiliary fuel gage selector switch on the left subpanel to "AUX" or "MAIN" position and the "FUEL GAUGE" switch to the desired right or left position.

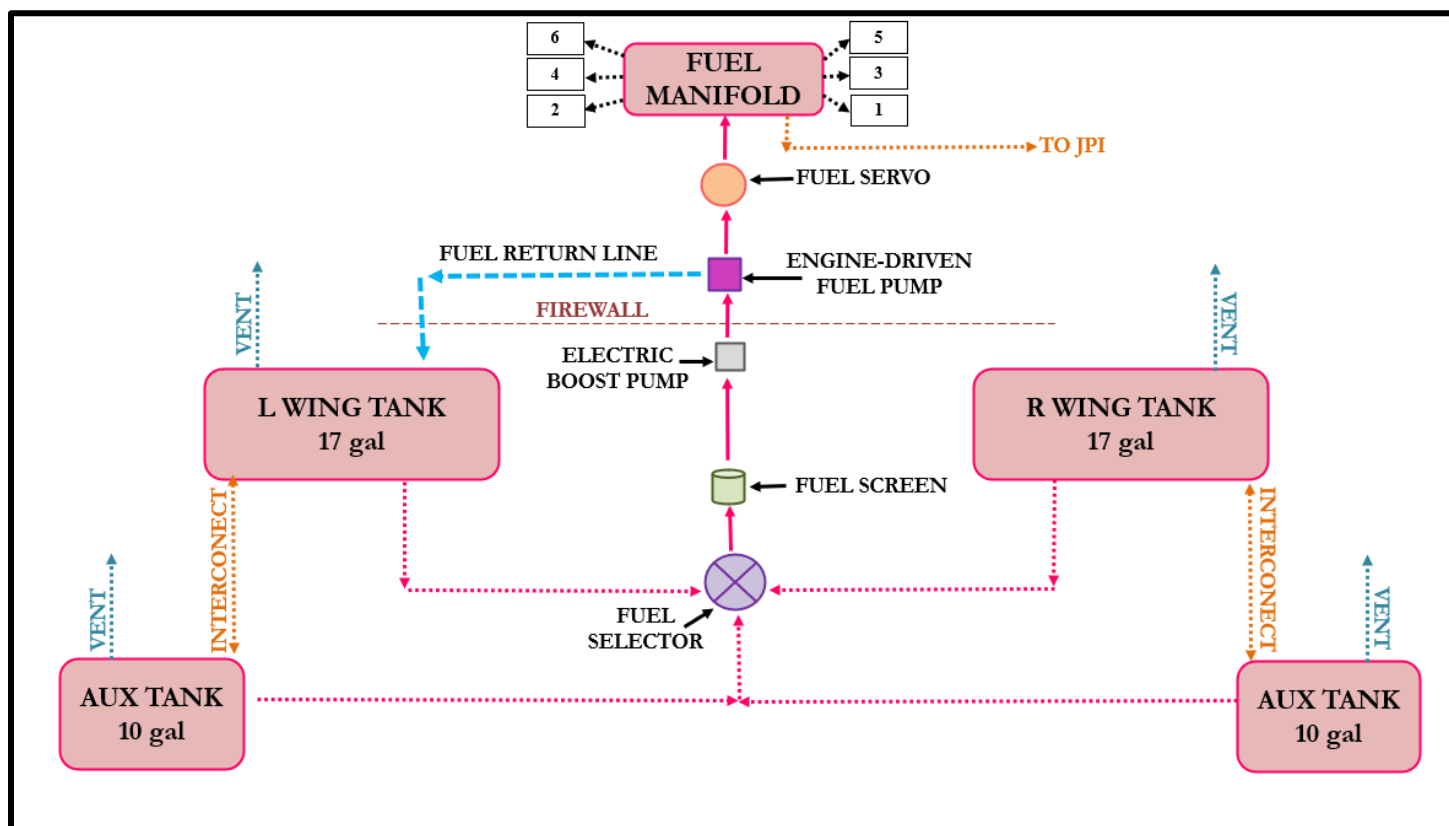
Figure 3: Fuel System Diagram

From the fuel selector, the fuel was plumbed to the electric-driven fuel pump and then through the firewall to the engine-driven fuel pump. From the fuel pump, the fuel was routed to the servo. The fuel then continued to the manifold (mounted on top of the engine), where it was divided to each cylinder through GAMI injectors.
