April 20, 2021

### Evolution Door Latch Advisory:

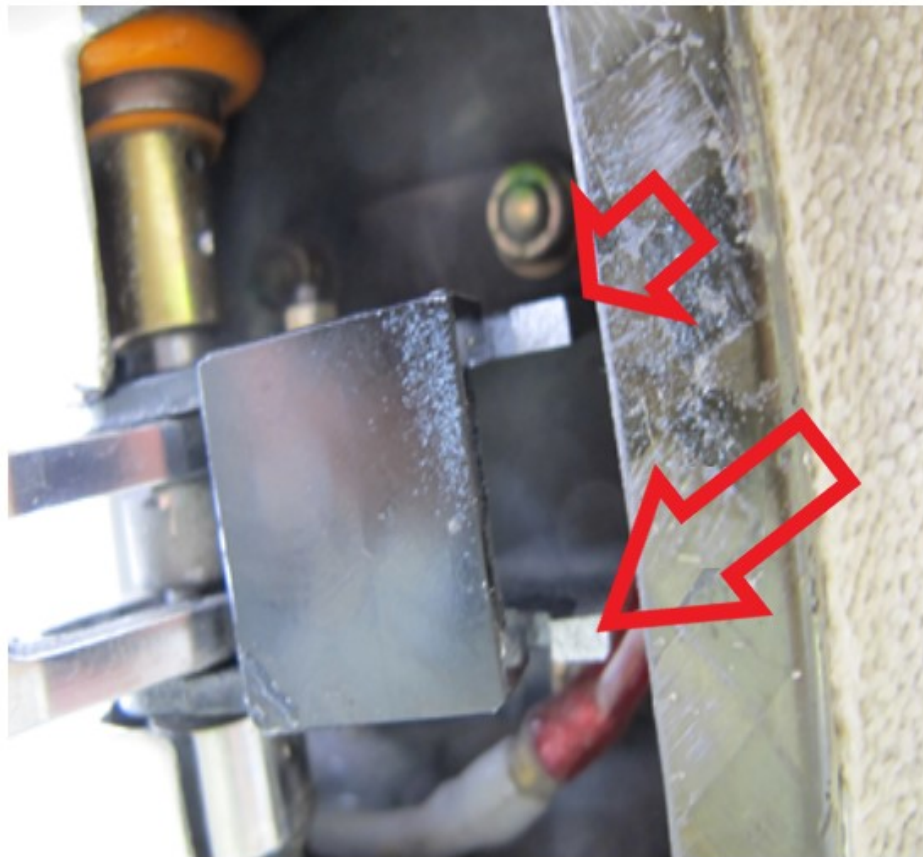
Before the next flight ensure that all seven latch balls fully seat in their sockets. You may have to remove the pilot seat to assess that they do seat properly. There should be no clearance

between the ball and socket. This can be determined using a feeler gauge and a flashlight. Be aware that temperature differences can influence the ball and socket fit—so if your locale experiences wide temperature swings ensure you check ball and socket fit again when temperatures swing.

Before takeoff on every flight ensure that the balls are correctly seated (refer to your Pilot Operating Handbook). Additionally, ensure no clothing, cords, or other items become trapped between the ball and socket when you close the door. This interference will also contribute to a latch failure. Additionally make sure that you do not inflate your door seal prior to fully engaging the door lock system.
