## **NATIONAL TRANSPORTATION SAFETY BOARD**

# **AIRFRAME AND ENGINE EXAMINATION**

**WPR21LA292**

Location: Mt. Hood, OR.  
Date: July 23, 2021  
Aircraft: Cessna 180 / N8884  
NTSB IIC: Fabian Salazar

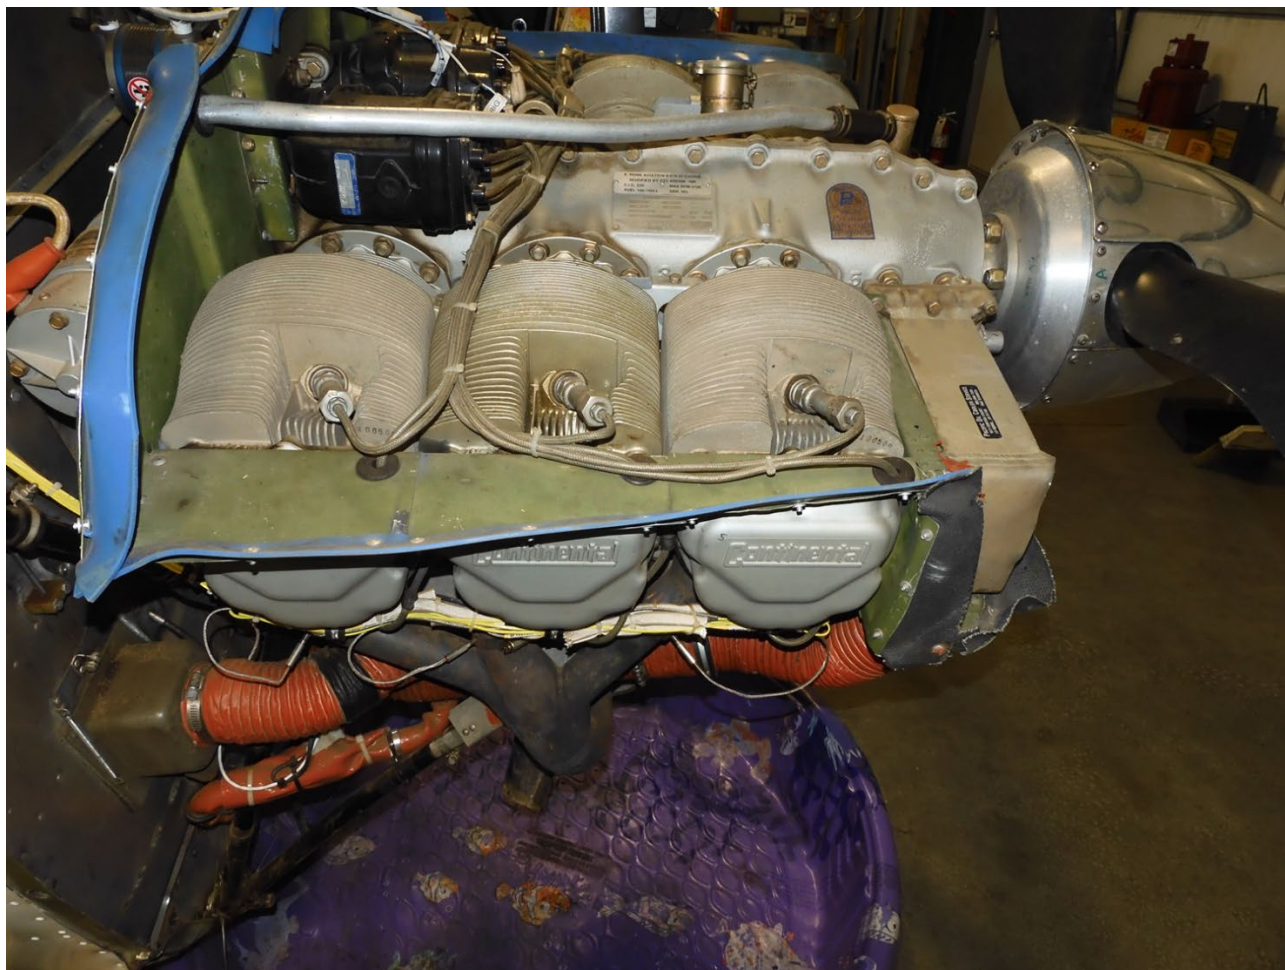
The engine remained secured to the fire wall by three of the four engine mounts. There was no damage to the engine or engine-mounted components. The fuel line from the gascolator remained secured to the gascolator to the fuel flow transducer and the second line from the fuel flow transducer to the carburetor remained secured. The fuel lines had two 90° bends and one 180° bend. There were no leaks detected. A blue colored fluid with the smell of aviation gasoline was present in the fuel lines. No water was detected in the fuel lines, gascolator or the carburetor bowl.

Figure 5. Right-side view of the engine.

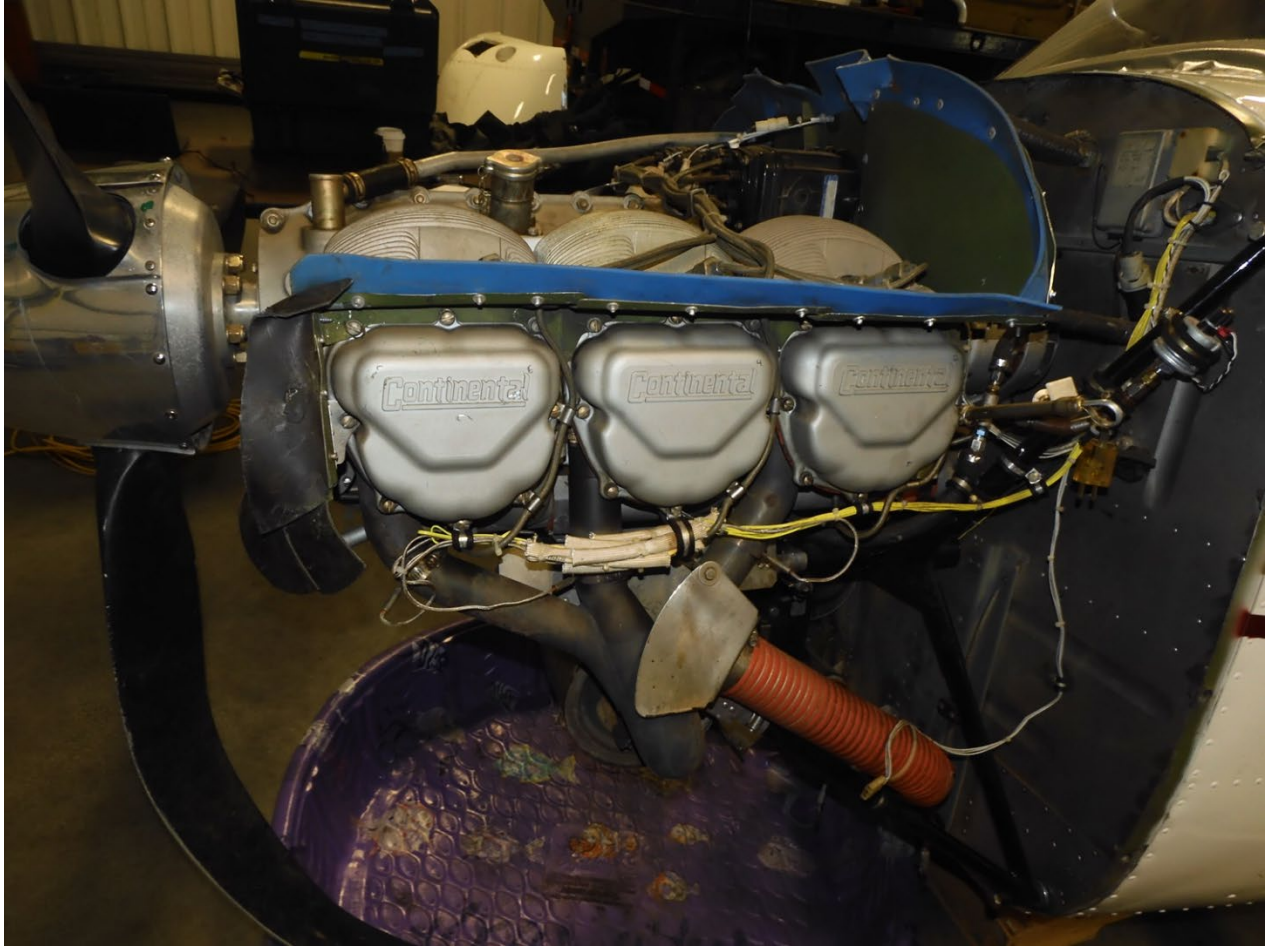
Figure 6. Left-side view of engine.

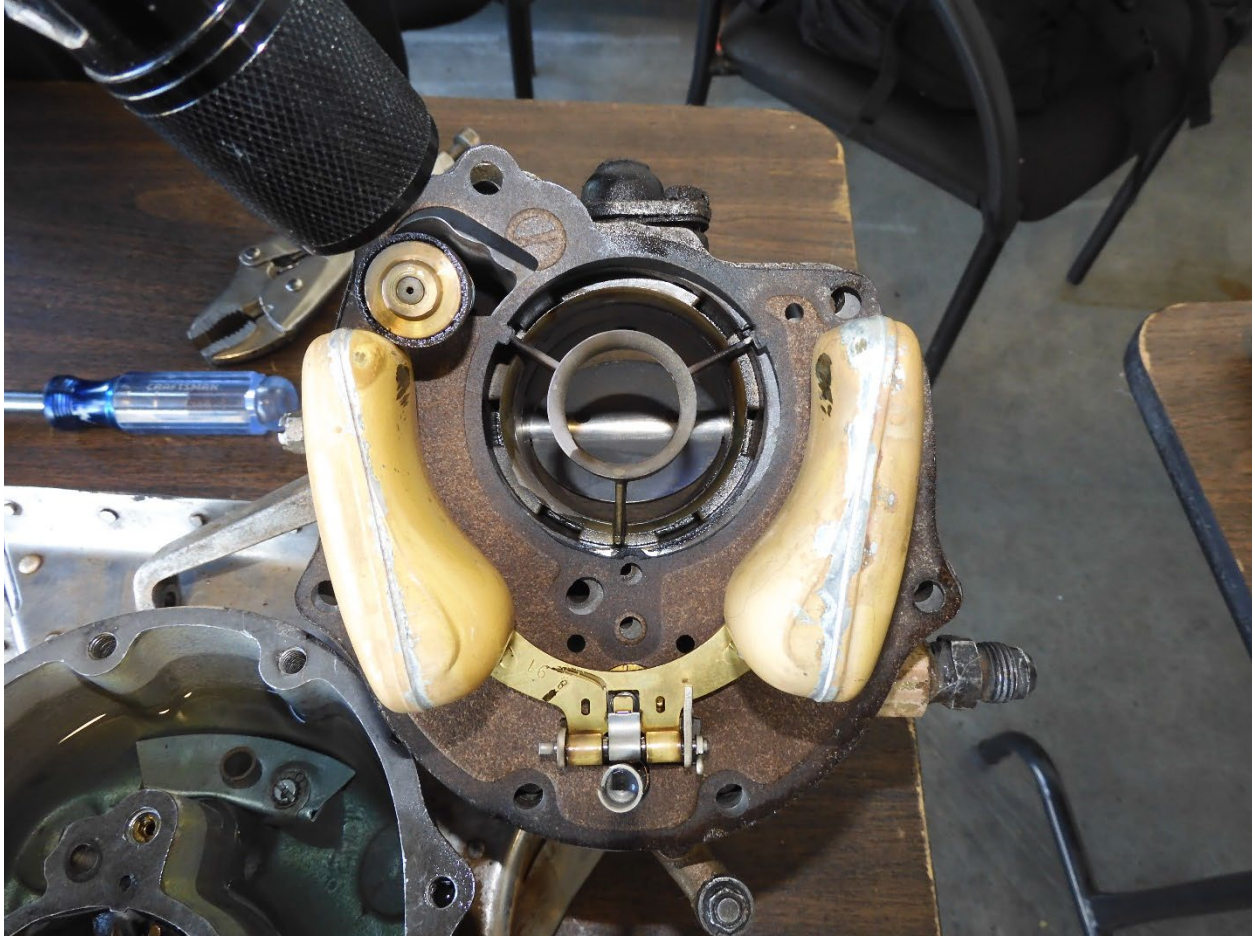
The engine was subsequently test run for ten minutes up to full power. The engine ran normally for the entire ten minutes with no anomalies observed or heard. After the engine run, the carburetor was removed and examined. There was no foreign debris found in the carburetor bowl.

Figure 9. Top end of the carburetor.
