# National Transportation Safety Board

WPR21LA325

## **COOLING SYSTEM EXAMINATION NOTES**

Location: Hanksville, Utah  
Date: August 16, 2021  
Time: 1515 Mountain daylight time  
Airplane: N133AC

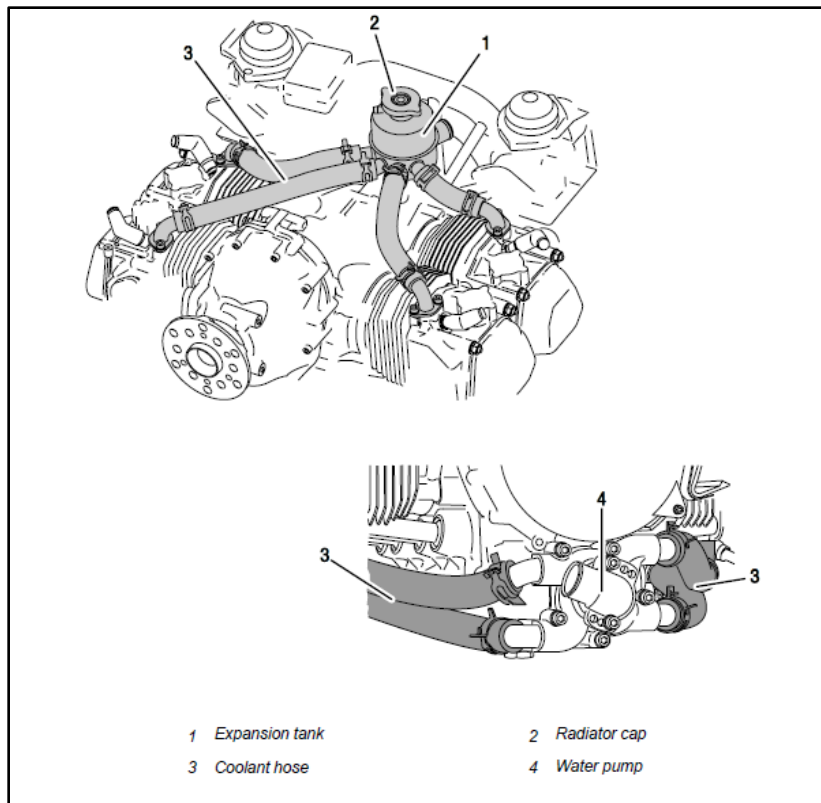
**Figure 3. Rotax 914 Cooling System Exemplar**

The expansion tank is closed with a pressure cap (with pressure relief valve and return valve). As the coolant heats up and expands, the pressure relief valve opens and the coolant flows via hose at atmospheric pressure to the transparent overflow bottle. As it cools down, the coolant is sucked back into the cooling circuit.

The temperature sensors are in cylinder head 2 and 3.

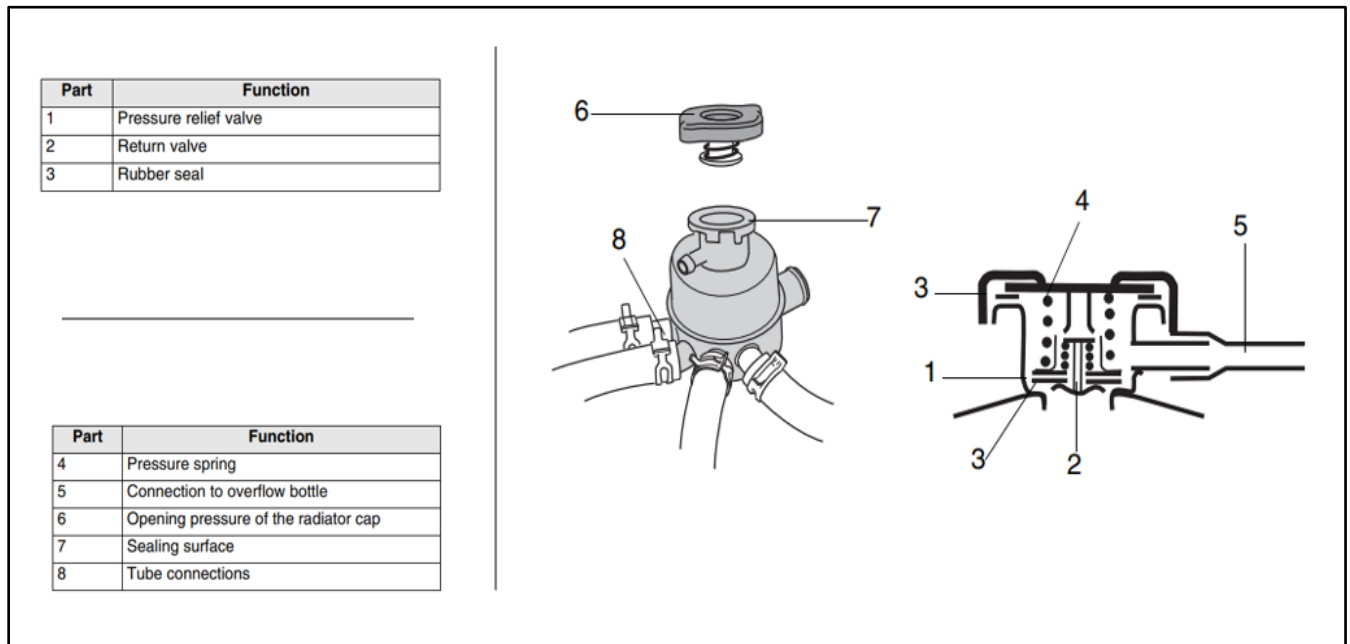
**Figure 8. Diagram of Rotax Radiator Pressure Cap**

The radiator caps were tested at an automotive radiator shop in Federal Way, WA in June 2022. The radiator caps were screwed onto an adapter, which connected to a compressor line. Compressed air was introduced to determine what the opening value was for the pressure relief valve. An audible air leak would be heard and according to the manufacturer, the pressure relief valve was to open at 1.2 bar or 18 psi. The test revealed that the original Rotax cap opened the valve at 12 psi with a corresponding audible air leak; conversely, the non-OEM accident radiator cap revealed that the valve opened at 3 psi, also with an audible leak.
