# National Transportation Safety Board

WPR22FA068

## **AIRPLANE PERFORMANCE GROUP**

Location: El Cajon, California  
Date: December 27, 2021  
Time: 1914 PST  
0314 GMT (December 28, 2021)  
Airplane: LearJet 35A, N880Z

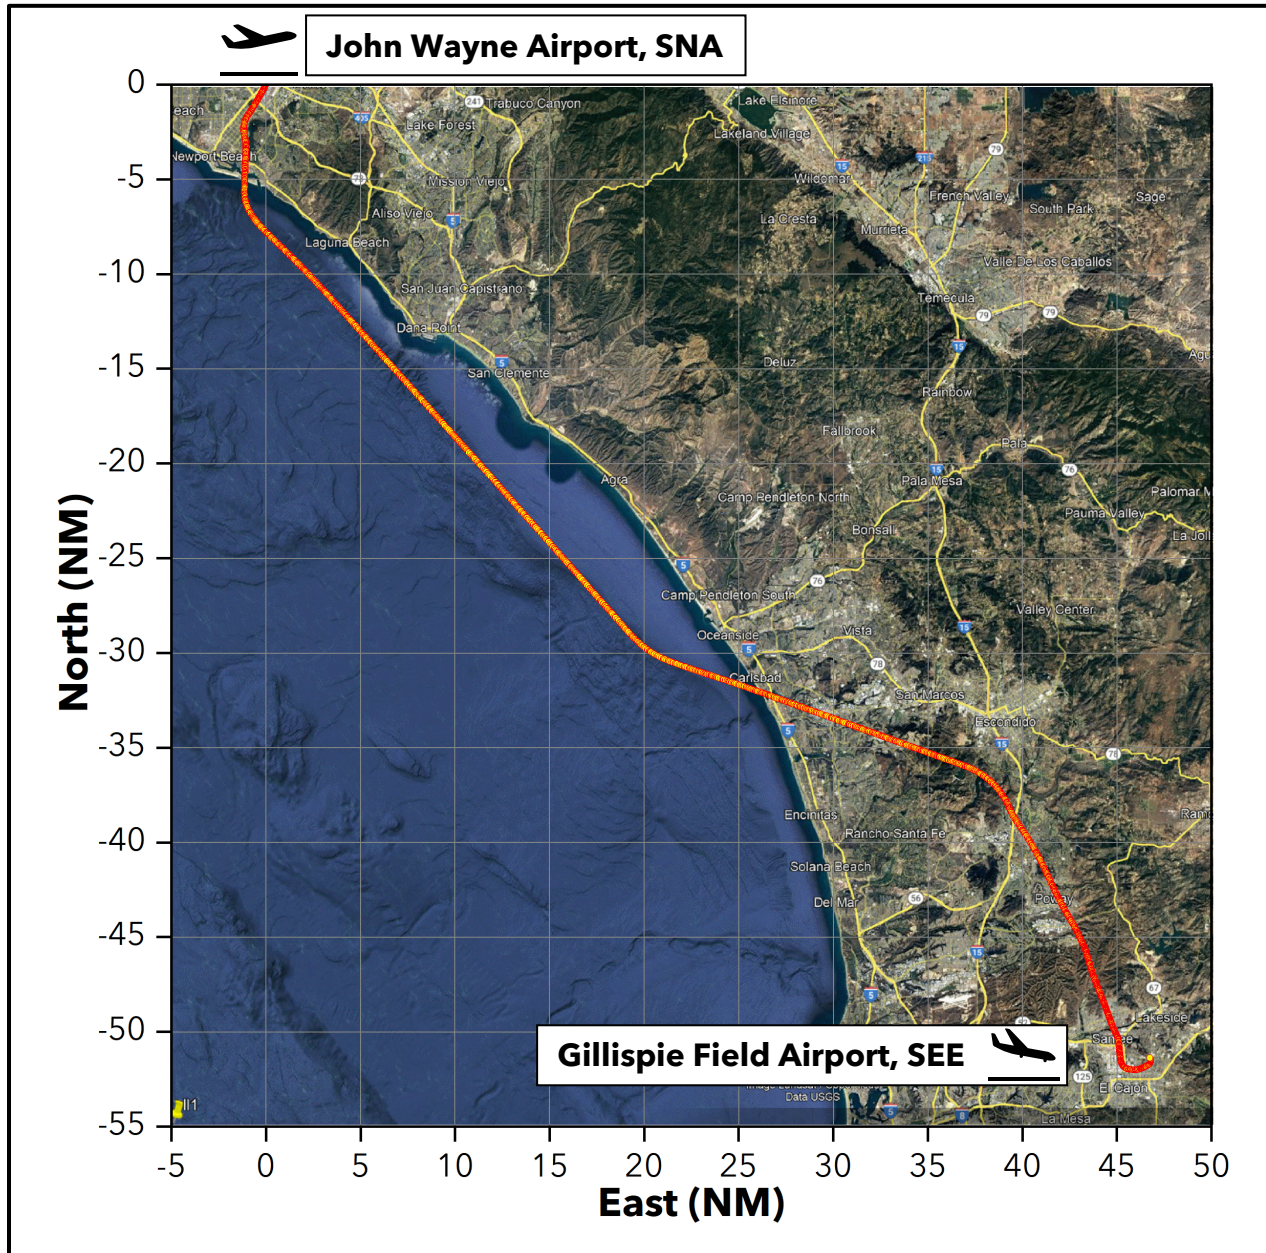
On December 27, 2021, about 1914 Pacific standard time (PST), a Gates LearJet Corporation 35A, N880Z, was destroyed when it was involved in an accident near El Cajon, California. The 2 pilots and 2 flight nurses were fatally injured. The airplane was operated as a Title 14 Code of Federal Regulations Part 91 repositioning flight on an instrument flight rules (IFR) flight plan. See Figures 1 and 2.

**Figure 1: ADS-B Ground Track of Accident Flight from SNA to SEE**

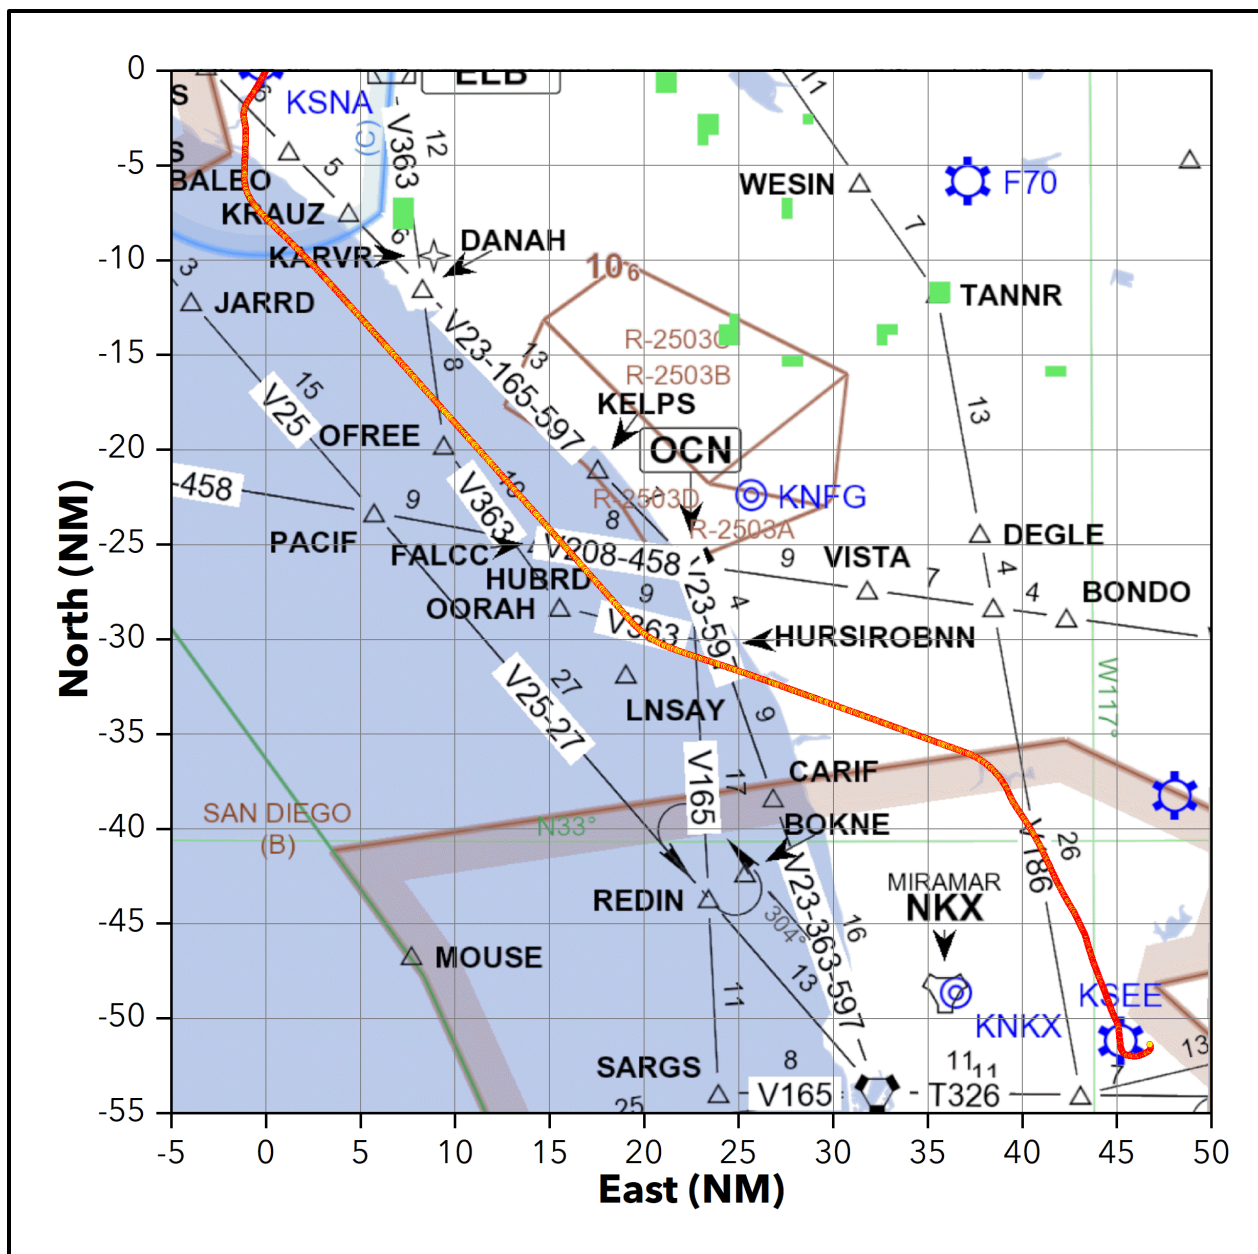
**Figure 2: ADS-B Ground Track of Accident Flight from SNA to SEE on Low Altitude Enroute Chart**

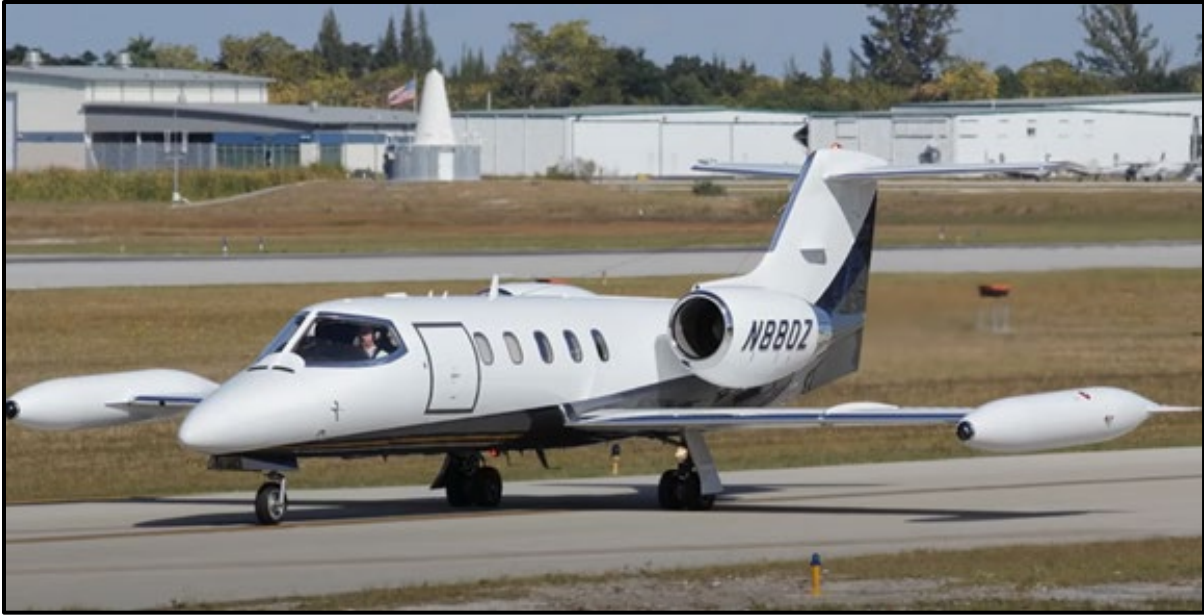
A picture of the accident airplane, a LearJet 35A, is shown in Figure 3. The airplane was manufactured in 1985 and is registered to Med Jet, LLC.

**Figure 3: Accident Airplane, N880Z, a LearJet 35A,  
Manufactured 1985**
