## **NATIONAL TRANSPORTATION SAFETY BOARD**

# **ACCIDENT SITE EXAMINATION SUMMARY REPORT**

**WPR22FA100**

Location: White Hills, Arizona  
Date: February 19, 2022  
Aircraft: N787NV; Vans RV-7  
NTSB Investigator-in-Charge: Andrew Swick

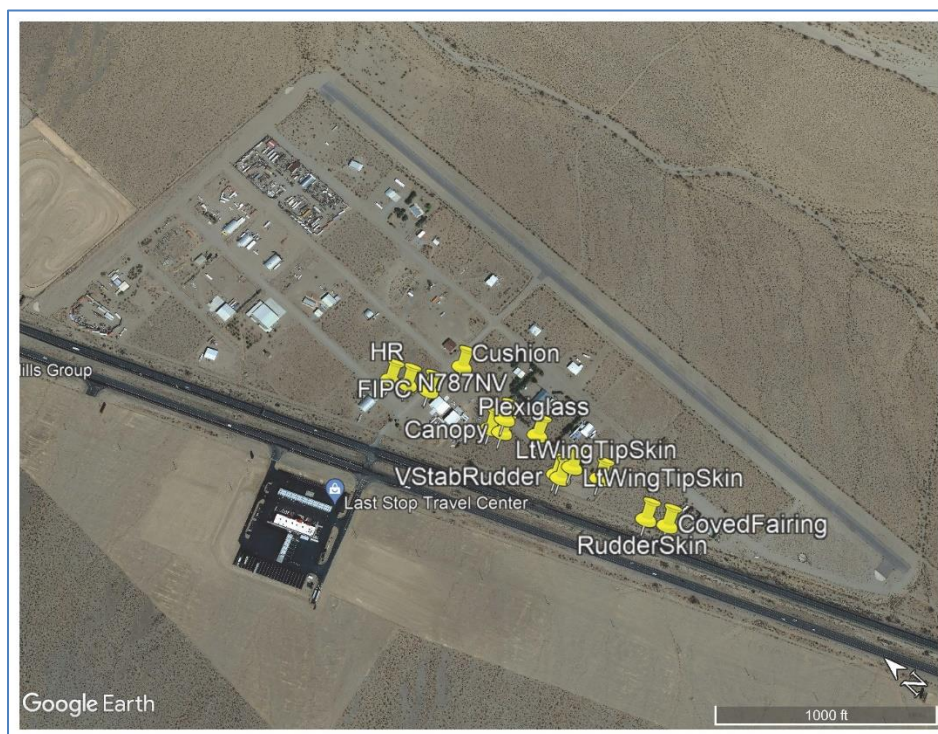
The accident site was on the Triangle Airpark (AZ50), White Hills, Arizona. The debris field was about 1,500 ft long and on a directional heading of about 345-degrees. The debris field was located along the northside of the highway and onto the airport property.

Figure 2-Google Earth view of the airport and accident site.
