# National Transportation Safety Board

WPR22FA151

## AIRCRAFT PERFORMANCE STUDY

Location: Heyburn, Idaho  
Date: April 13, 2022  
Time: 08:32 Mountain Daylight Time (MDT)  
14:32 Coordinated Universal Time (UTC)  
Airplane: Cessna 208B, registration N928JP

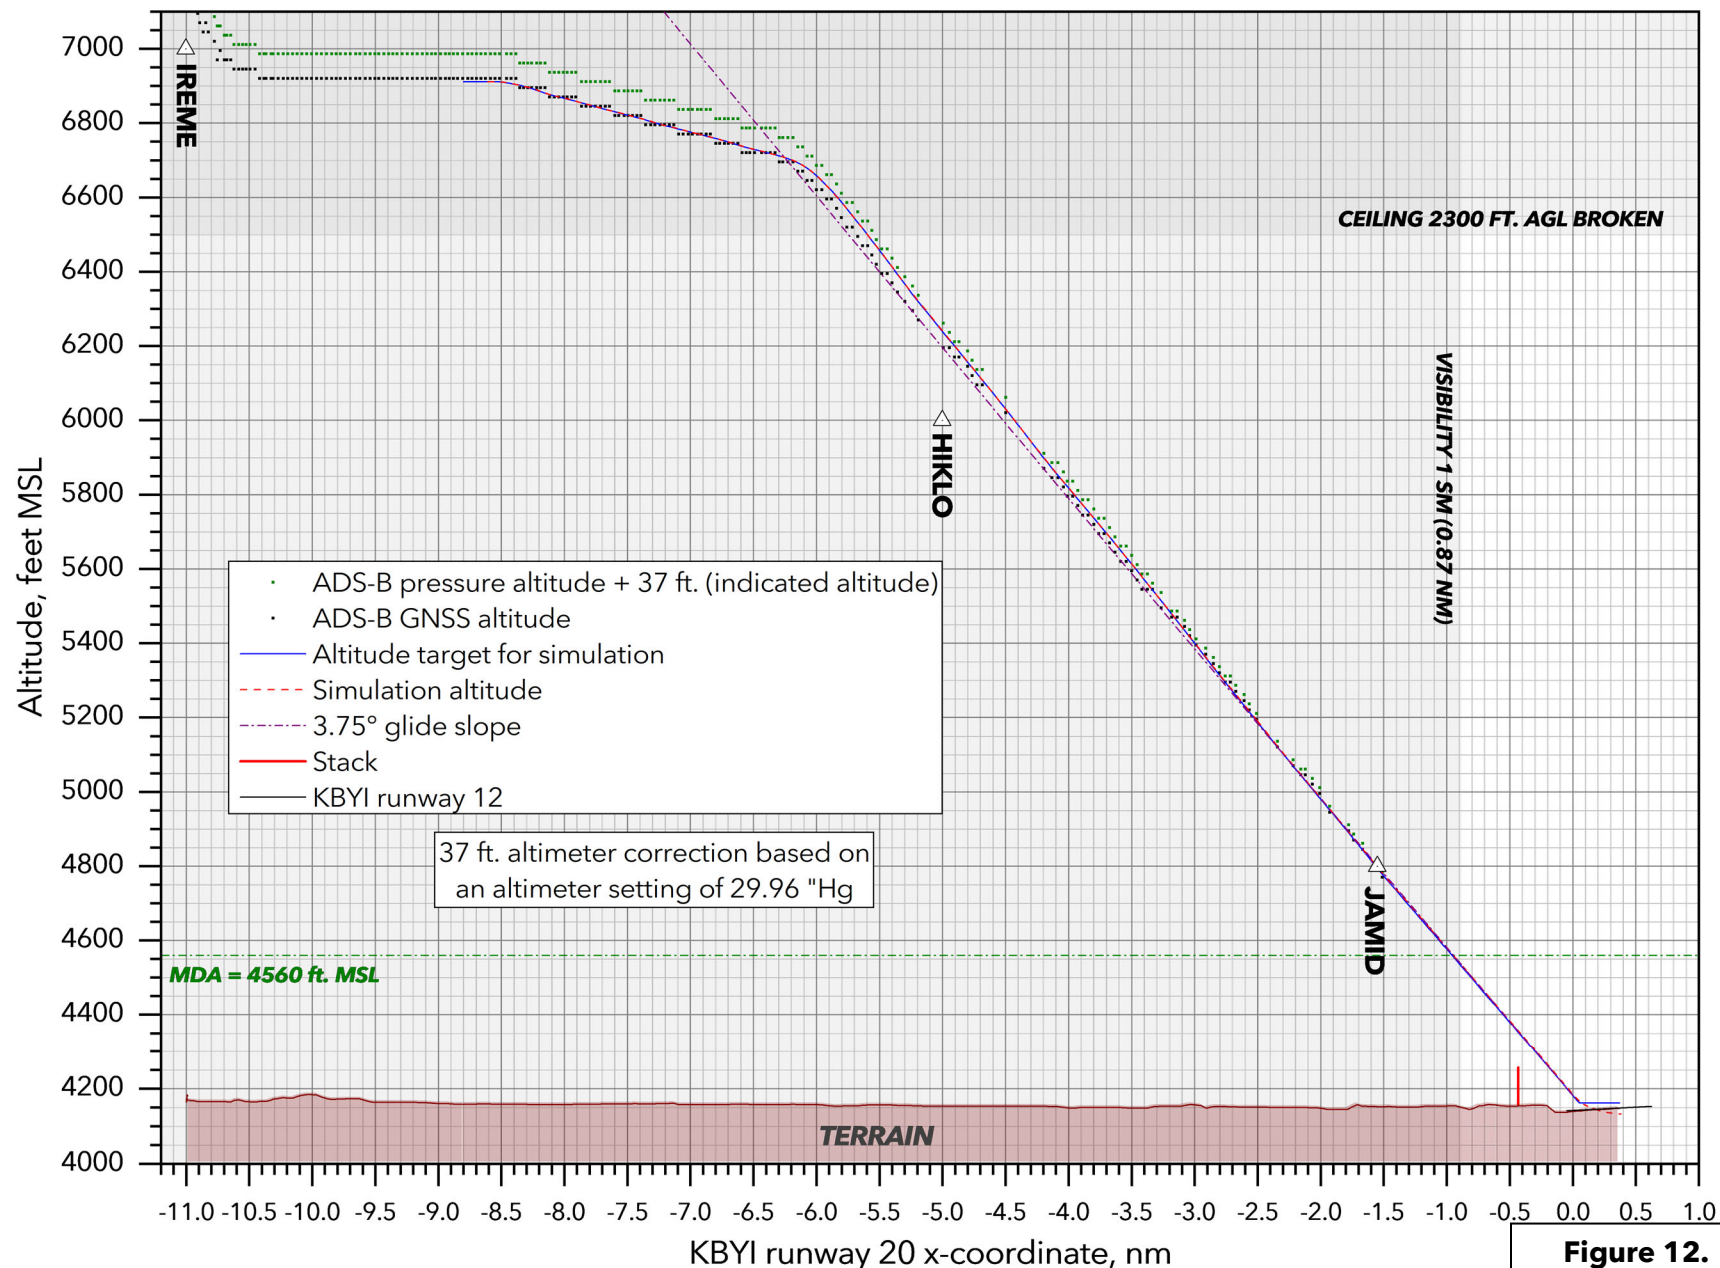
**Figure 12.**

As shown in Figure 12, on the first approach N928JP intercepted the nominal 3.75° glide path to runway 20 about 6.2 nm from the displaced threshold, and remained on the glide path throughout the descent recorded by the ADS-B data. The match of the nominal glide path while the airspeed and rate of descent varied (see Figures 13 & 14), together with the absence of visual vertical guidance to the runway, suggest that the pilot might have been following FPA guidance provided by the G1000 on this

MITRE provided the NTSB with a special version of the EPA software that also outputs exhaust plume properties, such as temperature and pressure, in the vicinity of the exhaust stack. Using these outputs, the density of the air as a function of distance from the stack could be computed. The results indicate that the temperature of the exhaust plume drops to that of the surrounding air very quickly, so that 200 ft. above the stack the density altitude in the plume is 99.7% of that of the surrounding air. Hence, the power (or equivalent performance) reduction in the simulation passing JAMID (550 ft. above the stack) is not likely the result of an increase in density altitude associated with elevated temperatures produced by the exhaust plume. Note also that no steepening of the glide path as N928JP passed through JAMID is observed on the first approach (see Figure 12).

## Altitude vs. distance during first approach to KBYI runway 20

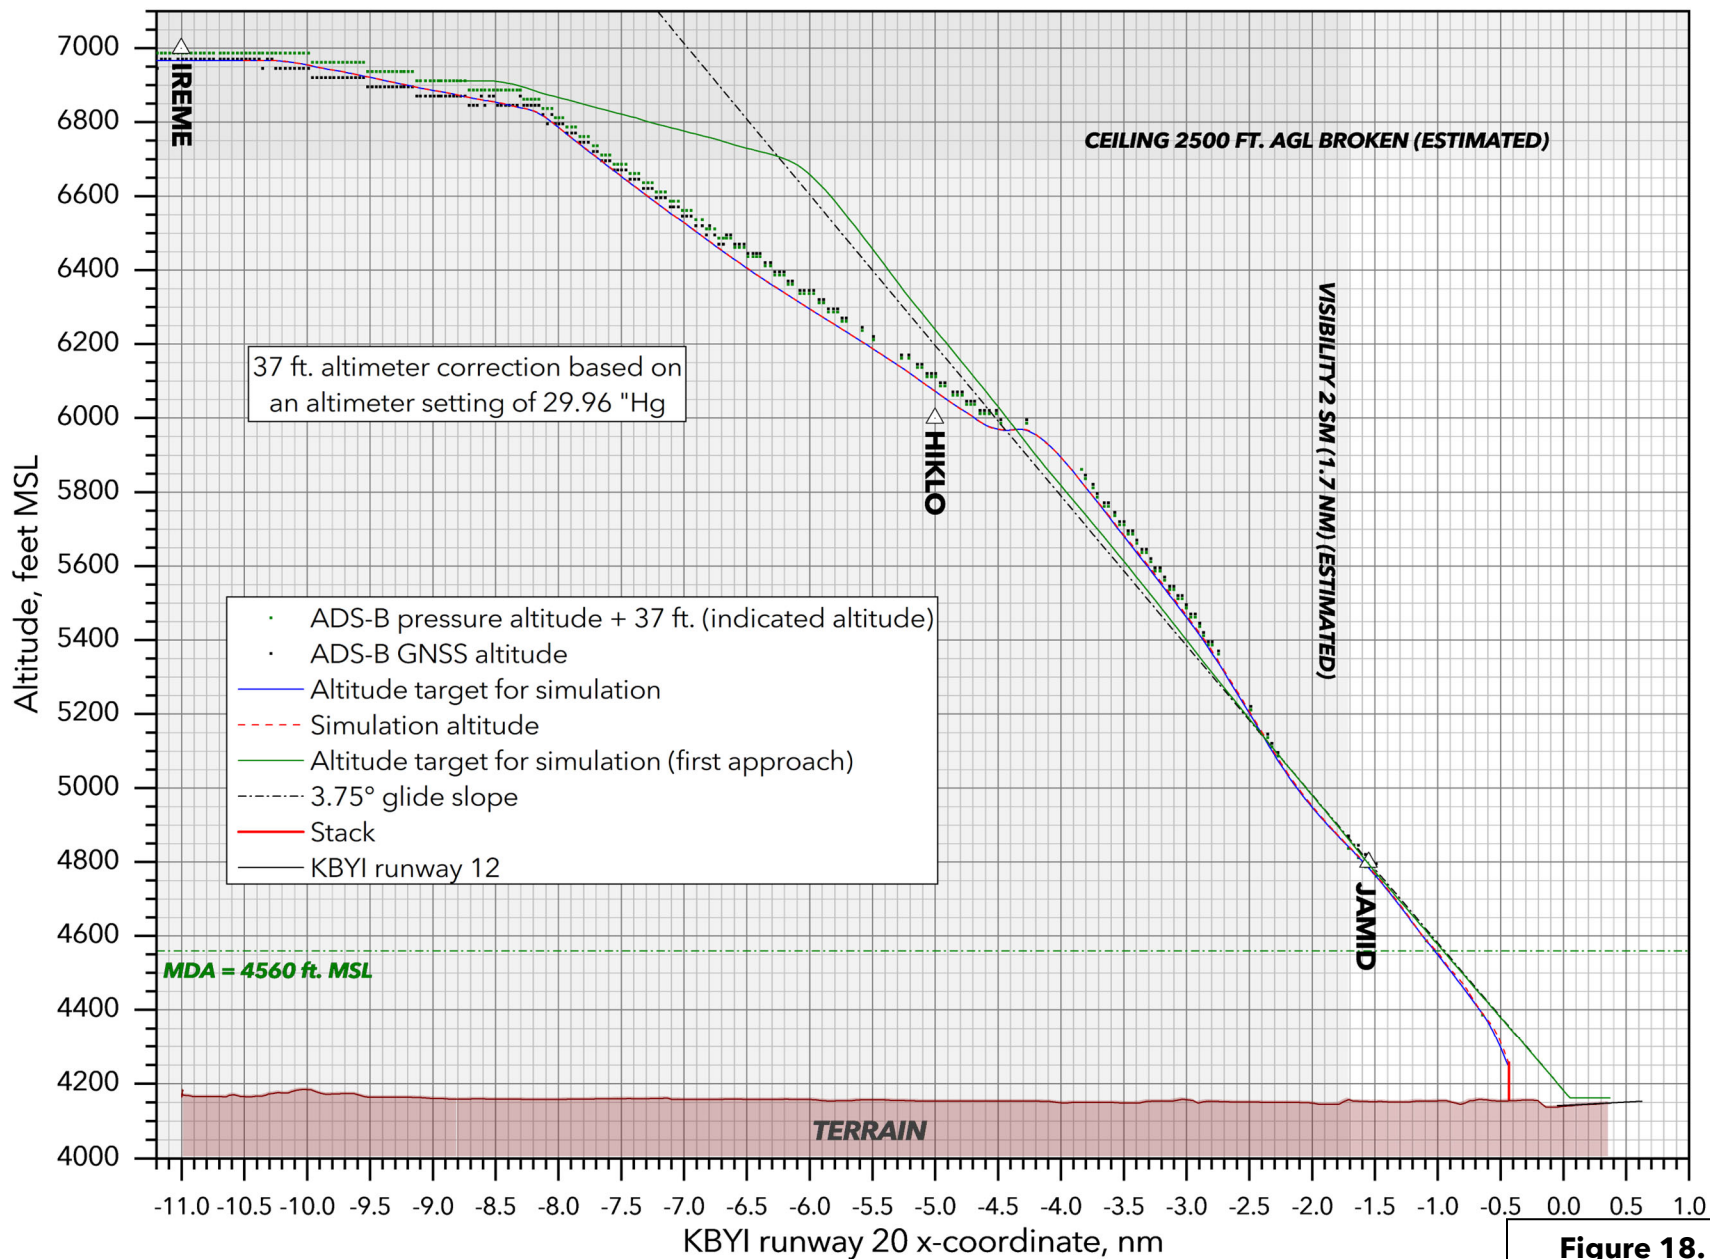
**Figure 18.**

On the accident approach, Figure 18 indicates that N028JP intercepted the nominal glide path at about 4.5 nm from the displaced threshold, but then deviated above it and had to descend more steeply to intercept it again (at about 2.4 nm from the displaced threshold). Notably, on the accident approach N928JP started a 500 fpm descent about 8 nm from the displaced threshold, well before the glide path intercept, whereas on the first approach the significant increase in rate of descent started at 6 nm from the displaced threshold, roughly coincident with the glide path intercept. This raises the possibility that the pilot used different vertical navigation strategies on the two approaches, and that perhaps the G1000 FPA guidance was used on the first approach but not on the accident approach (though it cannot be known for certain what strategies were employed on either approach, or whether the G1000 FPA functionality was used at all).

## Altitude vs. distance during accident approach to KBYI runway 20

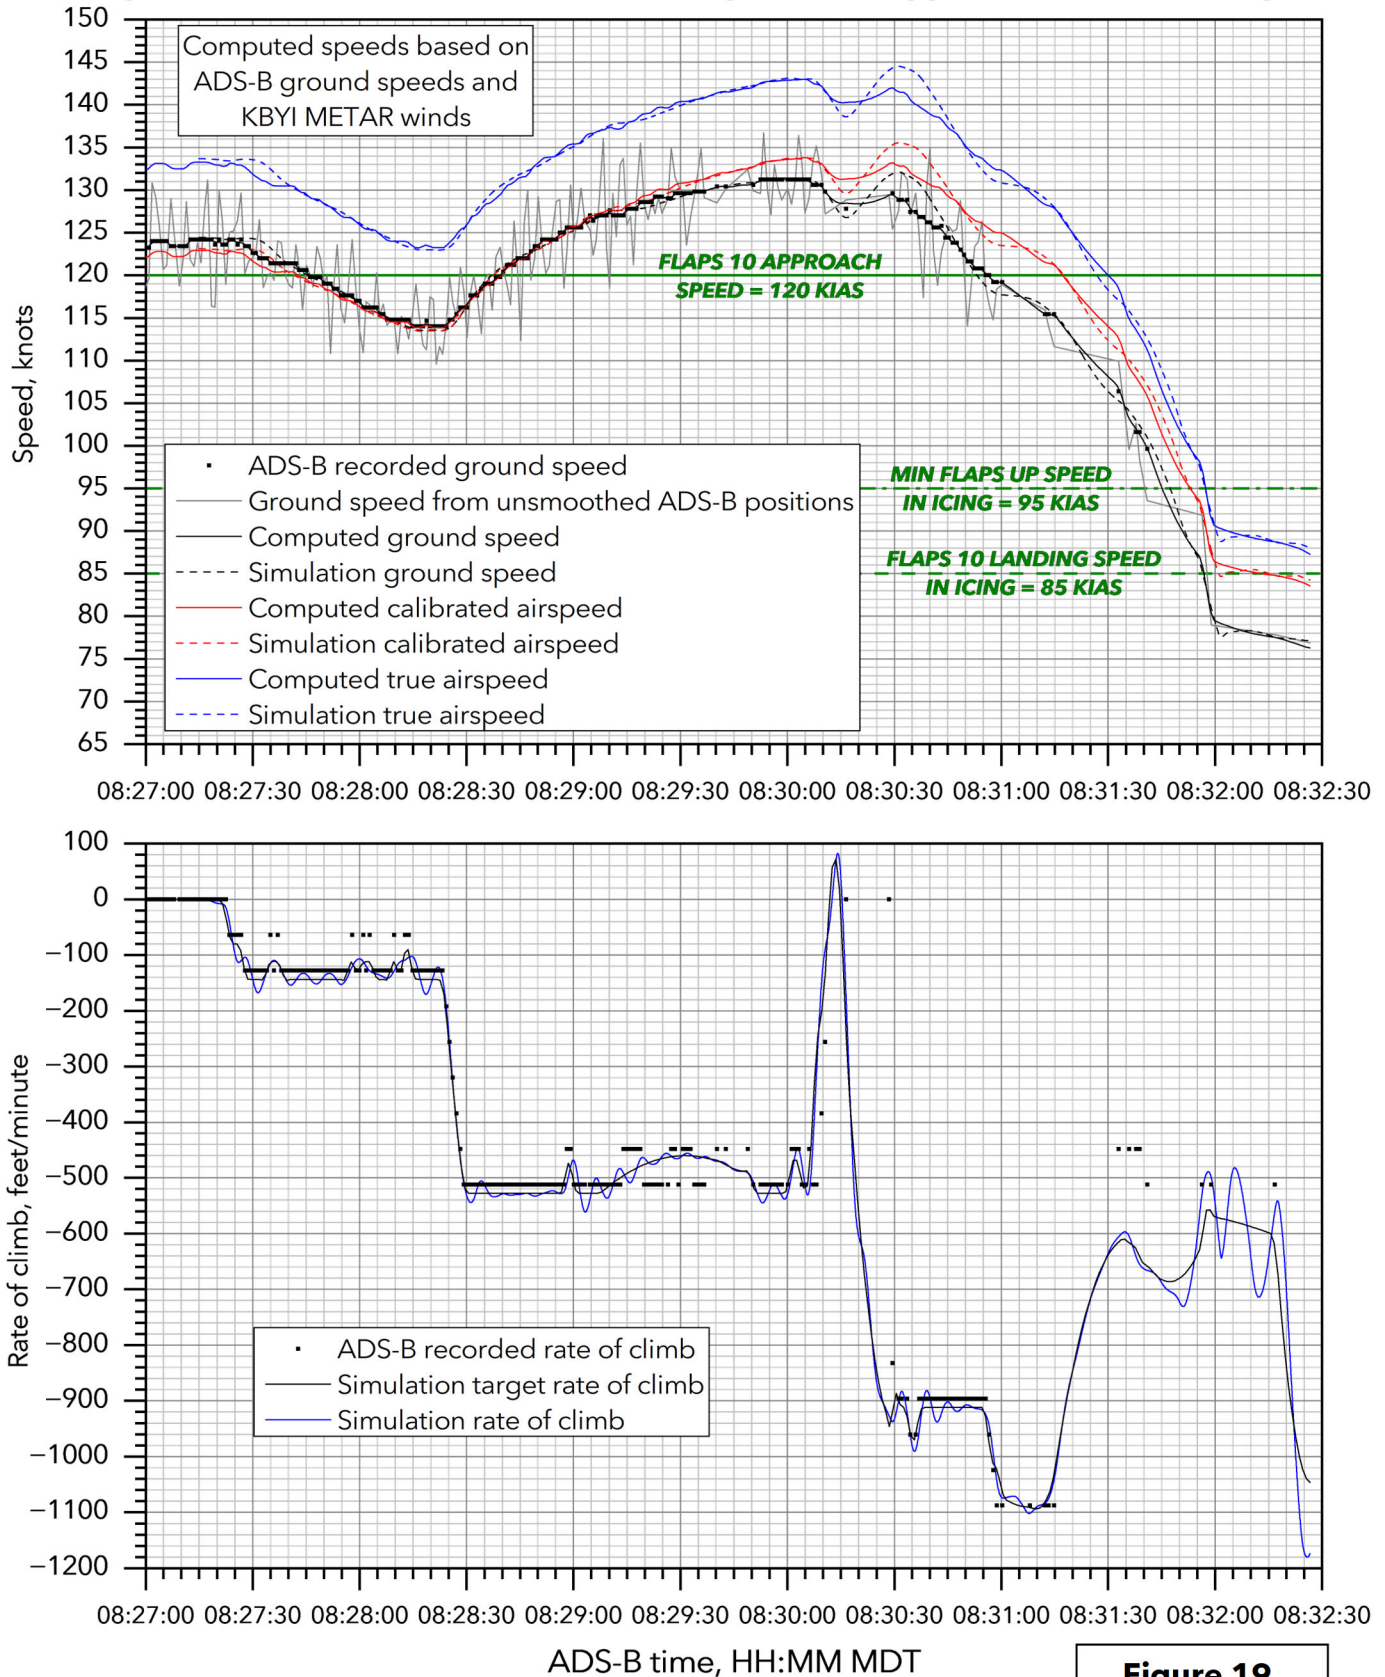
**Figure 19.**

During the accident approach, the last ADS-B messages provided position information but not ground speed information. However, the ground speed can be computed from the position data, though this calculation contains inherent "noise" as described above (and as shown in Figures 19 & 20). Nonetheless, the calculated ground speed indicates that N928JP continued to decelerate to approximately 78 kt. ground speed. This

The time and distance increments between the last ADS-B position and the impact with the exhaust stack indicate that N928JP's ground speed between these points remained close to the last computed ground speed value (about 78 kt.), as shown in Figure 19. The estimated ground speed at impact with the exhaust stack is about 76 kt.

The “Landing” portion of the “Normal Procedures” section of the Supplement recommends a flap setting of 10° and airspeed of 85 KIAS for landing (a maximum of 20° of flaps may be used, but the minimum airspeed is still 85 KIAS). Per Figures 19 & 20, on the accident approach the airspeed decreased to between 84 and 86 KCAS and remained there for about 26 seconds before impact, though the flaps remained fully retracted (the minimum flaps-up airspeed cited in the Icing Supplement is 95 KIAS).

## Speeds, rate of climb, & $\gamma$ vs. time during accident approach to KBYI runway 20

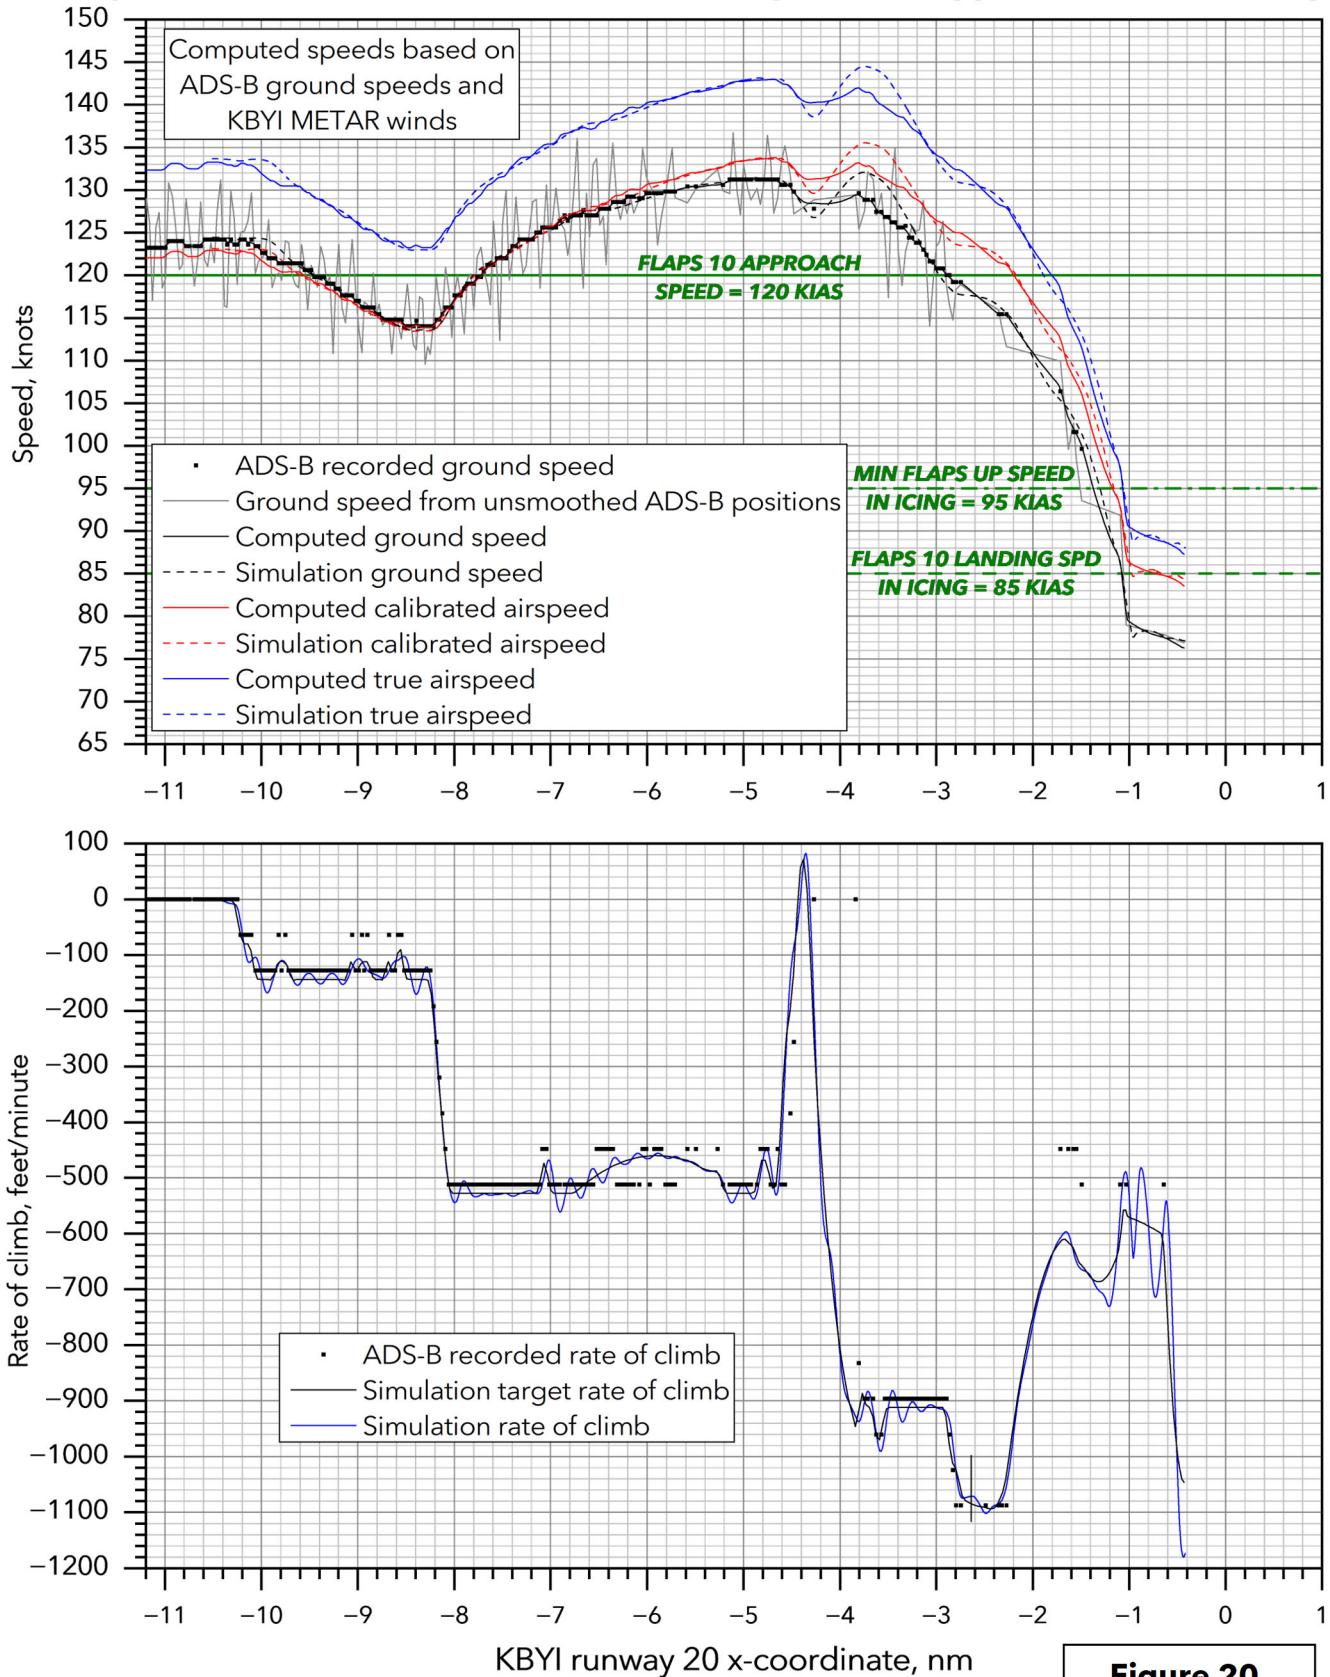
**Figure 20.**

## Speeds, rate of climb, & $\gamma$ vs. distance during accident approach to KBYI runway 20

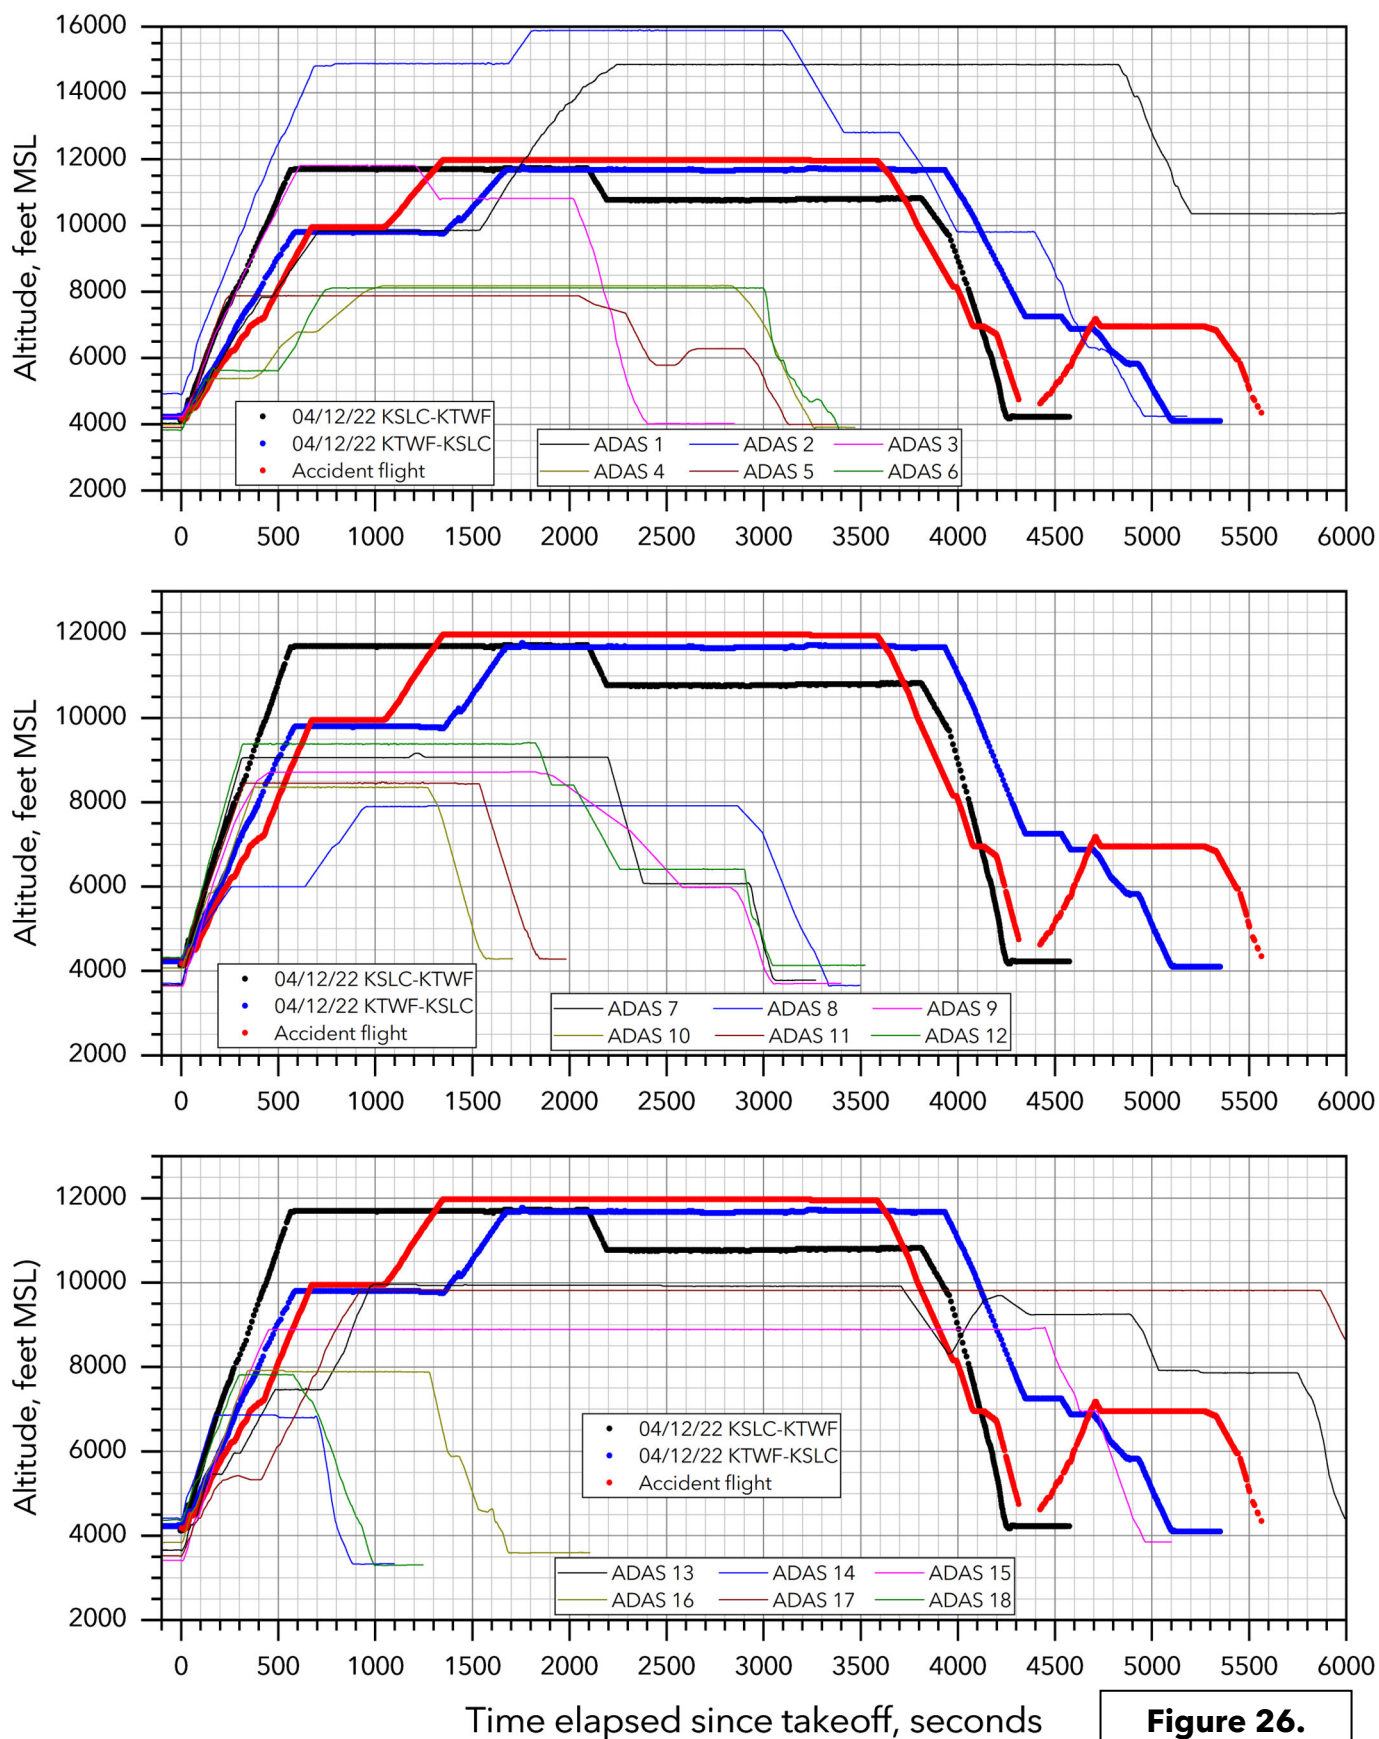
**Figure 26.**

The altitude data from the 18 flights recorded on the ADAS are compared to the ADS-B altitudes for N928JP's last three flights in Figure 26. Each ADAS flight was identified in the altitude data based on an initial low-level altitude followed by a climb, descent, and final low-level altitude (together with corresponding time gaps between candidate flights). For each ADAS and ADS-B flight in Figure 26, the time parameter is shifted so that an elapsed time of 0 seconds corresponds to the takeoff time, making it easier to compare the altitude profiles.

## Altitude comparisons: ADS-B data from known flights vs. ADAS data from unknown flights

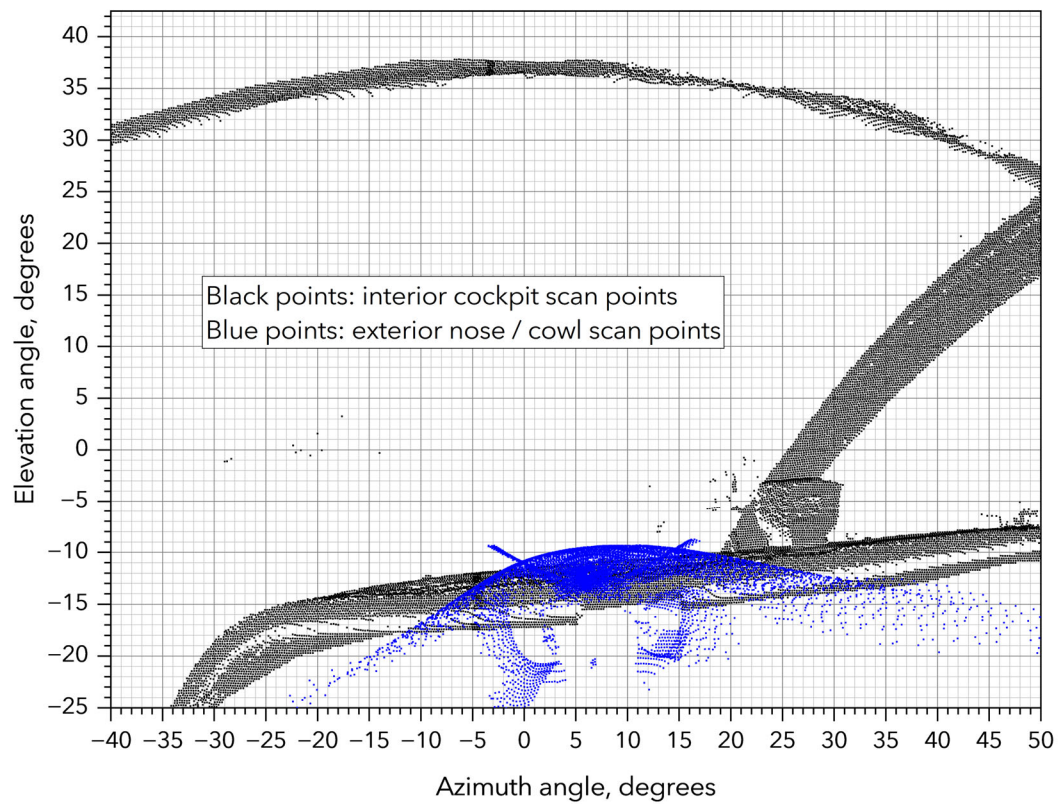
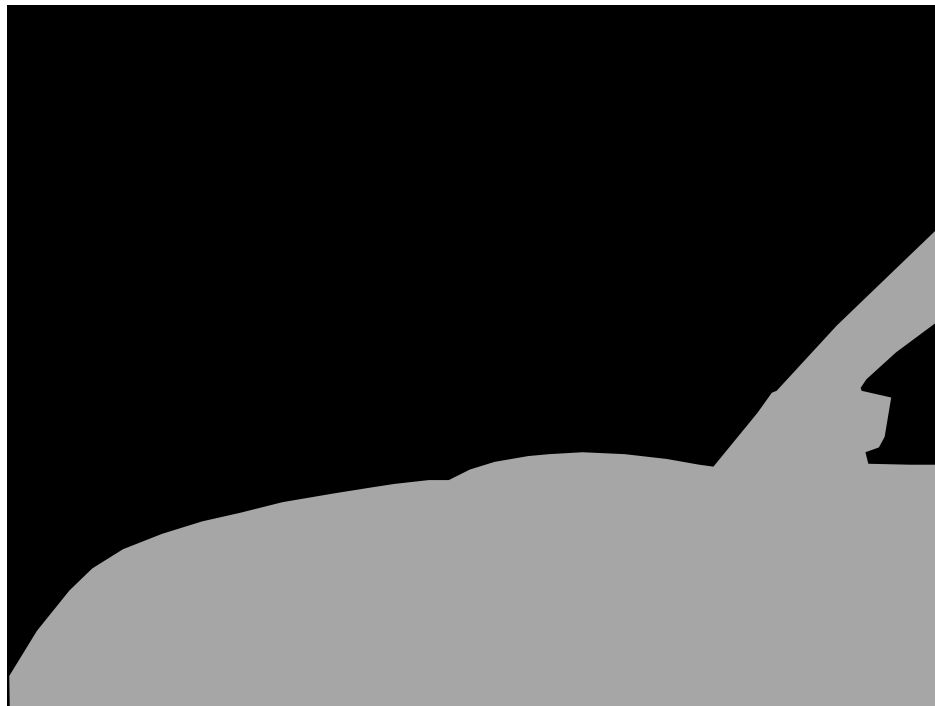
**Figure 28a.** Azimuth and elevation angles from scan of exemplar C208B.

The cockpit structure as seen from the nominal pilot's eye position (based on the laser scans) was constructed in *FSX* as a semi-transparent panel that "masks" the view from the cockpit (see Appendix B in Reference 3 for more information about the creation of such panels in *FSX*). The cockpit geometry built into the C208B airplane model that comes with *FSX* was not used. The azimuth and elevation coordinates of the laser scan points and the resulting panel mask are depicted in Figure 28.

Figure 28 shows that at the nominal eye position, between an azimuth angle of  $0^\circ$  and  $2^\circ$  the elevation angle of the top of the engine cowl is between about  $-10^\circ$  and  $-11^\circ$ . Consequently, the top of the stack is obscured below the nose of the airplane whenever its elevation angle is less than about  $-10^\circ$ ; this is depicted by the "nominal" green band in Figure 29 and the red-shaded area labeled "stack obscured at nominal eye height." At the nominal eye height, the stack would have been obscured from about 29.5 to 3.3 seconds before impact.

- When the top of the exhaust stack became unobscured about 3 seconds before impact, it was likely too late for the pilot to recognize the hazard and take action to avoid the collision.
