# National Transportation Safety Board

WPR22FA151

## **AIRFRAME AND ENGINE EXAMINATION REPORT**

Airplane: N928JP / Cessna 208B

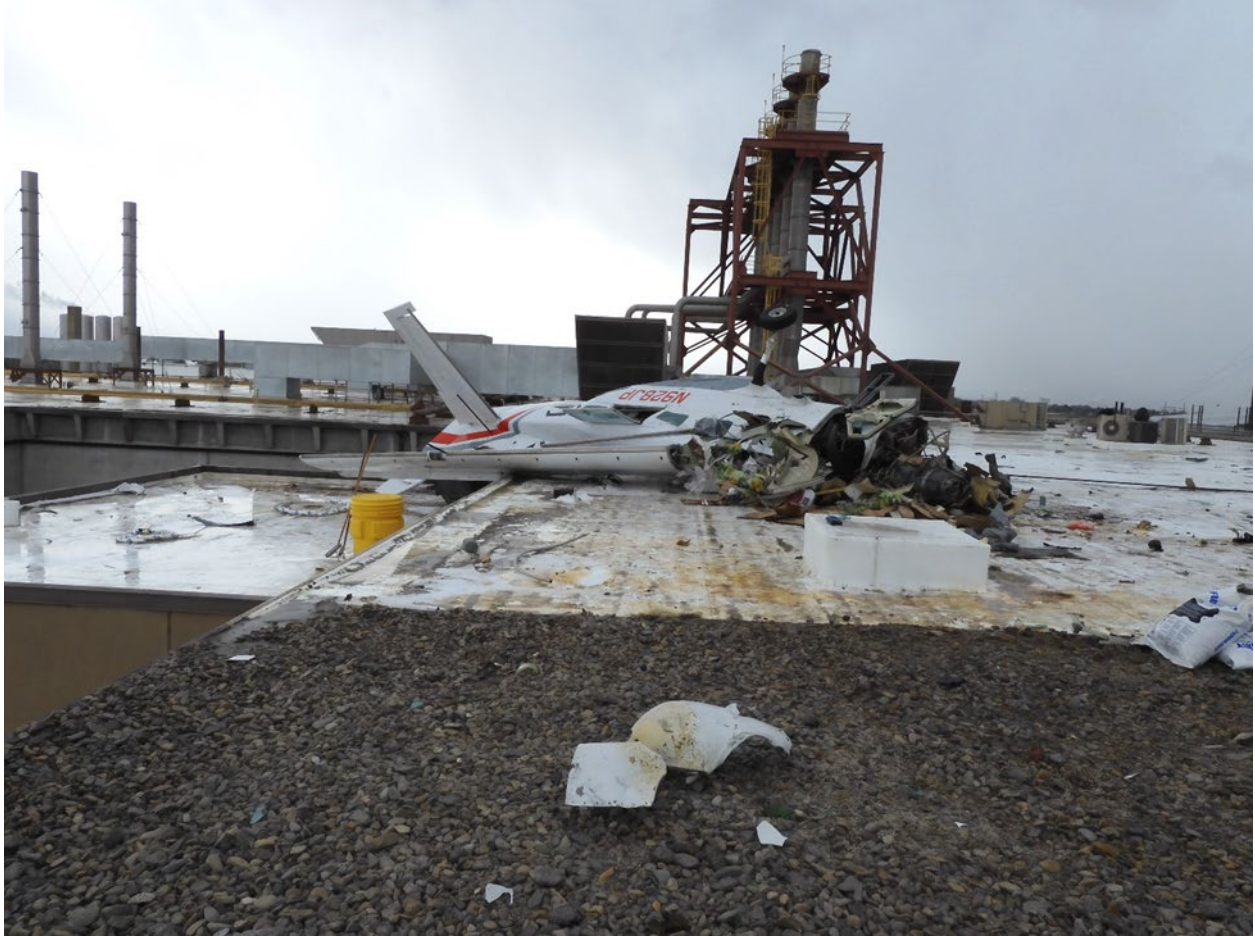
**Figure 6. Top-front view.**

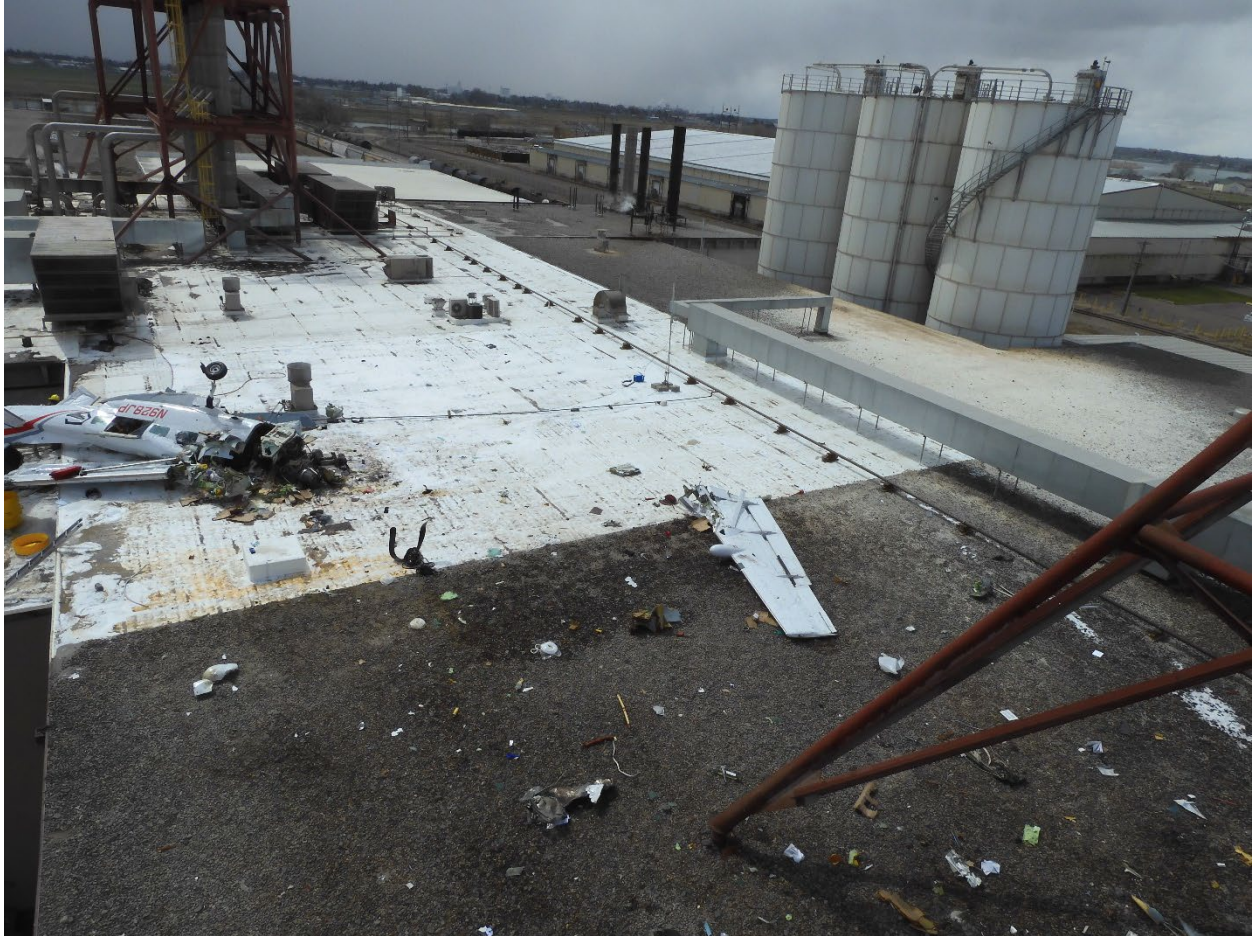
The right wing separated from the fuselage at the root and retained its shape and integrity. The wing was found near the fuselage, underside-up. There was debris on the wing, but overall, it appeared clean without evidence of ice or TKS fluid. The leading edge exhibited minor damage except for the last 4 feet nearest the root. A large circumferential dent extended inward (aft) through the wing spar. Yellow paint transfer was observed in this area. The flap remained attached to the wing and moved freely through its limits. The electric flap actuator remained attached at the bellcrank and had about 6.5 inches of threads exposed. The right aileron remained attached to the wing at its mounts, The aileron trim remained attached at the aileron. The aileron control cables remained attached to the aileron and extended to the wing root. Both control cables exhibited broom straw appearance at the separations. The weather radome remained attached to the right wing and exhibited minor damage. A very thin layer of ice was observed on the radome but was not significant or noteworthy. The right-wing pitot-static probe remained attached to the right wing and exhibited minor damage. The right-wing strut remained attached at the wing mount, but fracture separated at the fuselage. The leading edge separated from the

wing strut and was found in the wreckage. The wing tip remained attached along with the position light. The leading edge remained intact except for the root area. The landing light remained intact and exhibited minor damage. The right-wing finger filter was clean and clear of debris.

**Figure 8. View showing the left and right wing.**

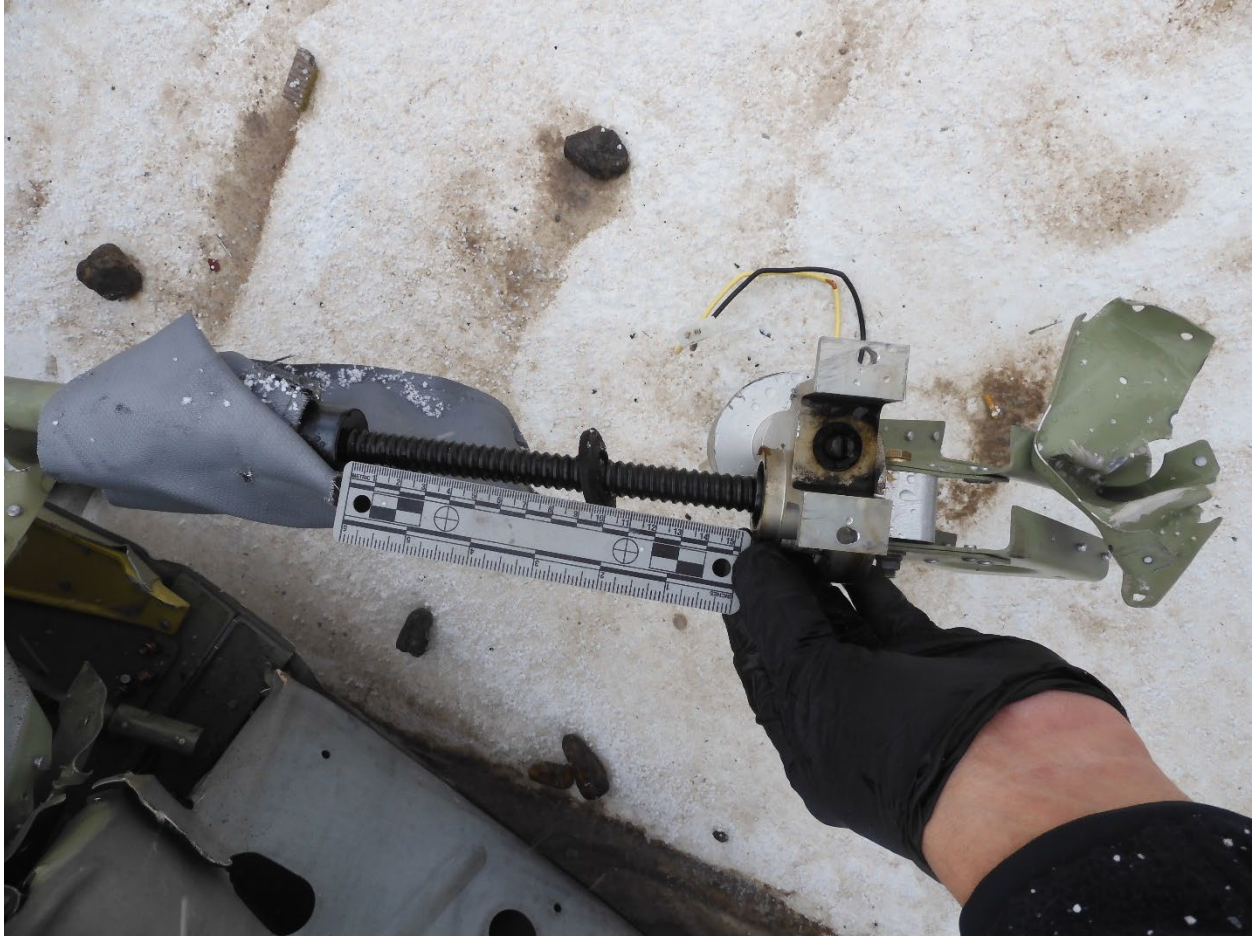
**Figure 13. Flap actuator.**

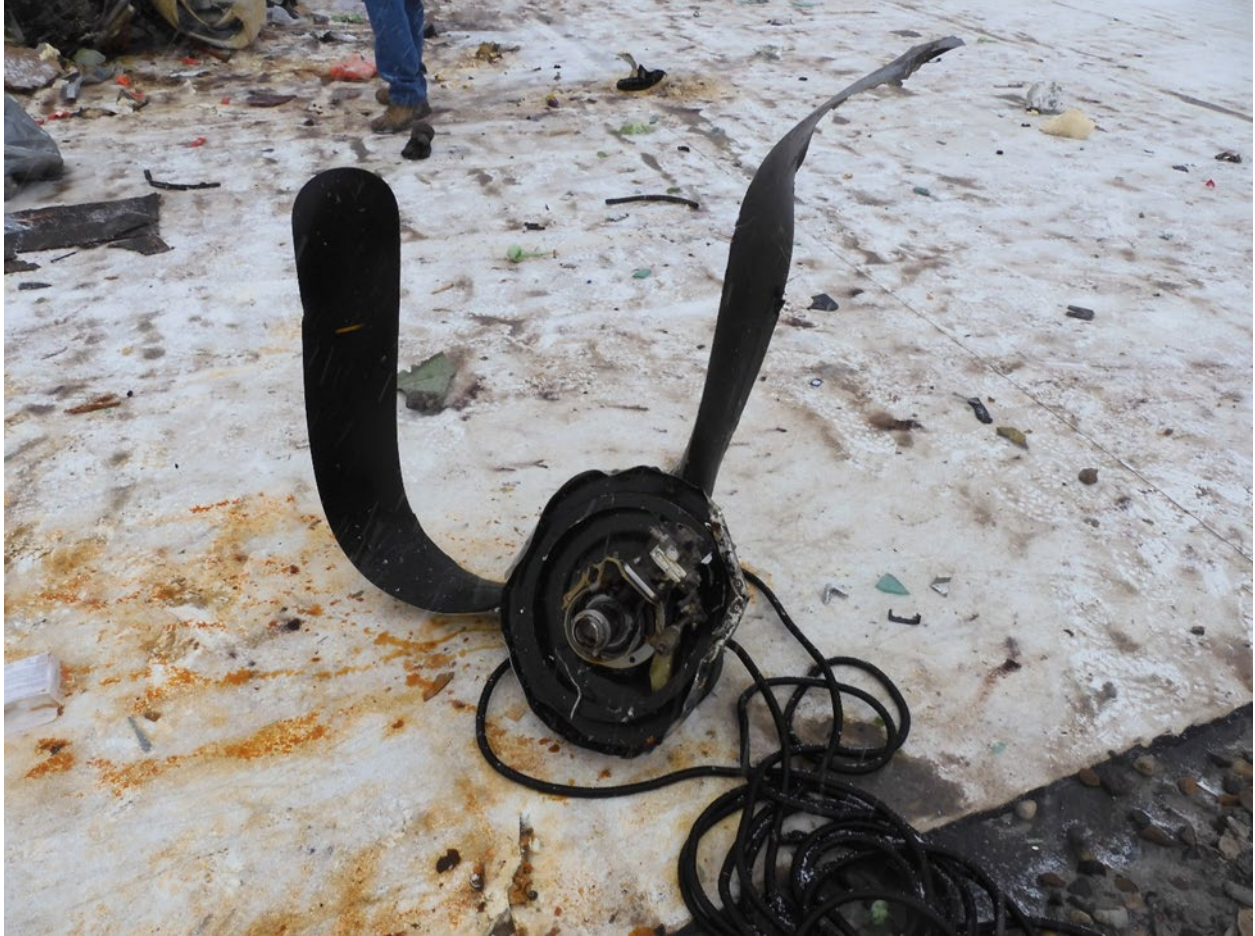
tip fell to the ground and was recovered. The oil dome was fractured, and oil was on the roof top where the prop came to rest. The spinner was crushed inward and remained secured to the hub.

**Figure 22. Propeller rear view.**
