**NATIONAL TRANSPORTATION SAFETY BOARD**  
Office of Aviation Safety

**Wreckage Examination Group Field Notes**

**A. ACCIDENT      WPR22FA172**

Location:            Sausalito, California  
Date:                May 6, 2022  
Time:                1210 PDT  
Operator:           Private  
Aircraft:            Vans RV-10  
Registration:       N54MG

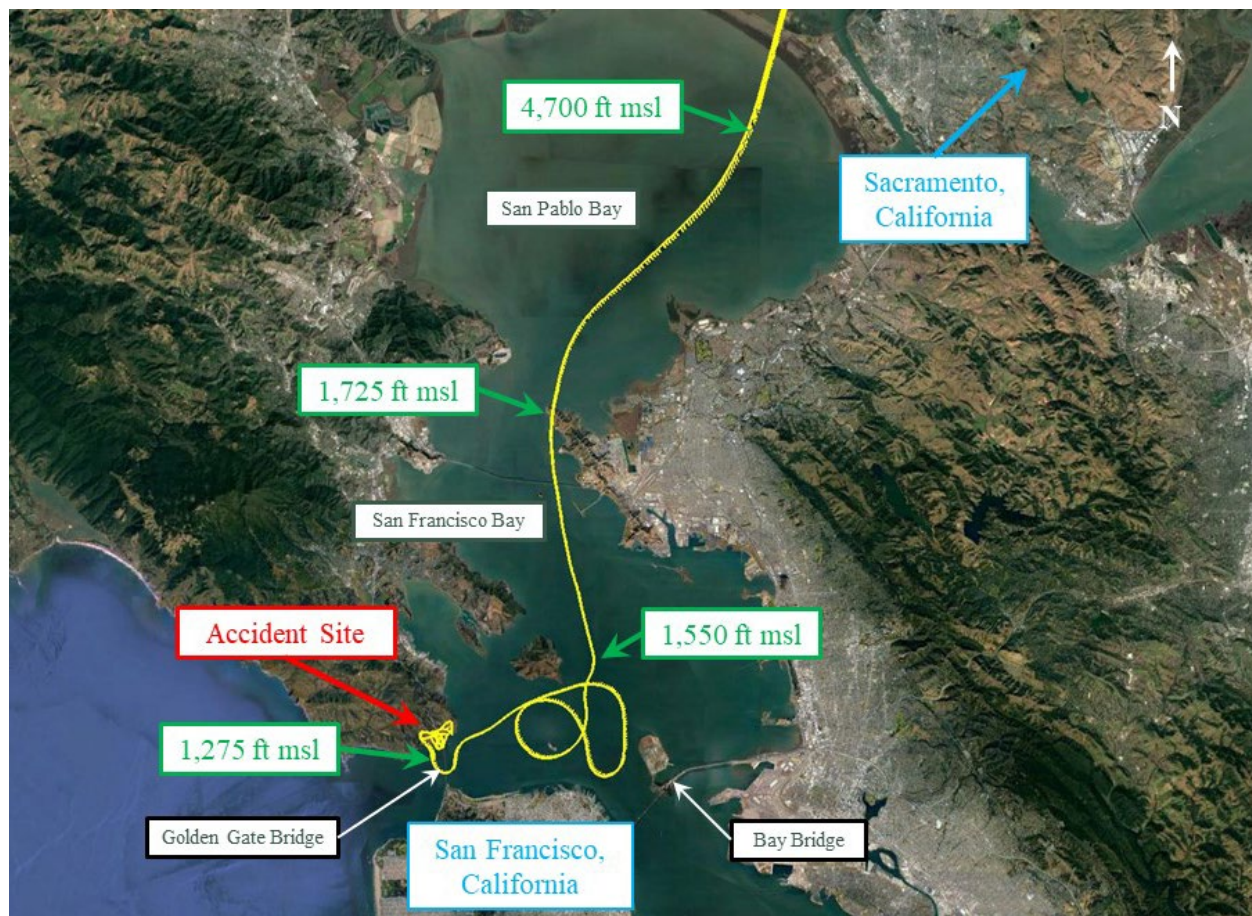
Figure 1: Airplane's route of flight

According to preliminary track data obtained from a commercially available third-party source, the airplane departed Sacramento Executive Airport, Sacramento, California about 1129 and transitioned into a climb on a southwest heading. The airplane leveled off about 5,500 ft mean sea level (msl) approximately 6 minutes later. The airplane turned south about 12 minutes later and subsequently entered a descent as it flew along San Pablo Bay towards San Francisco Bay. Preliminary air traffic control (ATC) audio recordings from the Federal Aviation Administration revealed that the pilot made radio contact with ATC at 1152 and requested a “Bay Tour” while enroute to his destination of Half Moon Bay, California. The controller instructed the pilot to remain northwest of the Bay Bridge and to remain clear of Class B airspace. He then advised the pilot to notify him when they had obtained local weather for his destination airport. The airplane descended to about 1,300 ft msl after it had reached San Francisco Bay and then began a climb a few seconds later.

At 1158 the airplane started a 360° right turn around Alcatraz Island and then resumed a southerly heading for about 1 minute before making a left turn to the north, over Treasure Island. At 1202 the airplane turned southwest after it climbed to about 2,400 ft msl and then began a descent. The airplane approached the north tower of the Golden Gate Bridge about 1205 at which time the pilot contacted ATC to request the transition route to his destination airport and the controller instructed him to remain outside of Class B airspace. The pilot then made another request for the transition route and the controller issued the same instructions. During the next 5 minutes, the airplane made a series of turns at various altitudes below 2,100 ft msl near the north end of the Golden Gate Bridge. The track ceased at 1209:41, about 1,700 ft south of the accident site at approximately 850 ft msl.

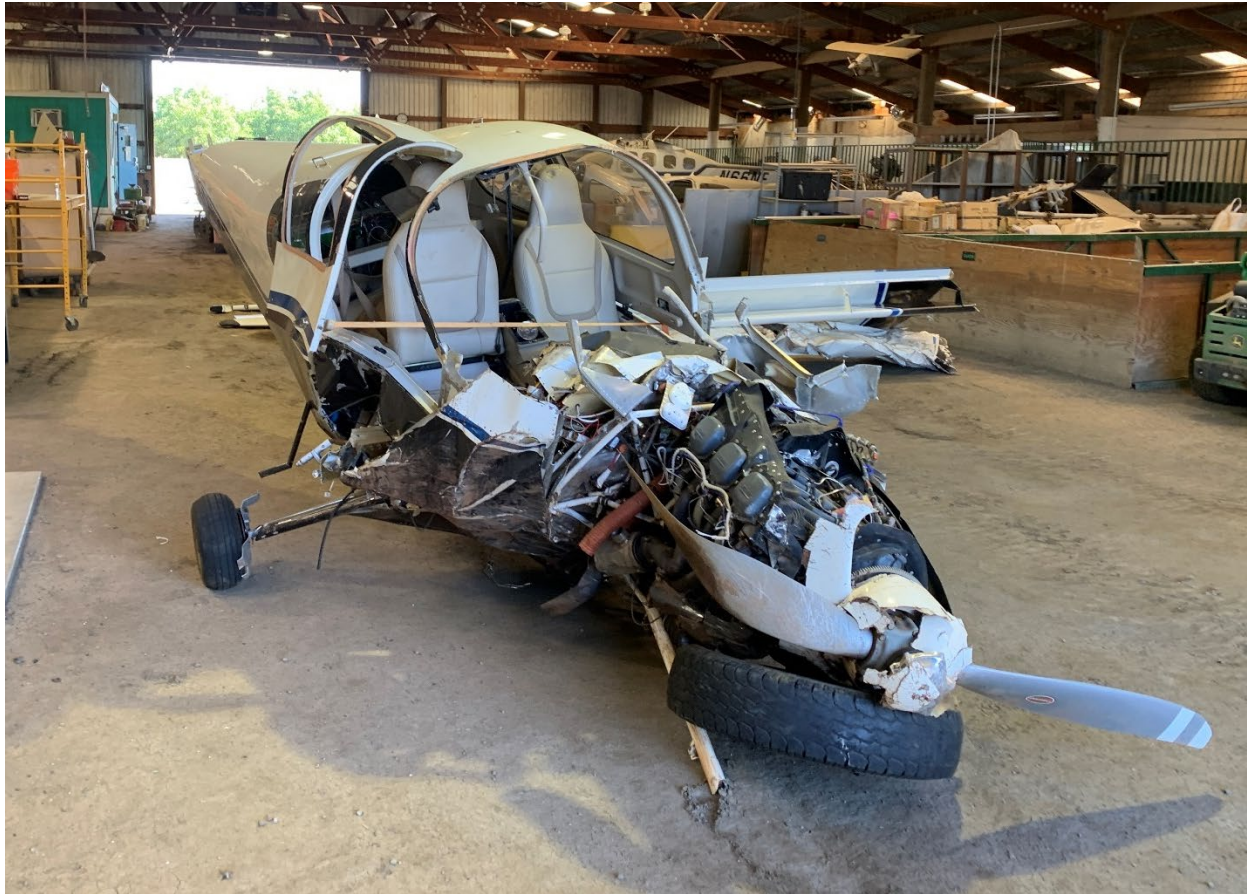
*Photograph 1: Accident airplane and engine prior to examination*

The airplane was recovered to Plain Parts in Pleasant Grove, California where an examination was completed on July 19, 2022.
