National Transportation Safety Board

WPR22FA119

**INVESTIGATIVE SUPPLEMENTAL MATERIAL**

Location: Oceanside, California  
Date: 06/03/2022  
Time: 1347 Pacific daylight time  
Airplane: Cessna 208B Supervan 900

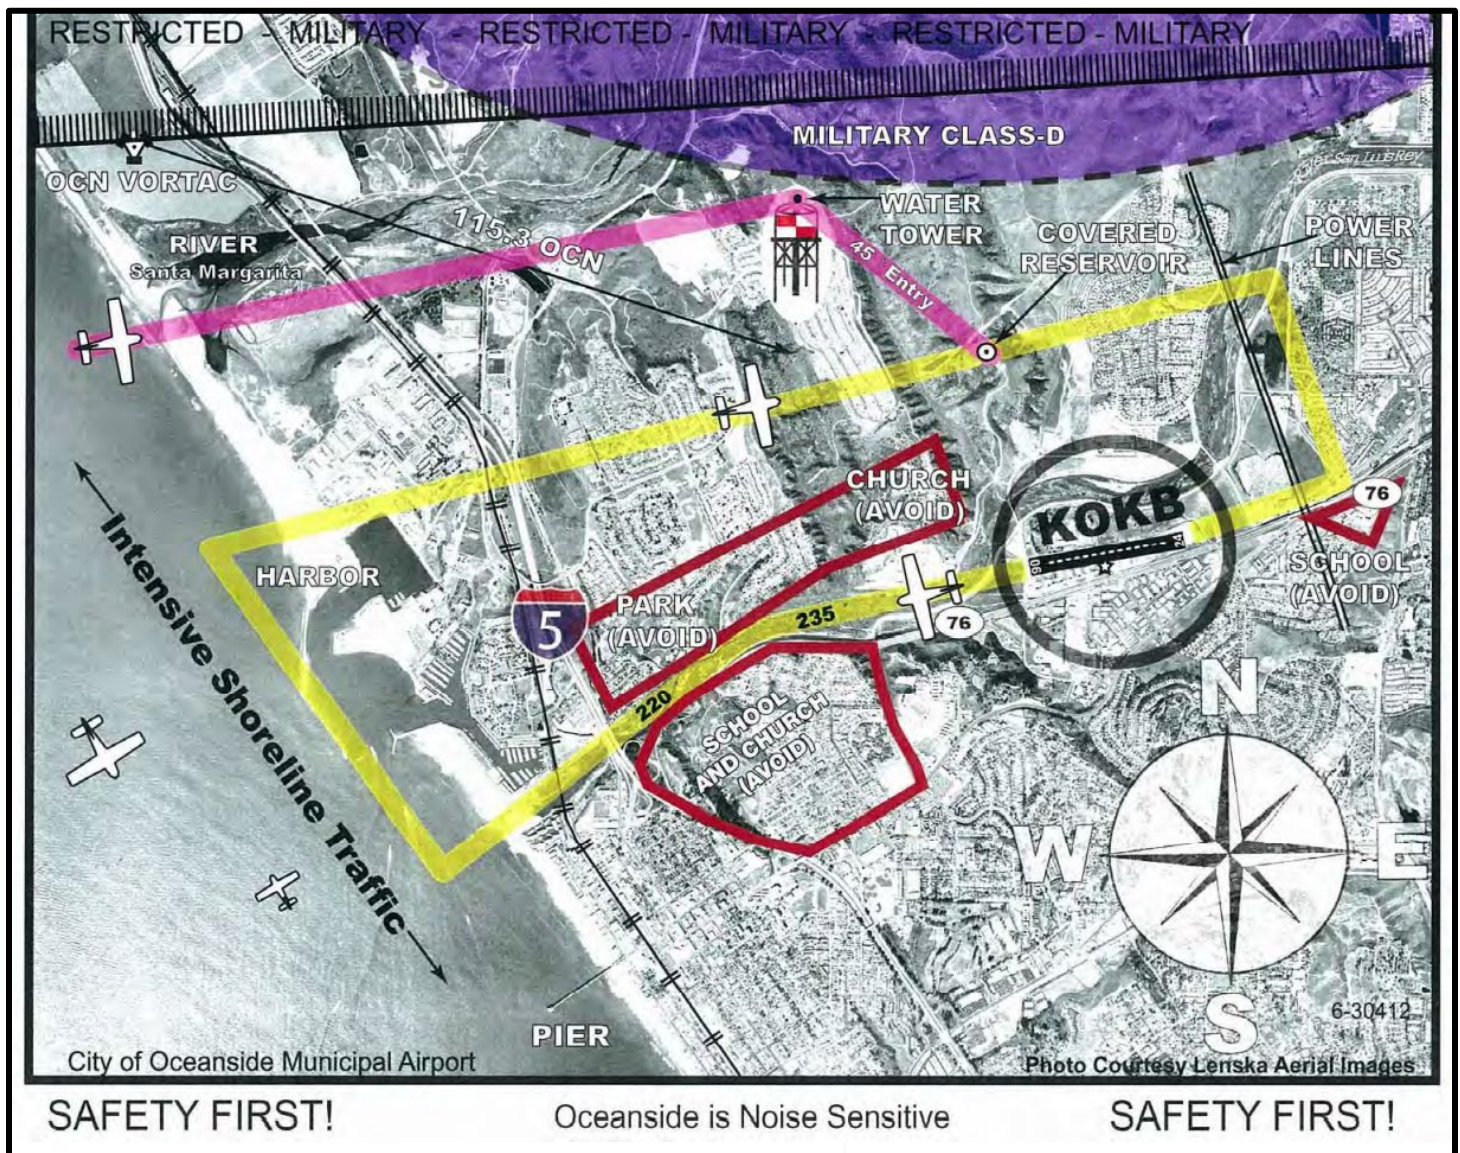
Figure 18: Landing Specifications

There is a parachute landing area on the north side of the airport located west of the segmented circle and airport service road where it turns from heading west to heading north. This area is outside of the San Luis Rey River floodplain zone and covers approximately an acre. The area is open space with little vegetation other than mowed grass. The parachute pattern is similar to that traffic pattern of aircraft. The downwind follows Alex Road. Approximately abeam to Runway 24 the parachute pattern turns to base and on final approach flies between the segmented circle and wind sock and Runway 6-24.
