# National Transportation Safety Board

WPR22FA227

## EXAMINATION

Location: Mendon, Utah  
Date: June 24, 2022  
Time: 0903L  
0303 (UTC)  
Airplane: N934JH, 1979 Cessna Aircraft Company, Model 152

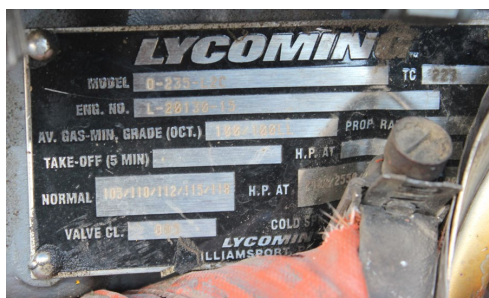
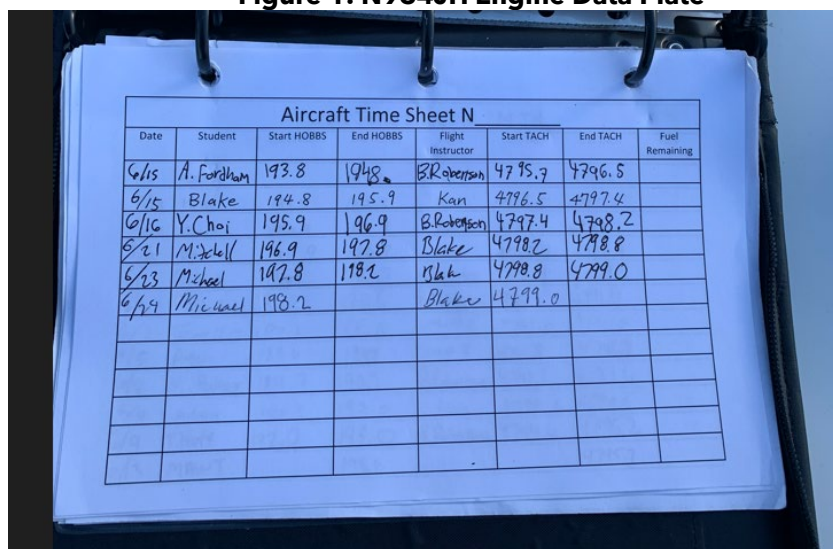
The engine remained attached to the airframe by the impact damaged engine mount. The engine had sustained moderate impact energy damage to the forward exhaust system components, induction pipes and carburetor airbox. Visual examination of the engine revealed no evidence of pre-impact catastrophic mechanical malfunction or fire.
