National Transportation Safety Board

WPR22FA331

**INVESTIGATIVE SUPPLEMENTAL MATERIAL**

Location: Wichita Falls, Texas  
Date: August 20, 2022  
Time: 1331 central daylight time  
Airplane: Smyth Sidewinder TD

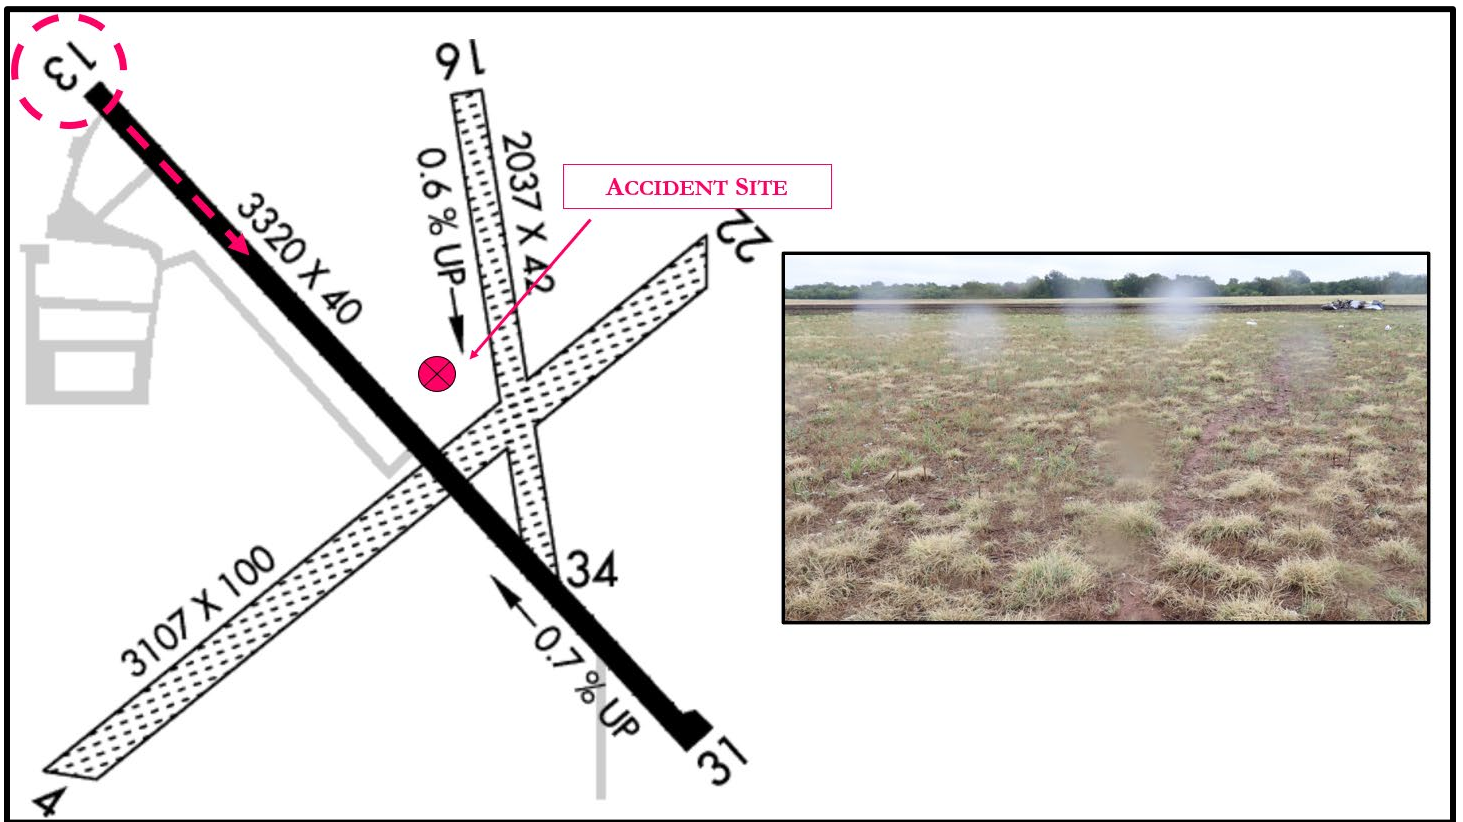
Figure 2: Accident Site in Reference to the Runway

The accident site was located in a fallow cotton-field adjacent to the runway. In character, the debris field was located on flat terrain with loose dirt and dry vegetation distributed over a 200 ft distance on a median magnetic bearing of about 95°. The main wreckage, consisting of the engine and the fuselage, came to rest inverted. The majority of the airframe was consumed by fire with the exception of the empennage and outboard right-wing. The airplane was situated with the fuselage on a magnetic bearing of about 37°.

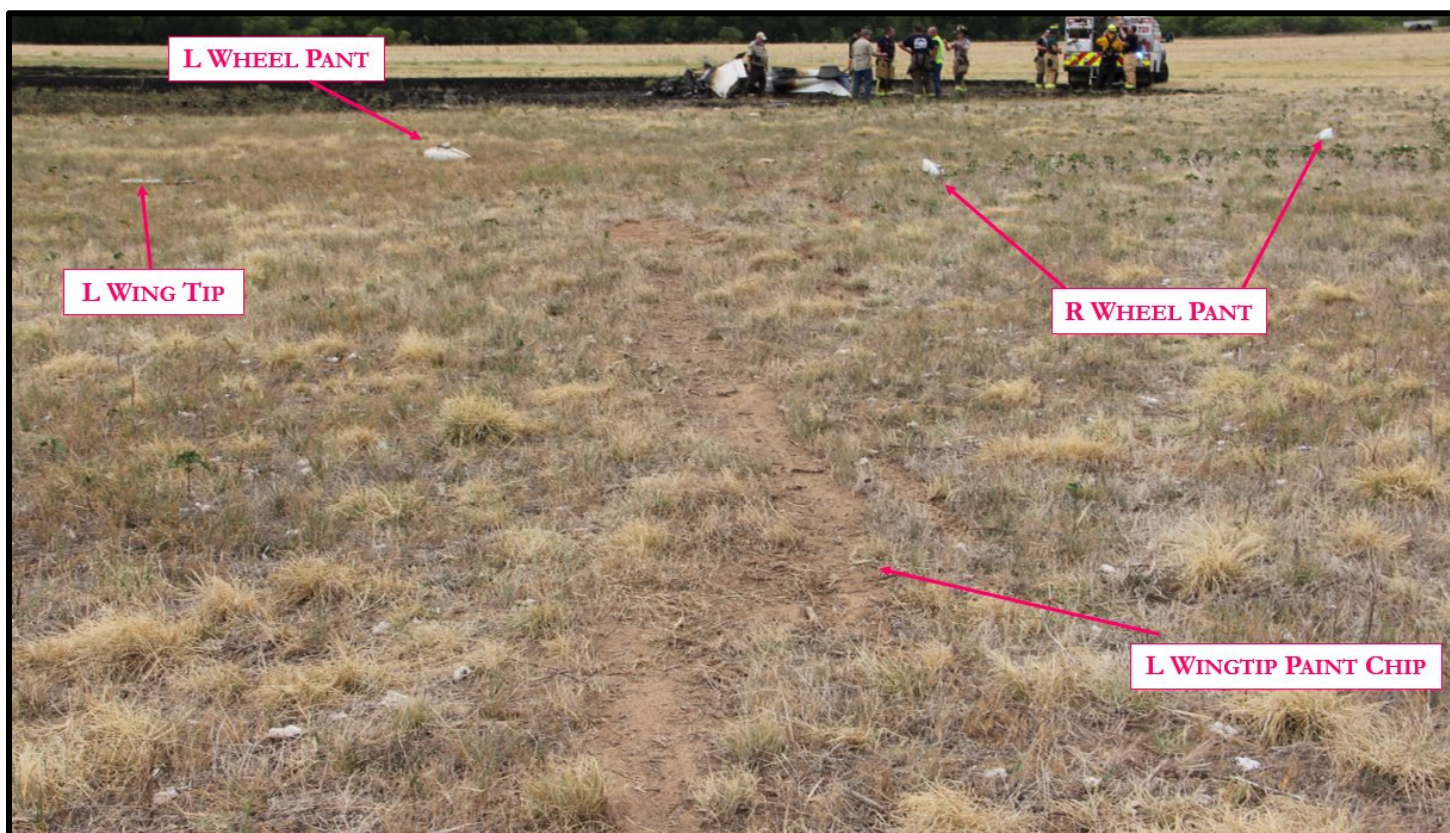
Figure 6: Start of Debris Field

The first identified point of contact consisted of disrupted dirt and paint chips. An approximate 6-inch-wide ground scar from the initial impact was continuous for about 19 ft, consistent with the left wing dragging along the terrain. Thereafter, there was an approximate 14 ft path of disrupted dirt. The remaining 25 ft to the wreckage the disrupted dirt ended. In that debris field, there was part of the propeller, right wing tip, and numerous pieces of fragmented canopy.

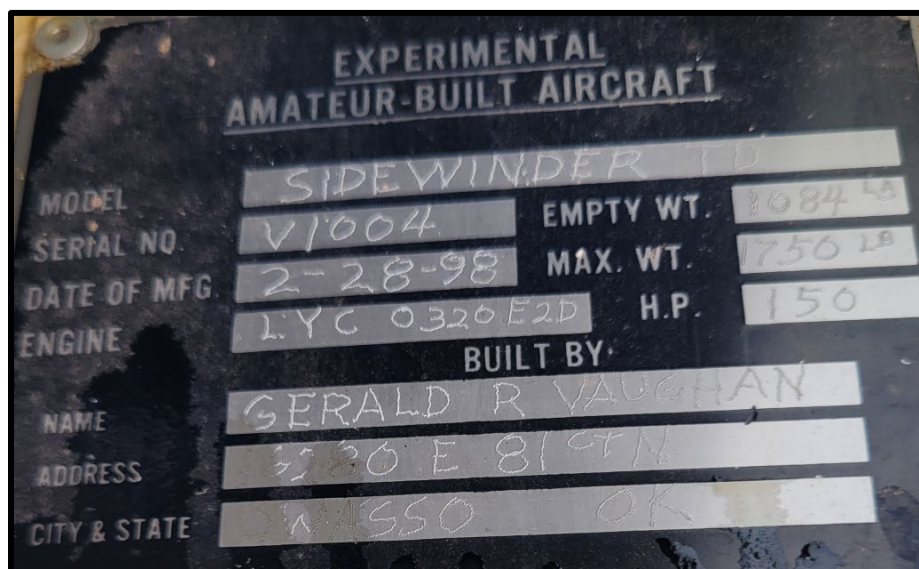
Figure 10: Airplane's Data Plate

The fuselage came to rest inverted and was partially consumed by fire. The data plate indicated the airplane was a Sidewinder (s/n V1004).

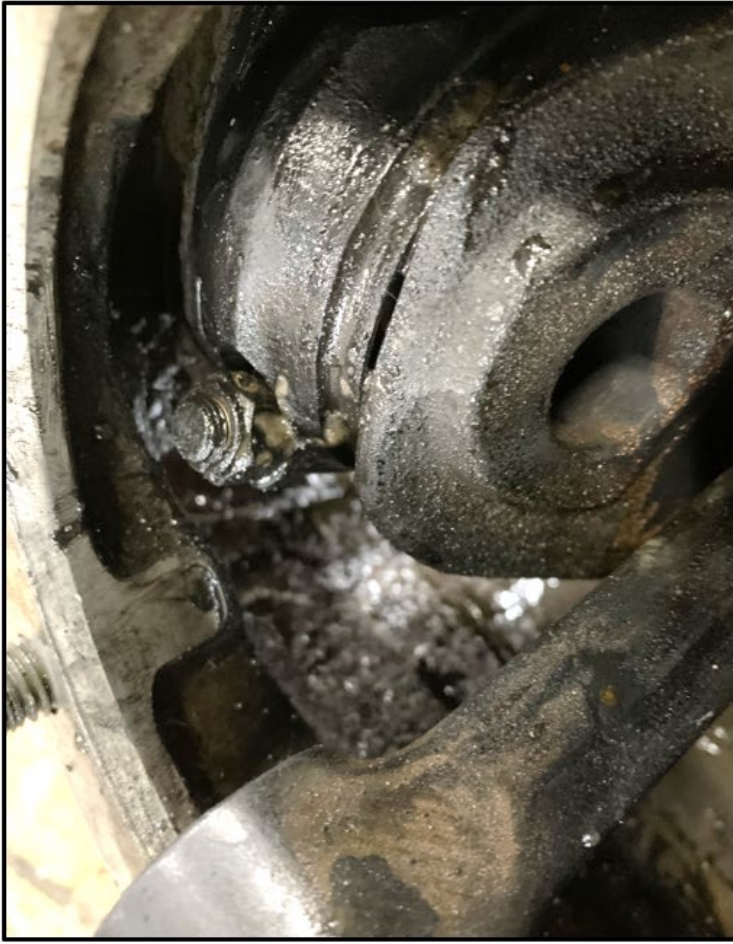
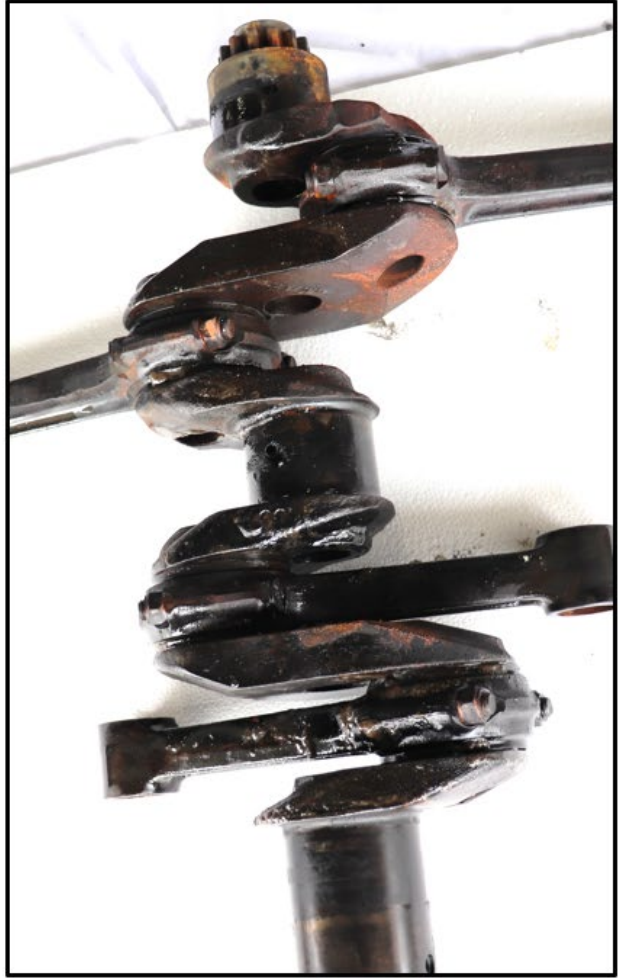
*Figure 14: Crankshaft*

Investigators completely disassembled the engine. The cylinder's combustion chambers remained mechanically undamaged, and there was no evidence of foreign object ingestion or detonation. The valves were intact and undamaged. There was no evidence of valve-to-piston face contact observed. The gas path and combustion signatures observed at the spark plugs, combustion chambers, and exhaust system components displayed coloration consistent with a post-crash fire.
