# National Transportation Safety Board

WPR22FA354

## **MATERIALS LABORATORY**

Factual Report 23-050

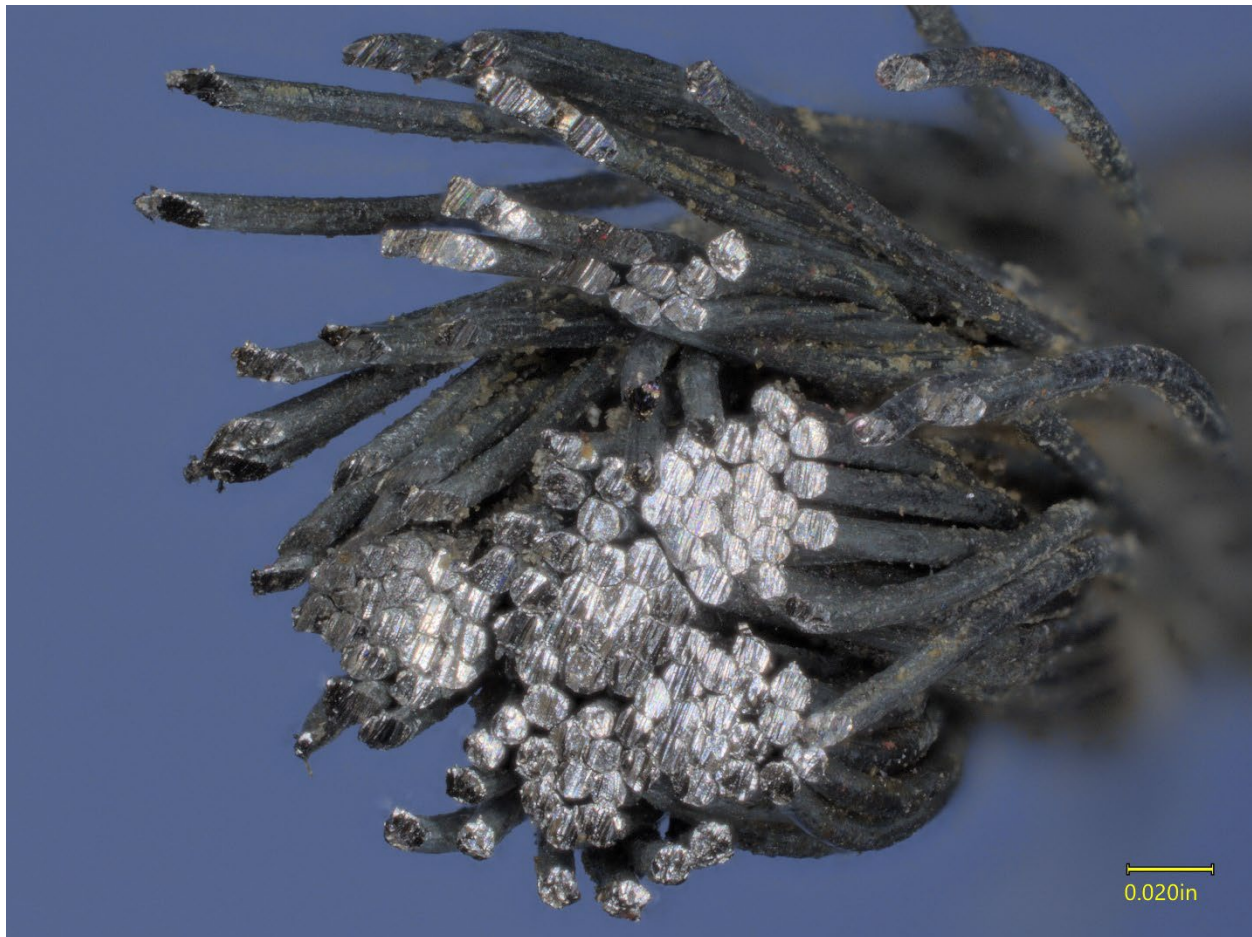
**Figure 11.** Comparative view of the opposite cut and sectioned wires from the left aileron cable, shown for comparison to the fractured end.
