## **NATIONAL TRANSPORTATION SAFETY BOARD**

# **AIRFRAME AND ENGINE EXAMINATION**

**WPR22LA061**

Aircraft: Rans RV-3 / N9YY

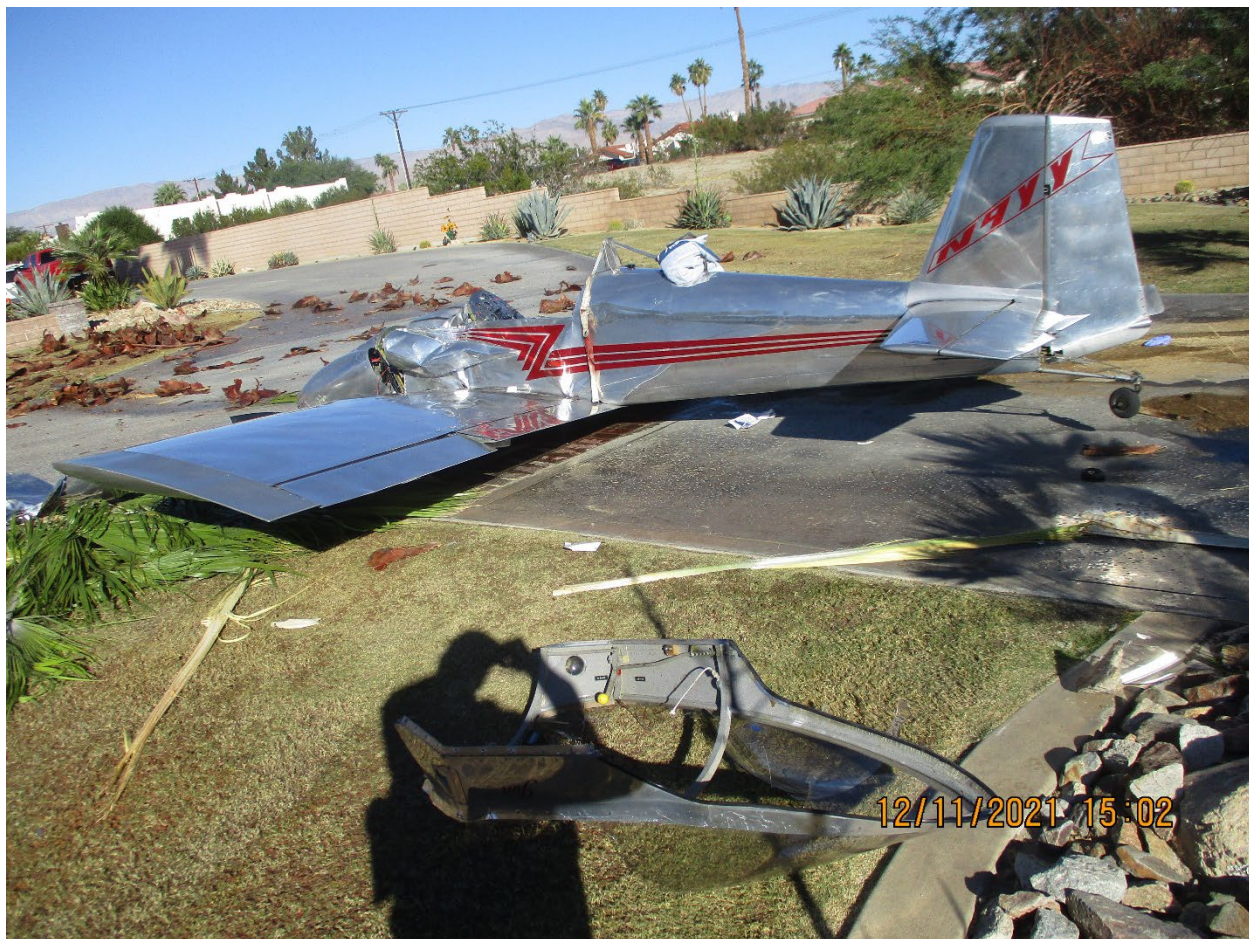
Figure 3. N9YY at accident site. Photo courtesy of the Riverside Sheriff's department.

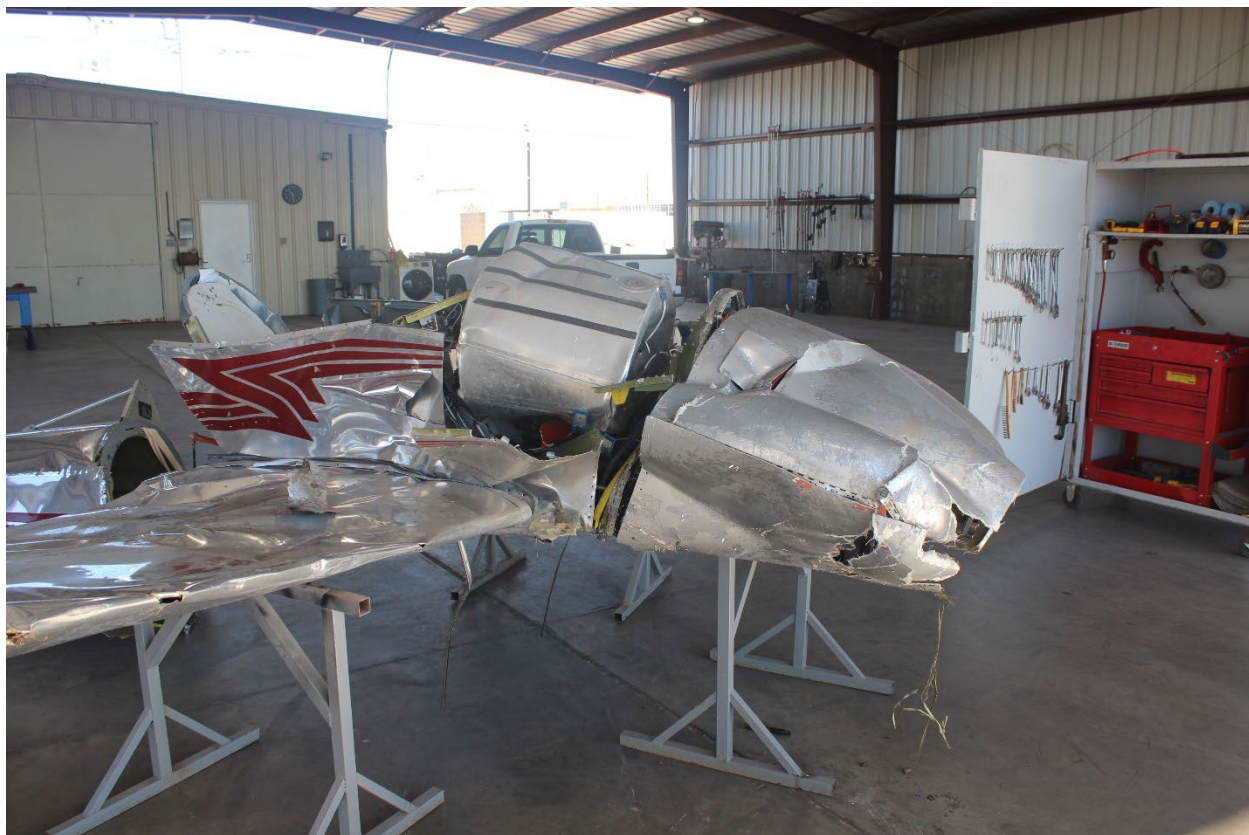
Fuselage. Beginning on the right side. The fuselage sheet metal on the right side was pulled away from the cockpit area, possibly for recovery purposes. The fuselage skin was damaged with dents and wrinkled skin throughout. The 24-gallon fuel tank remained partially separated and has held in place only by the fuel line at the bottom of the tank. The fuel shutoff valve was found with the lever 90° to the fuel line. This position placed the orifice about 50% open. A fuel gauge, located on the rear of the fuel tank indicated 15 gallons, with the tank empty. There were multiple breaches in the tank. According to the recovery agent, about 8 gallons of fuel drained from the fuel tank after the accident. The one-piece canopy separated from the fuselage, possibly by first responders. The acrylic had shattered and was found withing the wreckage.

The right wing remained attached to the fuselage and exhibited substantial damage in the form of aft crushing near the root, and dents and wrinkling of the sheet metal throughout the top of the wing. The leading edge did not exhibit indentations from striking an object. The right-wing tip and inboard to about two feet of the wing exhibited upward bending and scoring of the lower skin of the wing consistent with contacting a hard surface. The aileron remained attached at its mounts and moved with moderate force to the stops. The flap remained attached at its mounts and appeared to be in the full up position. Damage to the right flap was observed at the root. The flap would not move.

Figure 4. N9YY at the recovery facility. Right-side view.

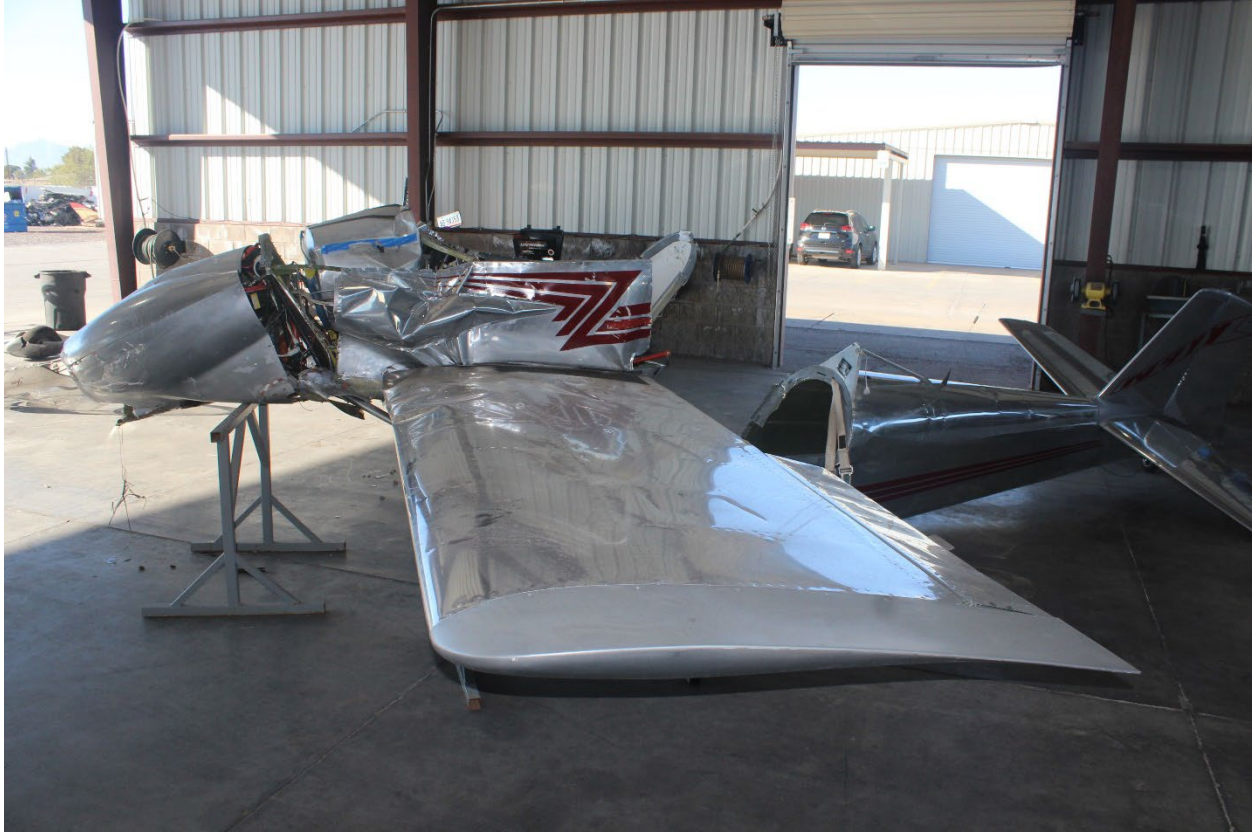
The left side of the fuselage exhibited substantial damage in the form of dents and wrinkles to the sheet metal. The left wing remained attached to the fuselage and exhibited substantial damage at the root, outboard to about 4 feet, mostly along the leading edge aft to about mid chord length. The leading edge did not exhibit direct contact with an object. The wing tip was undamaged. The aileron remained attached at its mounts and moved to its limits. The left flap remained attached at its mounts and appeared in the full up position. The flap would not move.

Figure 7. Left-side view.

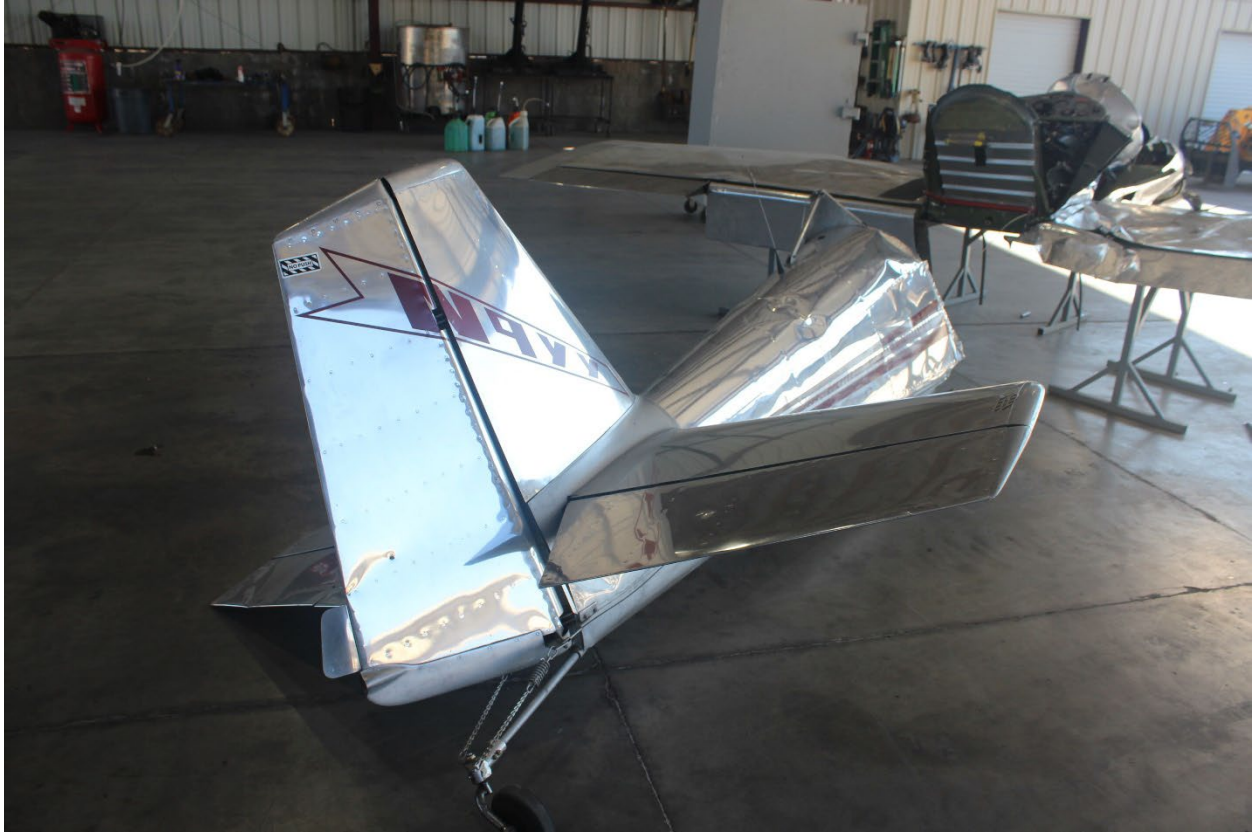
The aft fuselage, from the rear of the pilot's seat to the empennage was separated during recovery and exhibited minor damage throughout with some dents and wrinkling of the sheet metal. The right horizontal stabilizer remained attached to the empennage and exhibited no damage. The right elevator remained attached to the horizontal stabilizer and exhibited no damage. The vertical stabilizer remained attached to the empennage and exhibited no damage. Th rudder remained attached to the vertical stabilizer and exhibited no damage. The left horizontal stabilizer remained attached to the empennage and exhibited no damage. The left elevator remained attached to the left horizontal stabilizer and exhibited minor damage with slight upward bending at the outboard tip. The right side of the aft fuselage exhibited minor dents.

Figure 10. Right-rear view.

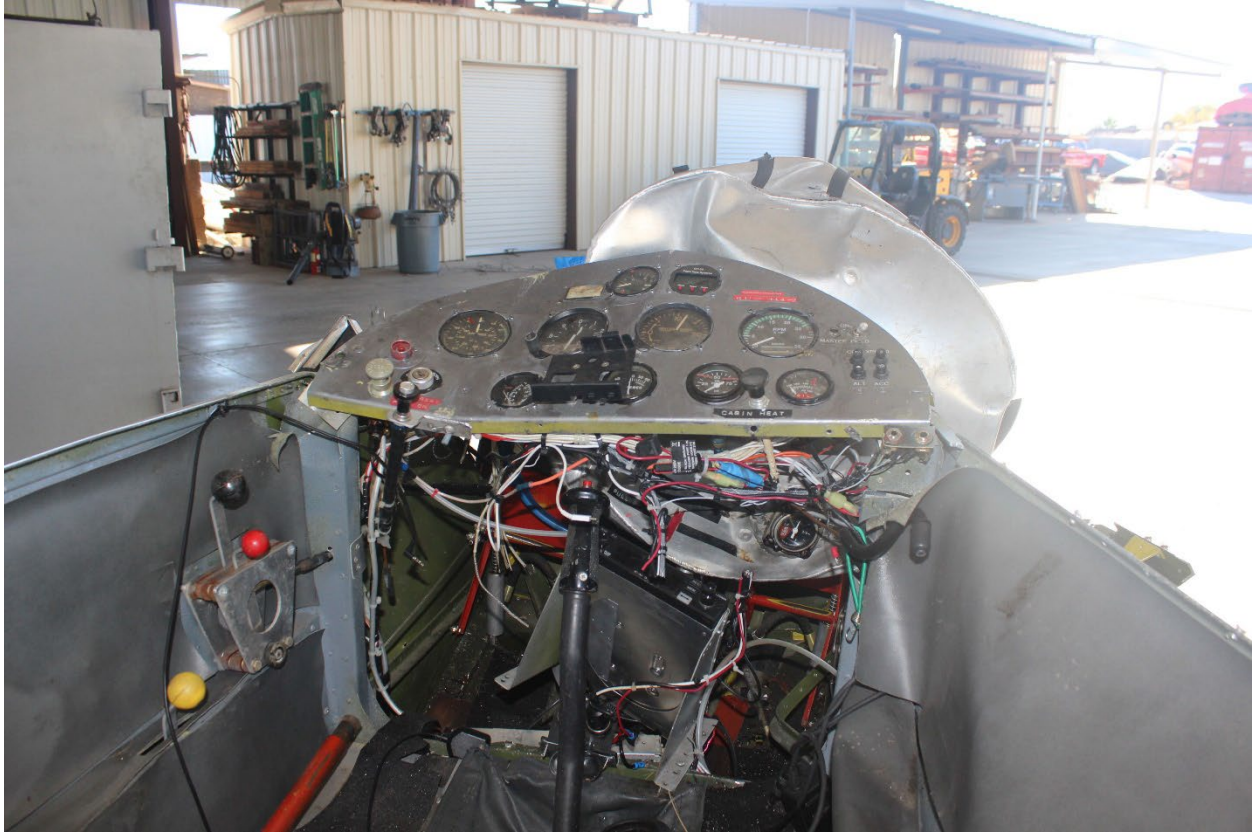
The single seat cockpit was not compromised for living space. The seat consisted of a one-piece cushion with a four-point seat belt and shoulder harness. The seat belt was unlatched but intact. The shoulder harness remained attached to the mounts located on the aft fuselage.

Figure 12. Cockpit view.

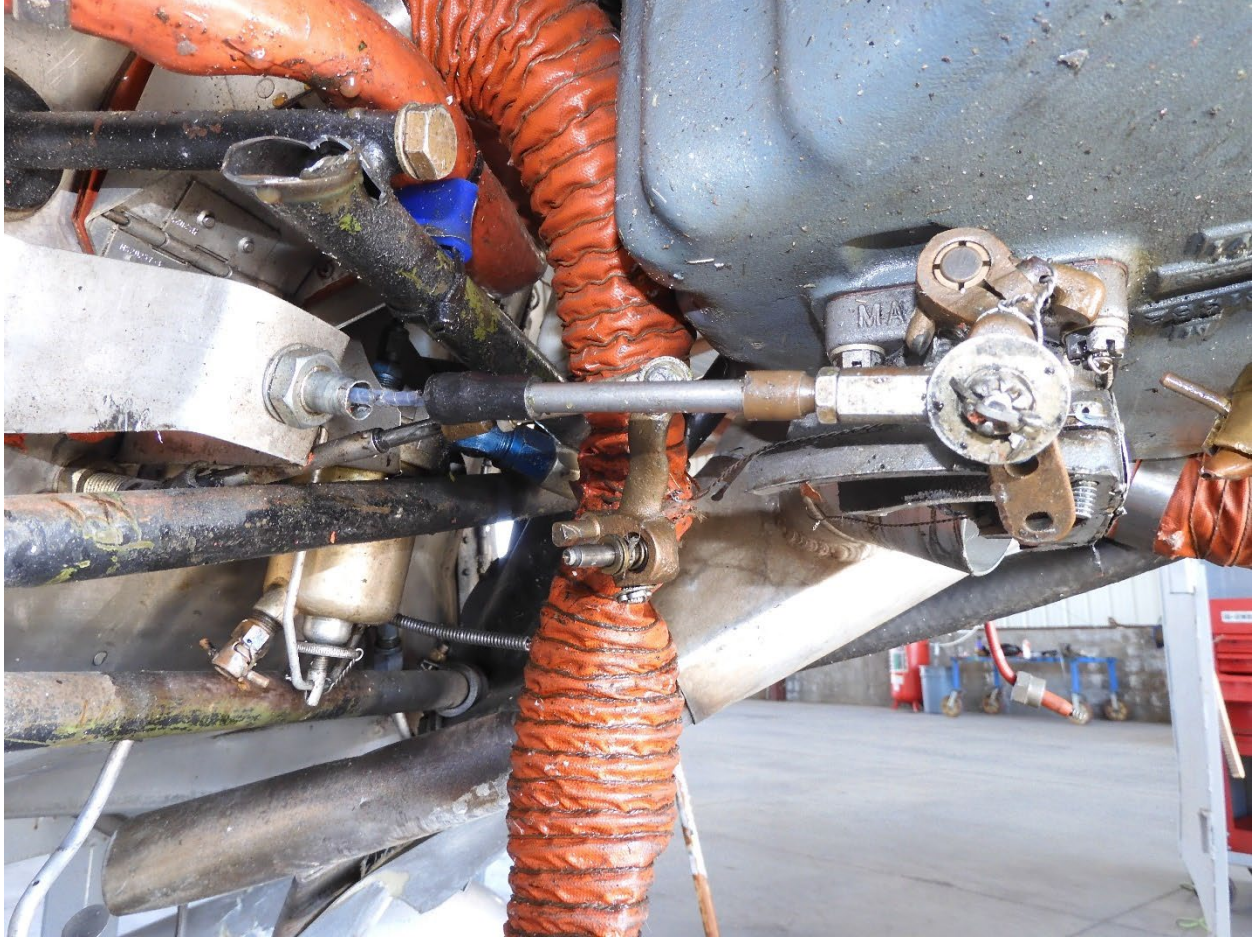
Figure 26. Throttle cable and throttle arm linkage.

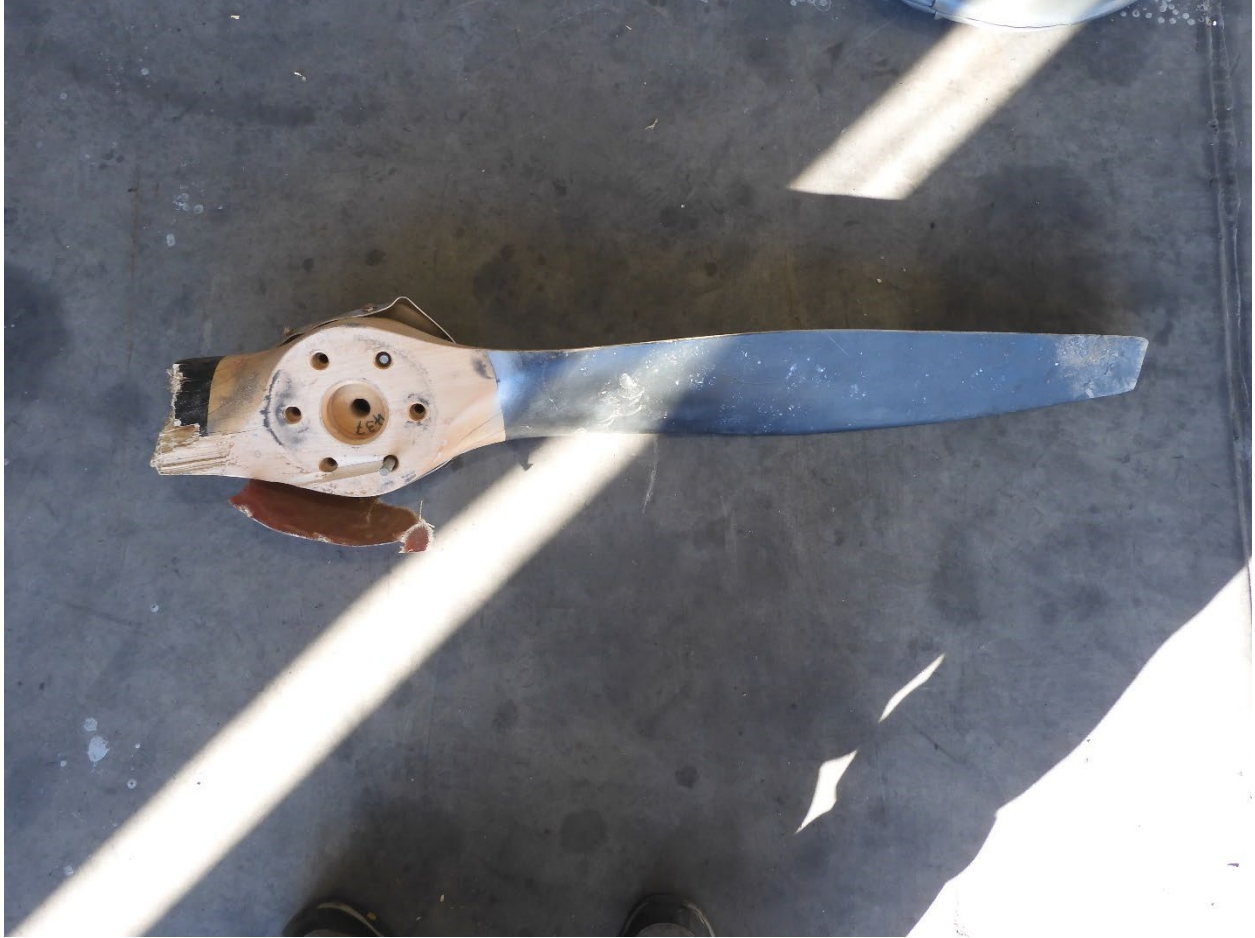
Propeller. The propeller was removed during recovery. The wooden propeller exhibited a fracture and separation of one blade. The blade was observed near the palm tree but not recovered. The fracture exhibited a front to back break. The opposite propeller blade exhibited very minor damage and did not appear to have struck an object. Minor removal dents were observed on the back side of the blade. The composite spinner was fractured into multiple pieces and mostly separated from its mount.

Figure 31. Back-side view of the propeller.
