**NATIONAL TRANSPORTATION SAFETY BOARD**  
Vehicle Recorder Division

## **Onboard Image Recorder**

### **Specialist's Factual Report By Kyle Garner**

| NTSB Number: | WPR22LA076 |

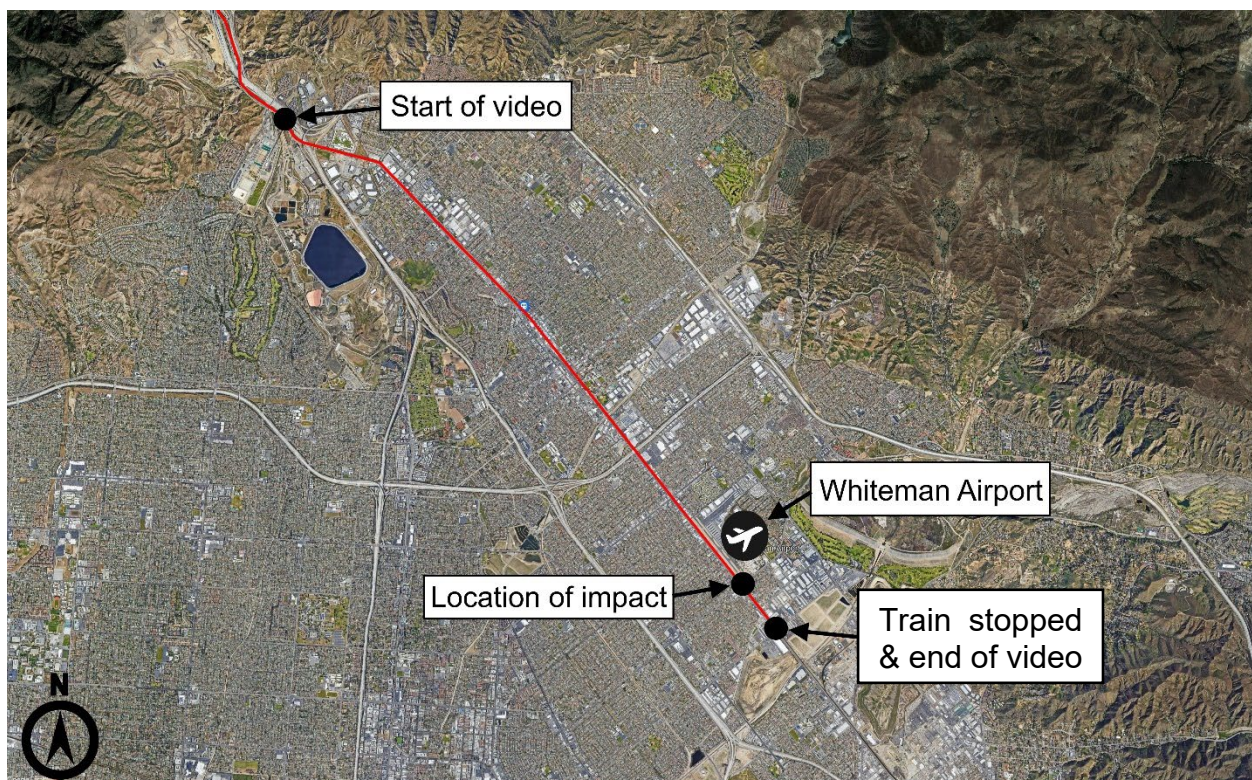
The four files included video data captured on the day of the event from 14:07:59 to 14:28:00 OIR time. Metadata in the file indicated that the video was recorded at a resolution of 672 x 224 pixels. Figure 1 is a Google Earth<sup>1</sup> overlay of the track location (in red), the location of the impact of the train and plane, the location of Whiteman Airport (from where the aircraft departed), and the final stopping point of the train as shown in the video.

**Figure 1.** Google Earth overview of the location of the track, airport, impact, and the stop/end of the video.

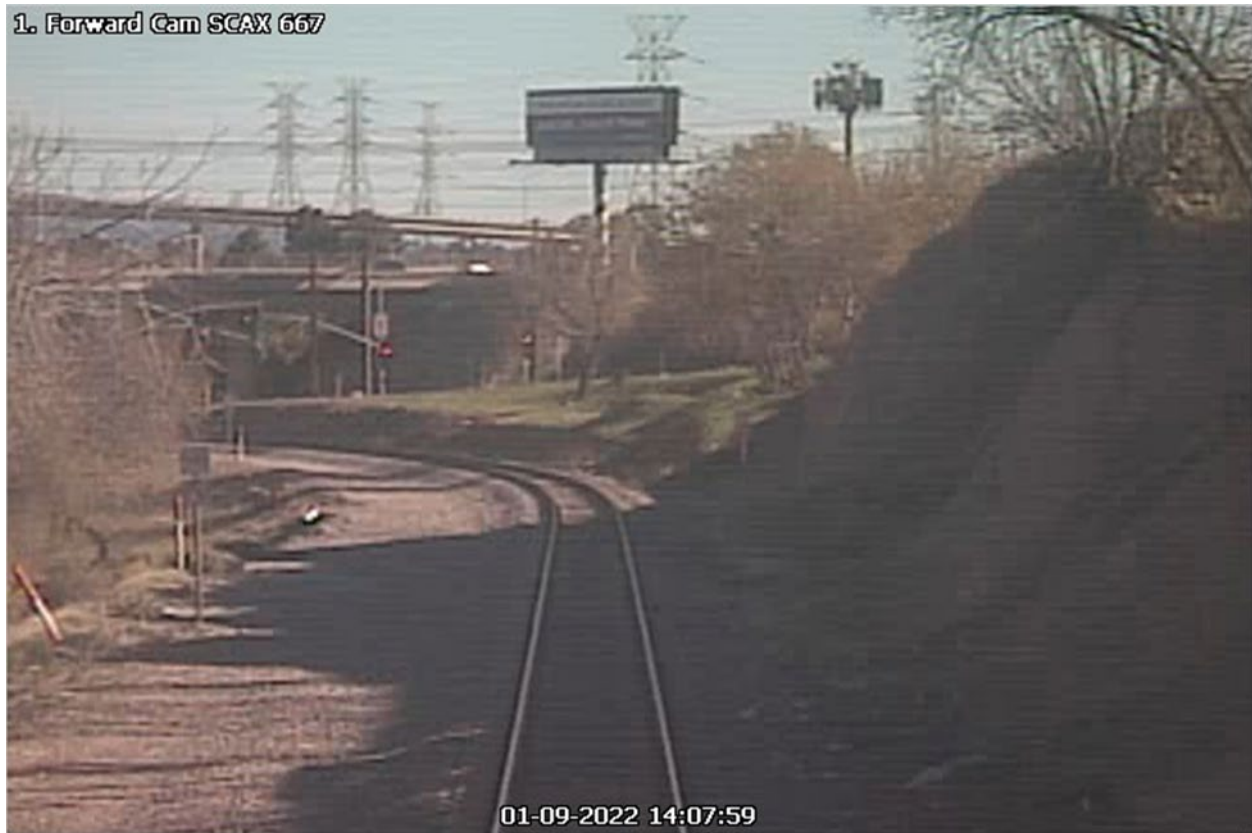
The recording began at 14:07:59 at the location shown in Figure 1. The first frame of the exterior forward-facing video is shown in Figure 2

**Figure 2.** The first frame of the exterior forward-facing video.
