National Transportation Safety Board

WPR22LA114

**INVESTIGATIVE SUPPLEMENTAL MATERIAL**

Location: Oceanside, California  
Date: February 24, 2022  
Time: 1245 Pacific daylight time  
Airplane: Cessna C208B Supervan 900

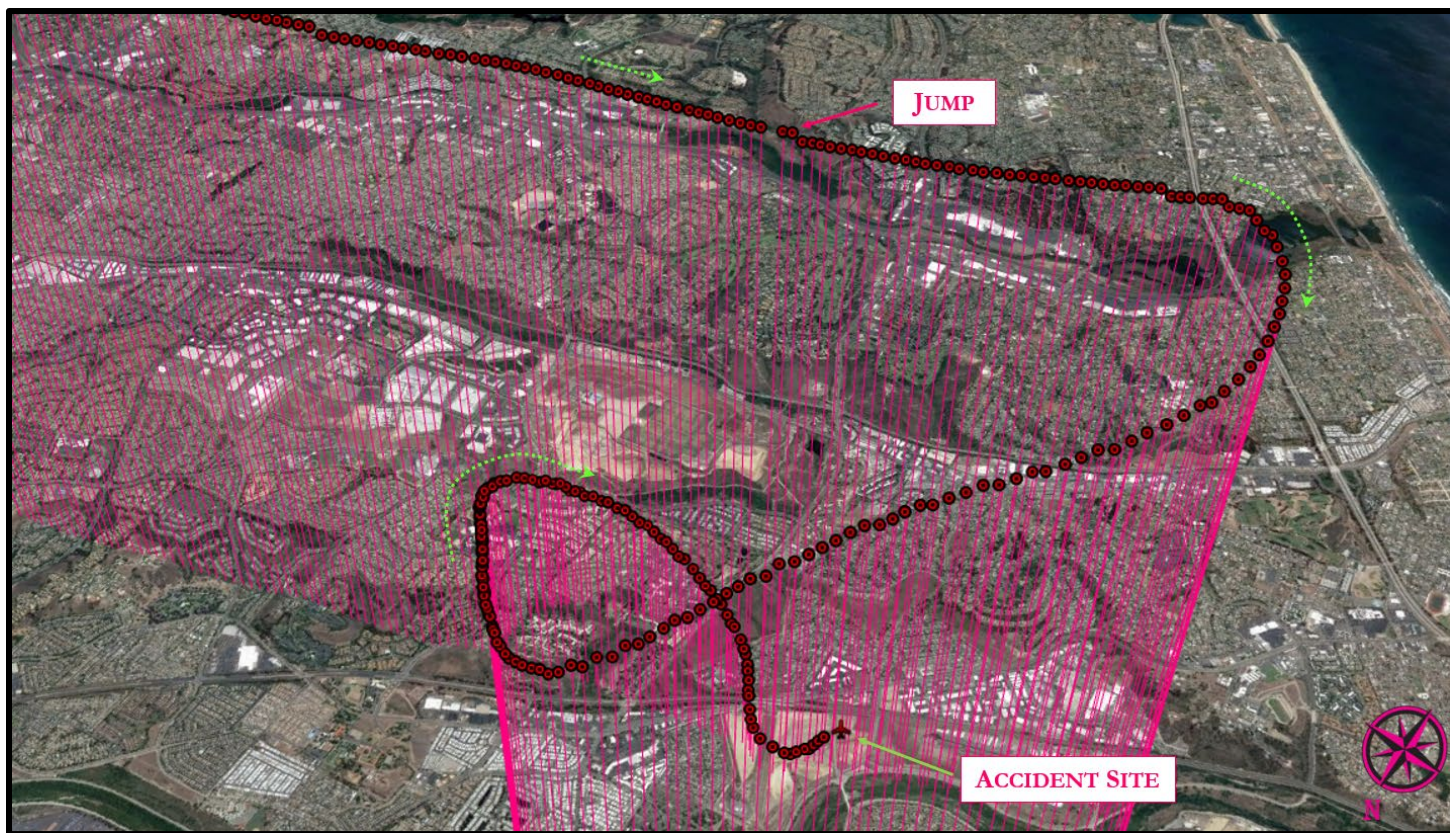
Figure 4: Final Portion of Accident Flight

The pilot further stated that despite his attempts to add power, movement of the power lever was unresponsive. He moved the propeller speed lever, which was also unresponsive. The pilot presumed the engine flamed-out and attempted a restart. With the propeller still windmilling, he switched the ignition to “continuous” and turned the boost pump on. He observed the torque gauge increase from 0% to 20%, but the thrust lever was still unresponsive. He added full nose-up trim and the control yoke was full aft, against the stop, but the airplane could not maintain a level attitude. With the airplane in a nose-low attitude, it collided with terrain about 1,400 ft short of the runway. The pilot stated that he did not feather the propeller.

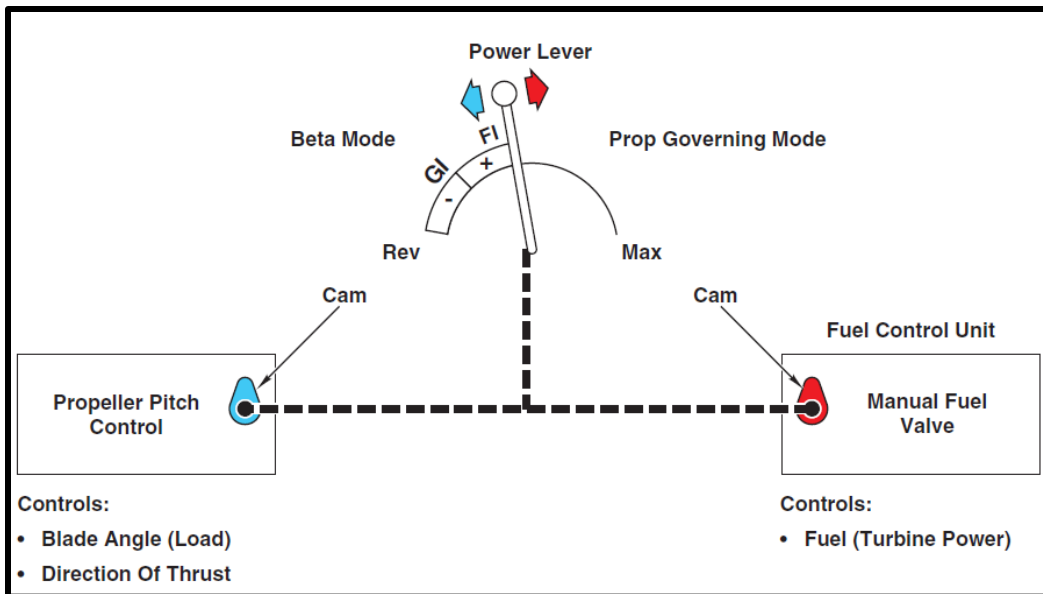
Figure 7: Diagram of Power Lever

In the TPE331 control system, if the pilot reduces the power lever to idle, the blade angle will lower to attempt to equal the demanded power, by a increase in pressure supplied from the propeller governor, until the blade angle cannot decrease due to the low pitch stop (5.5° in the accident airplane). Once it can't maintain 100% (1591 rpm), the rpm will drop until reaching 97% (1543 rpm). The underspeed governor then adds power/fuel as needed to maintain 97%.

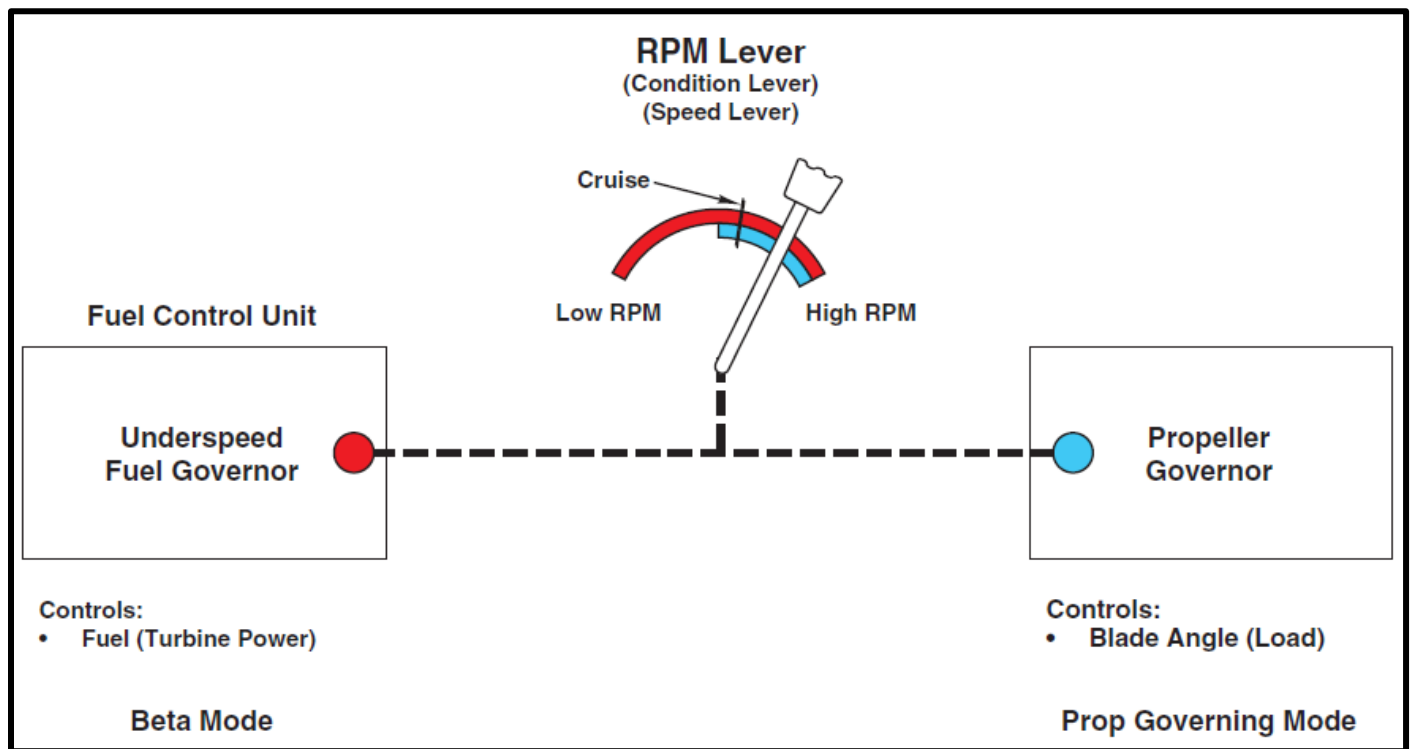
Figure 8: Diagram of Speed Lever

The propeller governor assembly regulates propeller speed at different engine settings, controlled by the speed lever in the cockpit to adjust preload on the governor's speeder spring. In beta mode, the propeller governor supplies high pressure oil directed through the propeller pitch control to adjust blade angle manually. This control comprises a cam-driven ported sleeve housing a beta tube, which aligns oil supply holes to balance propeller pressure. In case of a negative torque sensor malfunction, the pilot can move the power lever forward to maximize blade angle for minimal drag, using the beta follow-up system. The propeller oil-transfer tube, extending from the propeller dome to the propeller pitch control, regulates oil pressure jointly with the control during beta mode, while serving as a conduit in governing mode.

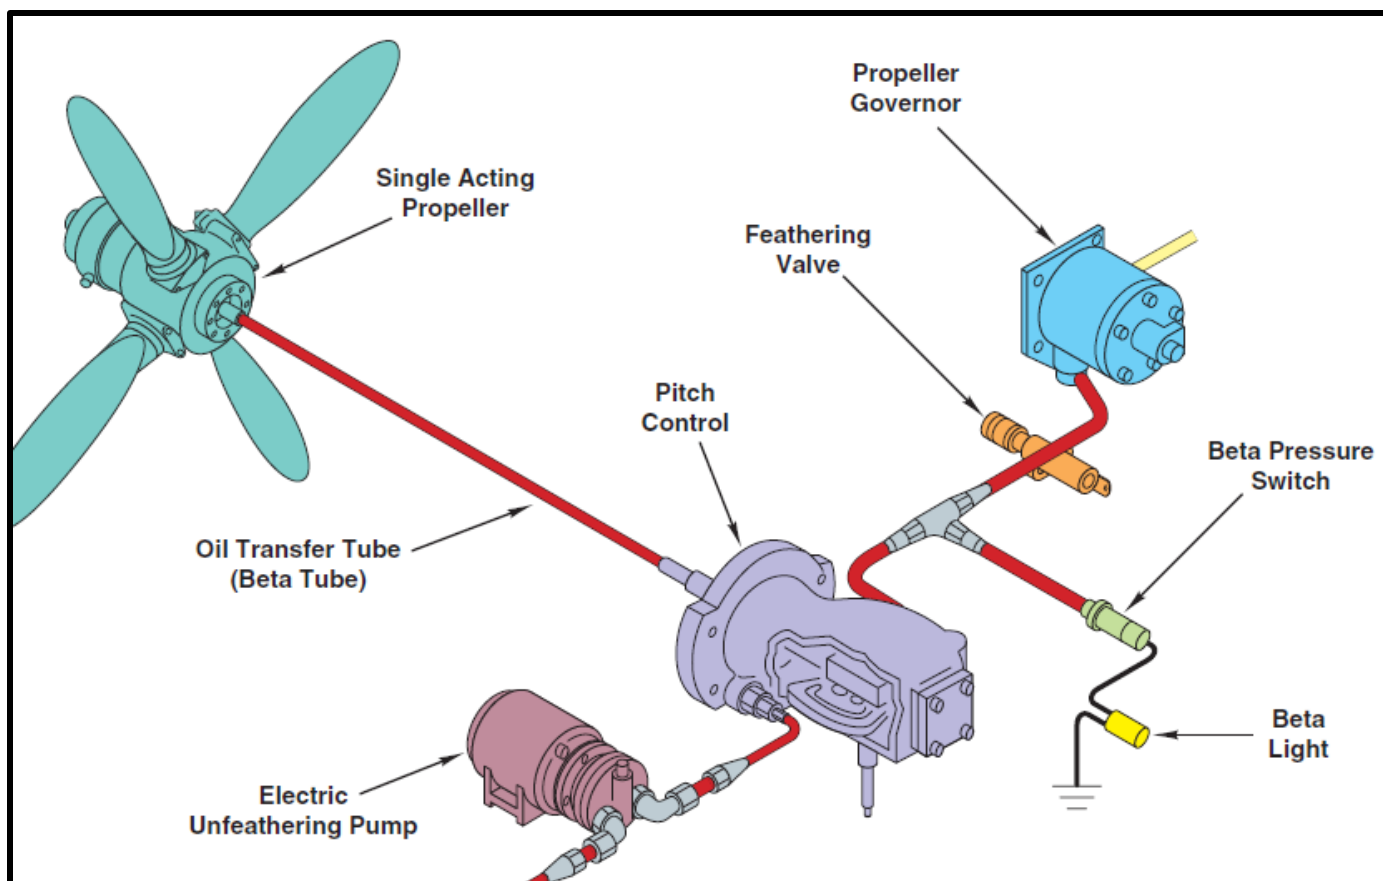
Figure 9: Diagram of Propeller Components

The aerodynamic forces acting on a propeller blade were contingent upon blade angle, aircraft speed, and rotational speed (rpm). During flight idle, the blade angle can become fixed aerodynamically, with the potential for complete locking to the reverse mechanical stop, due to the aerodynamic load on the propeller exceeding the forces of the propeller controls.. The prospect of decelerating the airplane towards stall at low altitude could pose a significant risk, exacerbated by diminished elevator control resulting from the low dynamic pressure within the propeller slipstream, which may impeded the pilot's ability to modulate airplane airspeed effectively.

Available recourse for the pilot involves reducing rpm beyond the transition from high to low on the speed lever. Under such conditions, the sole method to achieve this on the TPE331 engine is for the pilot to shut-down the engine completely (dumping all oil pressure). This action would provide a reduction in rpm, thereby diminishing the aerodynamic twisting moment and facilitating the "unlocking" of the propeller (override the twisting forces towards reverse).<sup>1</sup> Consequently, the forces of the feathering spring and counterweights would be greater than the aerodynamic forces and move the propeller blade angle towards feather. As long as the propeller is rotating and the blades are stuck in the reverse position, the drag on the propeller inhibits elevator control.
