VAN HORN AVIATION, L.L.C.  
Tempe, Arizona

**REPORT No. 206BT-STR-508**  
**STRUCTURAL TEST REPORT**  
**EVALUATION OF N90326 CRASH DAMAGE TO 2062200 TAIL**  
**ROTOR BLADES**

July 18, 2023

The following report presents a visual evaluation of damage to 2062200-301 Tail Rotor Blades with serial numbers C548 & C549 installed on Bell 206 JetRanger tail number N90326, which was involved in an accident near Stockton, CA on June 17, 2022 (Reference 1).

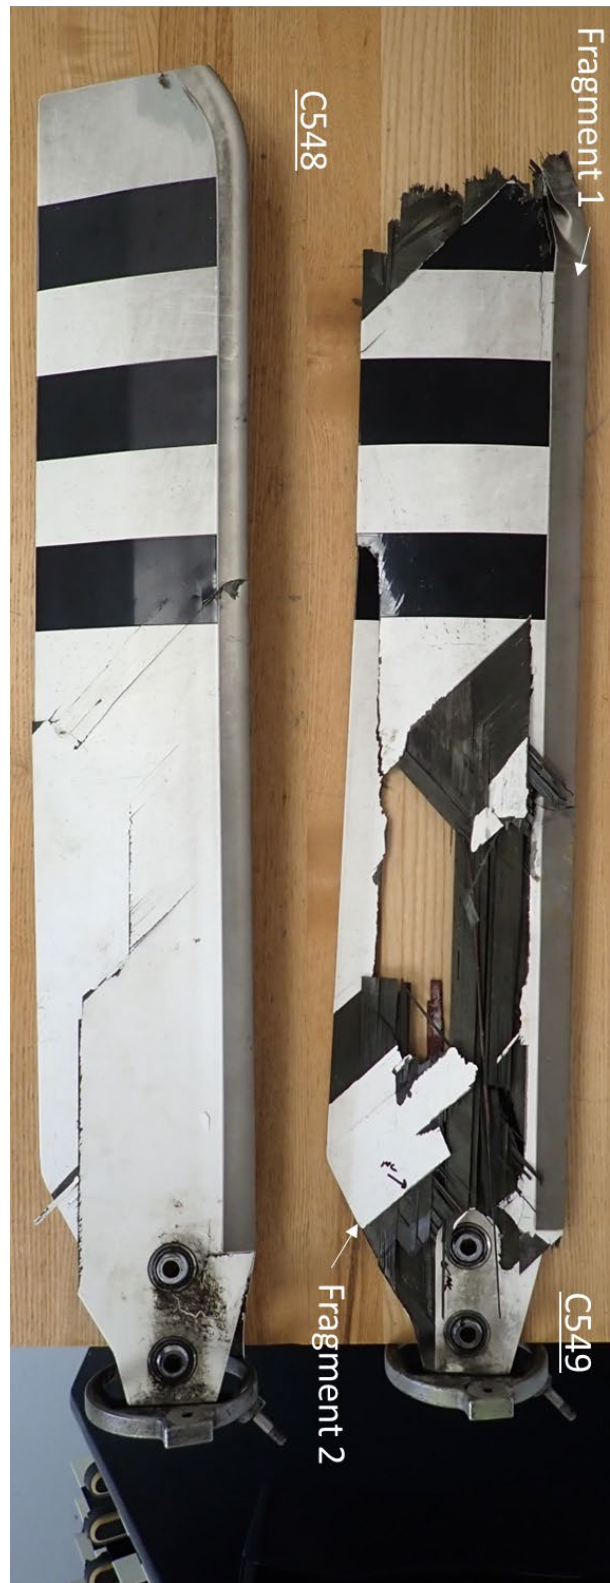
**Figure 5 – Overall View of Blades C548 & C549 Lower Surfaces**

The referenced 2062200-301 blades were sent to Van Horn Aviation for examination after a hard landing in which the pilot reported a vibration, hearing a bang, and a loss of yaw control. The helicopter came to rest in an orchard after contacting a tree. It landed flat but was spinning to the right and rolled onto its left side. Blade C548 was primarily intact and still attached to the tail rotor hub. Blade C549 was fractured into multiple pieces of which only the root fitting was still attached to the hub (Figure 3). According to the pilot, he recovered two additional fragments approximately 2000 ft from the main wreckage. Both blades, including the separated fragments of C549, are shown in Figure 5.

The mid-span fracture predominantly follows a 45 deg angle from leading to trailing edge. The lower surface (Figure 7) exhibits multiple parallel translaminar fractures following the 45 deg ply with nearly chordwise fractures through the abrasion and trailing edge strips. Of interest, some of the carbon laminate attached to the outboard side of the abrasion strip crack was forced past the lower surface of the inboard portion of the abrasion strip. Similarly, some of the inboard portion of the trailing edge strip was forced past the lower surface of the outboard laminate. On the upper surface (Figure 6), more extensive damage is seen including portions of the upper skin & spar missing and multiple core fractures. At the leading edge there are multiple scrapes and material transfer marks as well as a second smaller crack and a dent approximately 2" inboard of the main fracture (Figure 9). Immediately outboard of the fracture the abrasion strip is buckled on the upper surface and delaminated along its aft edge extending approximately 2 inches outboard. The residual strength and stiffness of the blade allows the tip to move easily upward and rotate nose down along the 45 deg fracture indicating this was the direction of deformation which caused the failure. Such a bending deformation would have put the lower surface in tension and the upper surface in compression. This is consistent with the buckling observed in the abrasion strip as well as the more extensive laminate and core damage observed on the upper surface. The missing laminate likely peeled away from the core, buckled, and fractured at either ends of the buckle which led to its departure.
