# National Transportation Safety Board

WPR22LA259

## **MATERIALS LABORATORY**

Factual Report 23-032

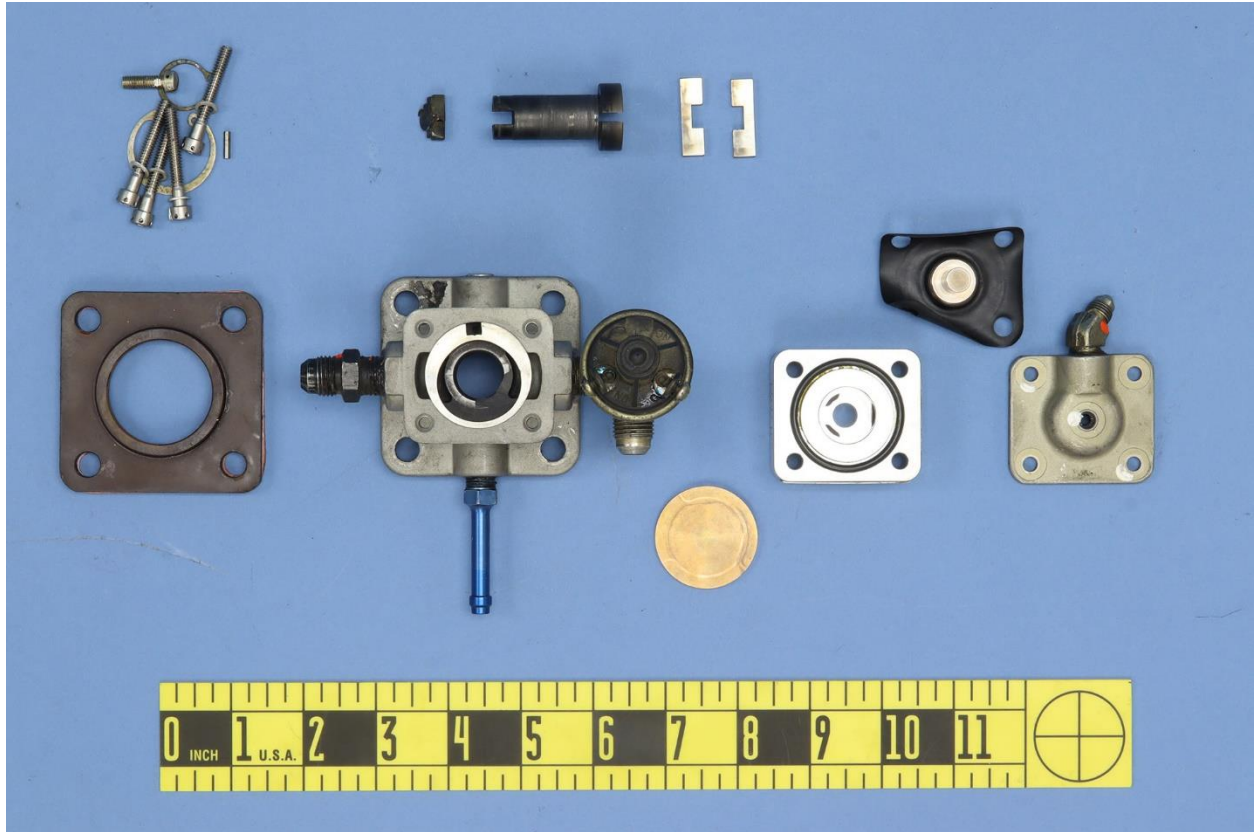
A partially disassembled engine-drive fuel pump was submitted to the NTSB Materials Laboratory for examination as shown in figure 1. The pump consisted of a case-hardened steel rotor (figure 2) that spun inside a carbon bearing (figure 3), both enclosed in an aluminum housing. A rubber O-ring (figure 4) sealed the driven end of the rotor. The driven end of the rotor also contained a slot for interfacing with the tongue of the drive coupling (figure 5). The drive end of the rotor consisted of larger diameter section with two slots at 90° to one another for housing the pump vanes (figures 2, 6, and 7). The vanes rotated within an eccentric liner (figure 8), sliding within the slots as the rotor turned, thereby achieving pumping action. The pump had failed in flight and the rotor had seized. It was sent to the overhaul facility for an initial teardown examination before it was sent to the NTSB lab.

**Figure 1.** Fuel pump assembly pieces, as received.
